STATE OF CALIFORNIA
CALIFORNIA NATURAL RESOURCES AGENCY
DEPARTMENT OF WATER RESOURCES
DIVISION OF SAFETY OF DAMS

INSPECTION OF DAM AND RESERVOIR IN CERTIFIED STATUS

Name of Dam Sand Canyon Dam No. 1029-2 County Orange
 Type of Dam Earth Type of Spillway Ogee weir and channel
 Water is 0.1 feet above spillway crest and 8.4 feet below dam crest.
 Water Surface Elevation El. 193.6'
 Weather Conditions Sunny
 Contacts Made Danielle Drake and Bill Wesson with IRWD
 Reason for Inspection Periodic Maintenance Inspection

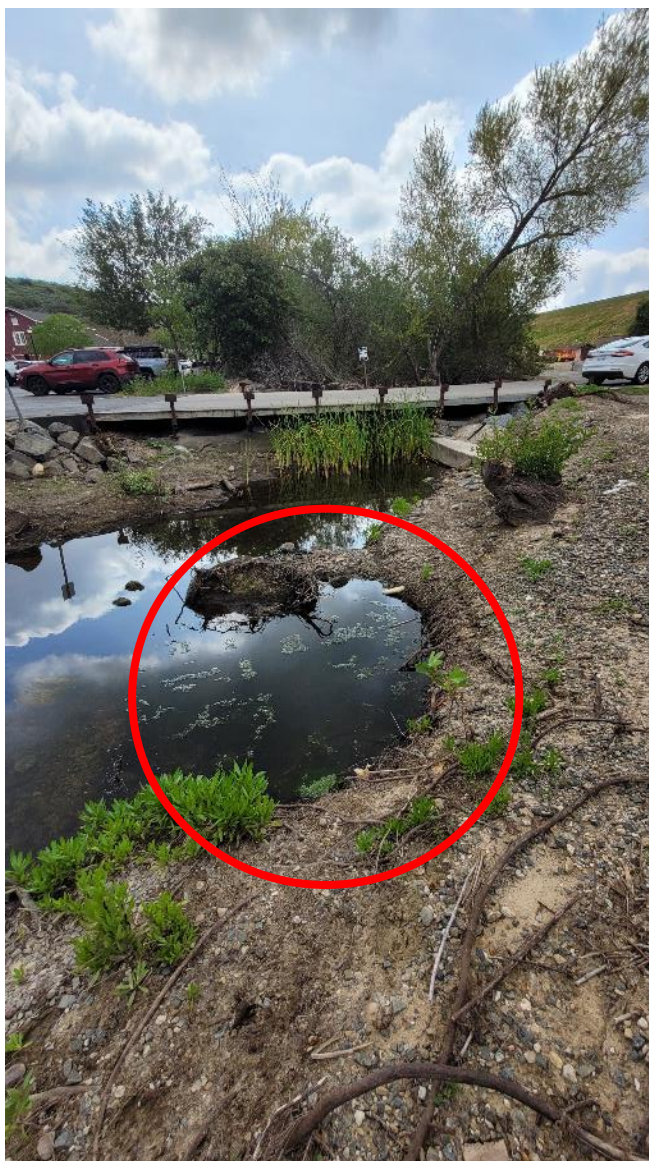
rehabilitate the exit portal area need to be submitted to Area Engineer Cameron Lancaster for review.

Photo 1: View of the exit portal looking upstream. The approximate location of the exit portal is circled and is underwater.

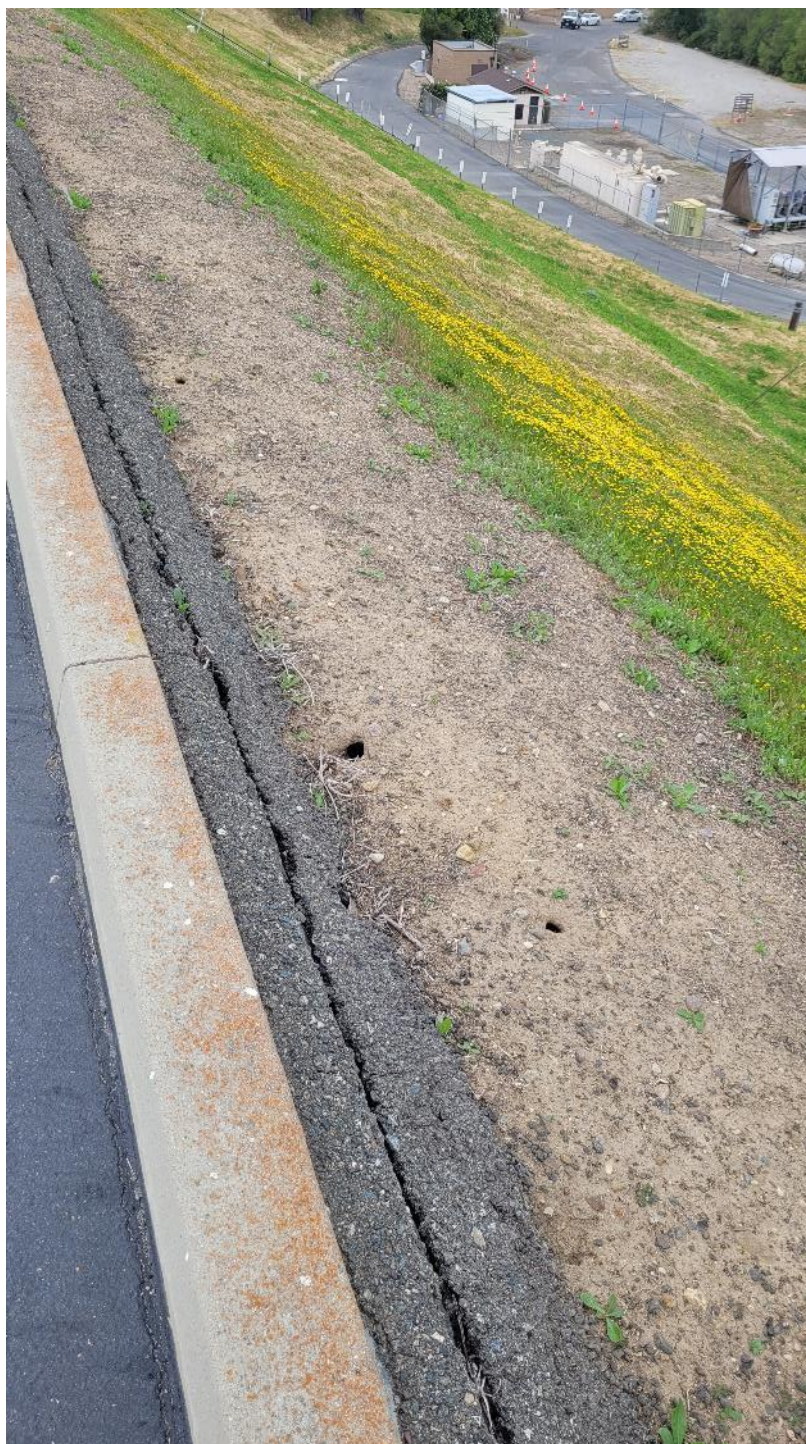
Photo 2: View of rodent holes near the crest and downstream slope.

- The owner needs to collapse, backfill, and compact the rodent holes with suitable material as an ongoing maintenance item.
- There are reeds growing at the exit of the spillway. The owner needs to clear the vegetation at least 10 feet from the exit by November 1, 2023.
- The owner needs to continue to closely monitor piezometer P-2B for any further spikes in the data.
- For future instrumentation reports, rain data needs to be incorporated into the piezometer data plots.
- Arrangements need to be made to fully cycle Slide Gate #2 in DSOD's presence once the slide gate is repaired.

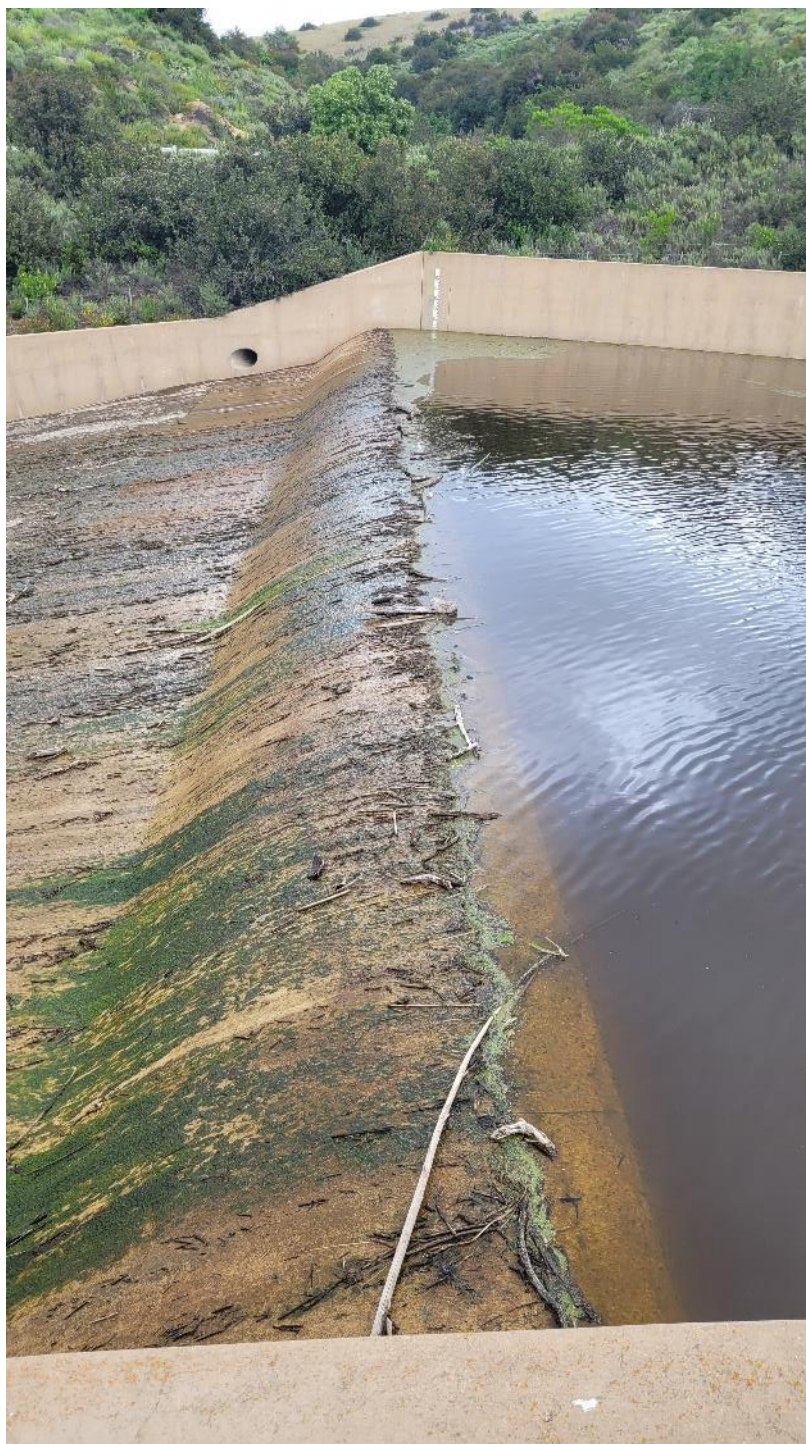
Photo 3: View of the ogee weir of the spillway.

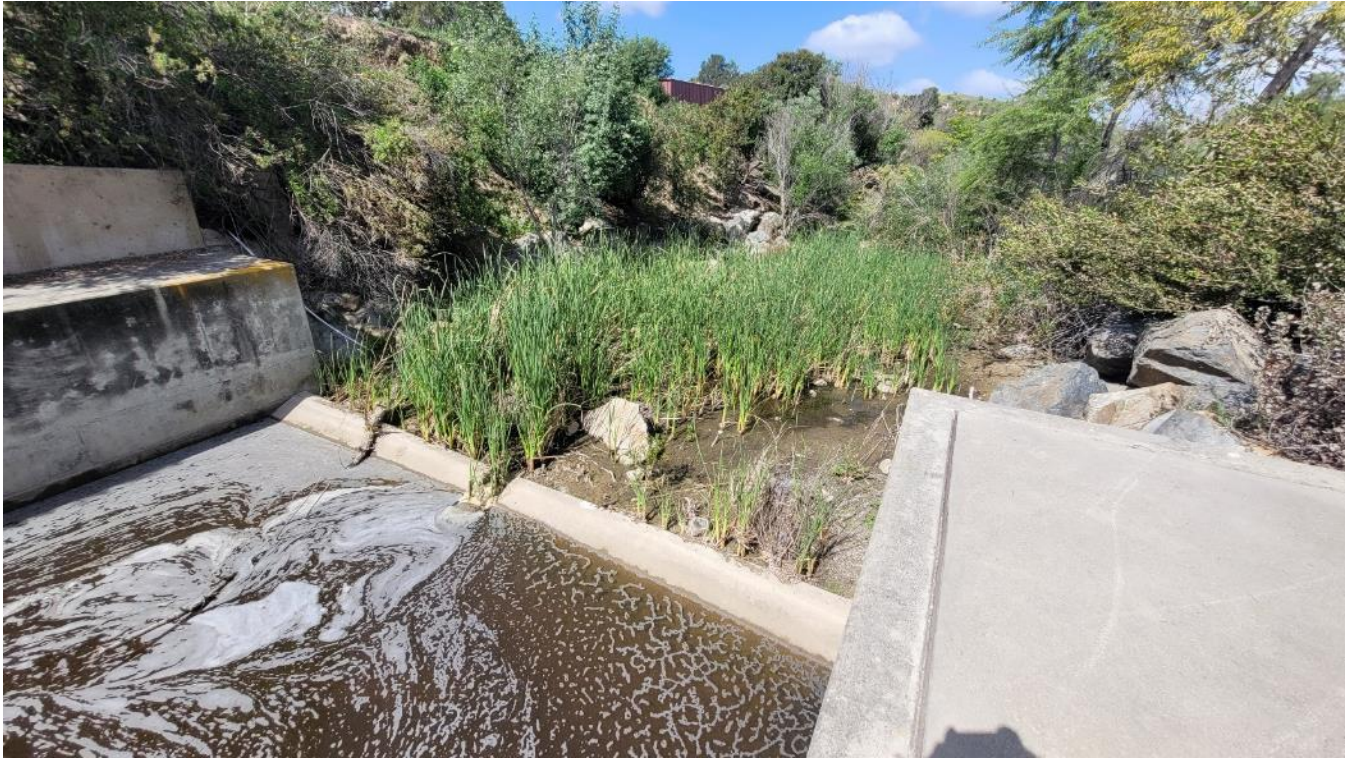
Photo 4: View of the reeds downstream of the concrete spillway channel.

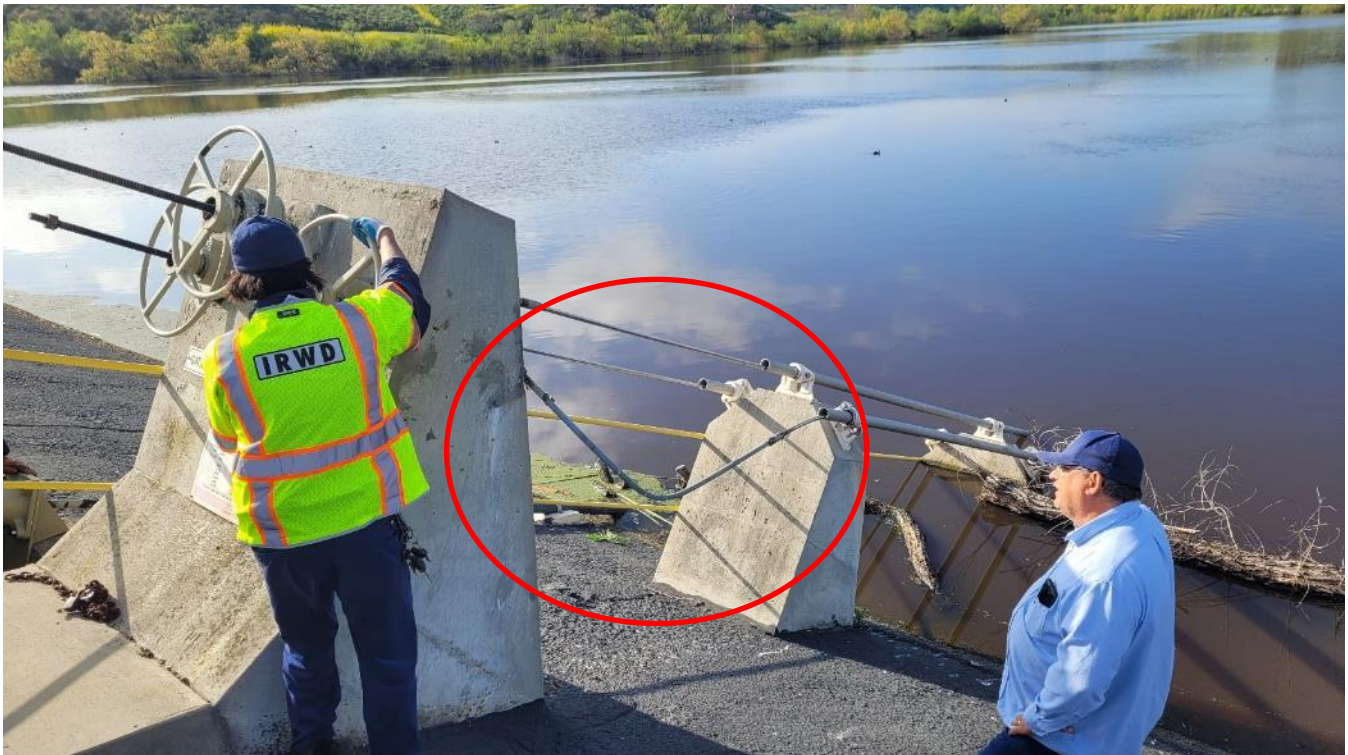
Photo 5: View of the bent slide gate stem.
