INSPECTION OF DAM AND RESERVOIR IN CERTIFIED STATUS

Name of Dam Rattlesnake Canyon Dam No. 1029-3 County Orange
 Type of Dam Earth Type of Spillway Side channel
 Water is 21 feet below spillway crest and 27 feet below dam crest.
 Water Surface Elevation EI. 391'
 Weather Conditions Sunny
 Contacts Made Danielle Drake and Bill Wesson with IRWD
 Reason for Inspection Periodic Maintenance Inspection

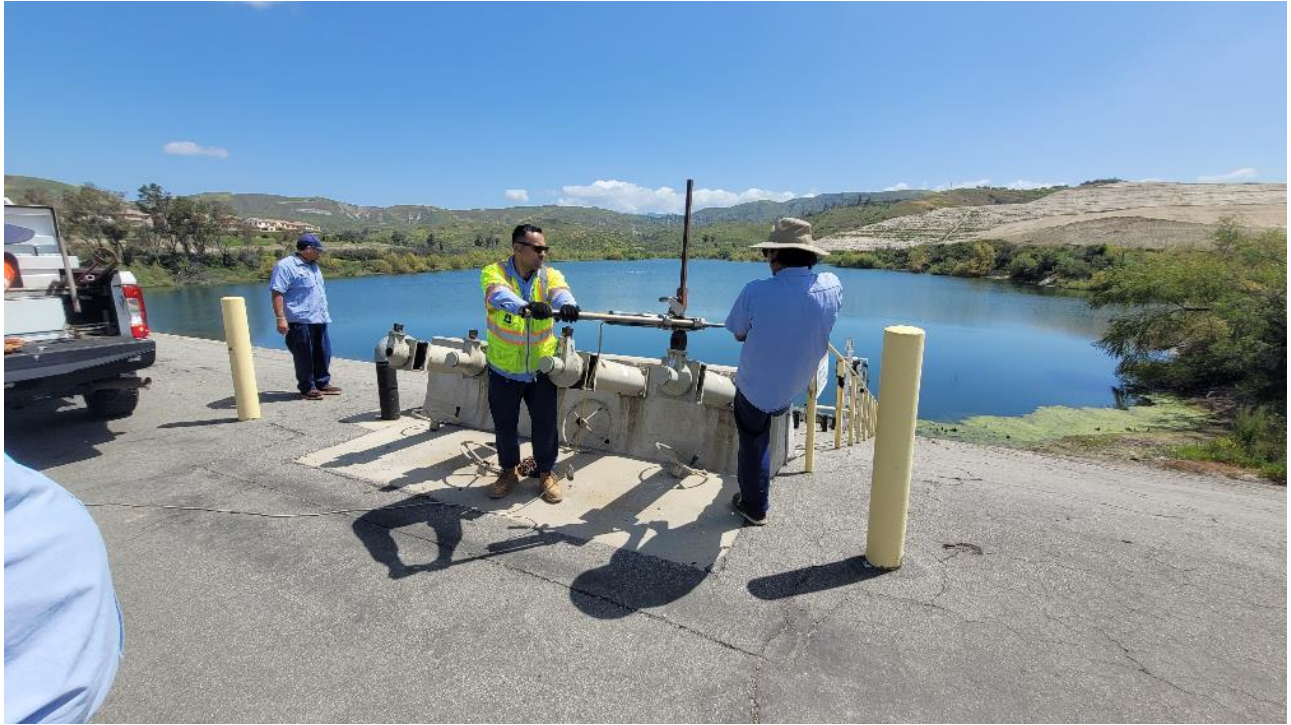
<u>Outlet</u>	The outlet consists of 4 upstream gate valves and 2 downstream valves. All valves were fully cycled during this inspection with no issues. The exit to the outlet was unobstructed. Accompanied with a letter dated May 4, 2023, the owner sent reports reviewing the CCTV inspection of the 24-inch steel outlet pipe and assessing its condition. The owner reported that the pipeline is corroding, and they are currently in the process of investigating the dam and determining possible repairs for the outlet pipe.
<u>Seepage</u>	This dam has 8 seepage points that are reported in the annual instrumentation report. During this inspection, drains 2, 5, 8, and 11 were all dry. Drains 3, 4, FP north, and FP south had flows less

Photo 1: View of the owner cycling the upstream gates.

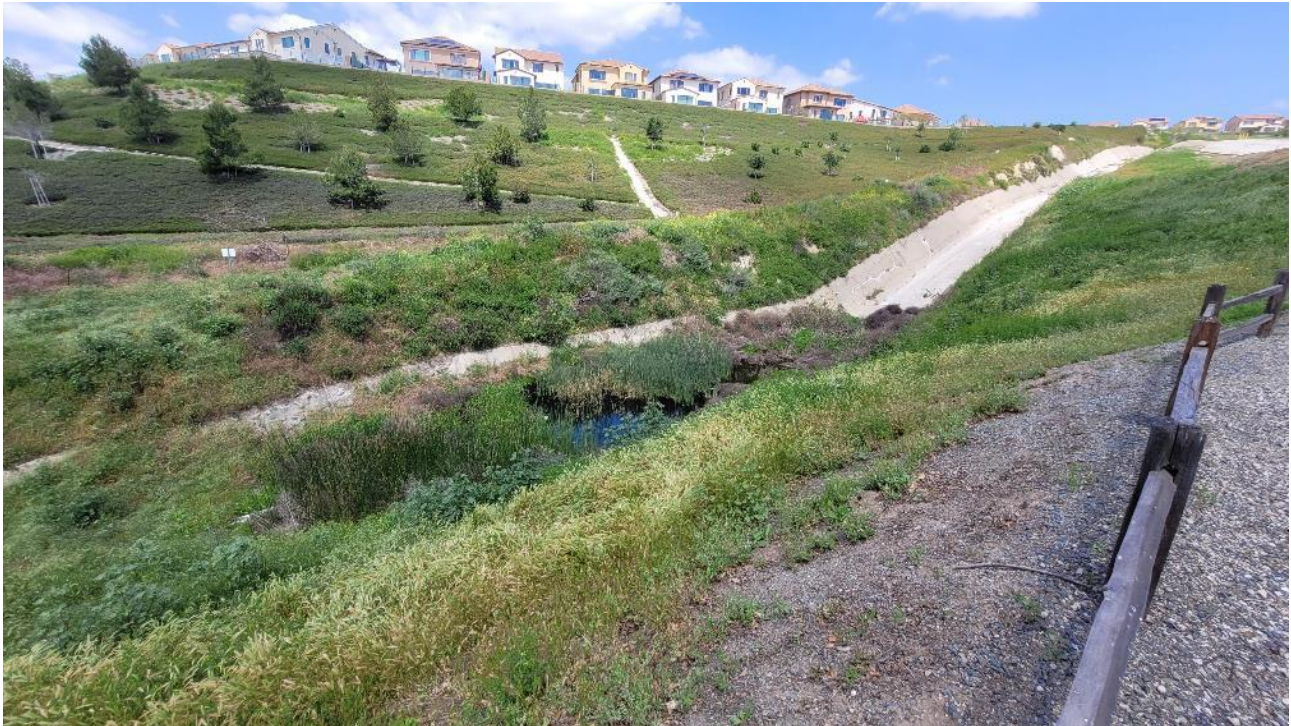
<u>Dam</u>	The asphalt-covered crest appeared level and well-aligned. The visible portion of the asphalt-lined upstream slope, and the earthen downstream slope appeared uniform, stable, and in satisfactory condition. The groins, downstream toe, and abutments appeared satisfactory with no signs of instability or distress. The vegetation is well managed with periodic vegetation control from the owner. The rodent control efforts need to be increased at this dam as rodent activity appears to have increased at the dam. The owner needs to collapse, backfill, and compact the rodent holes with suitable material as they appear.
<u>Spillway</u>	Overall, the spillway approach, weir, and side channel were clear of debris. There is vegetation growing throughout the cracks and joints of the spillway. The owner needs to remove the vegetation and seal the cracks and joints by July 1, 2024. The concrete elements of the spillway appeared to be in satisfactory condition. The exit of the spillway had dense vegetation growing throughout. The owner needs to remove the dense vegetation by July 1, 2024.

Photo 2: View of the spillway exit with dense vegetation growing within the channel.

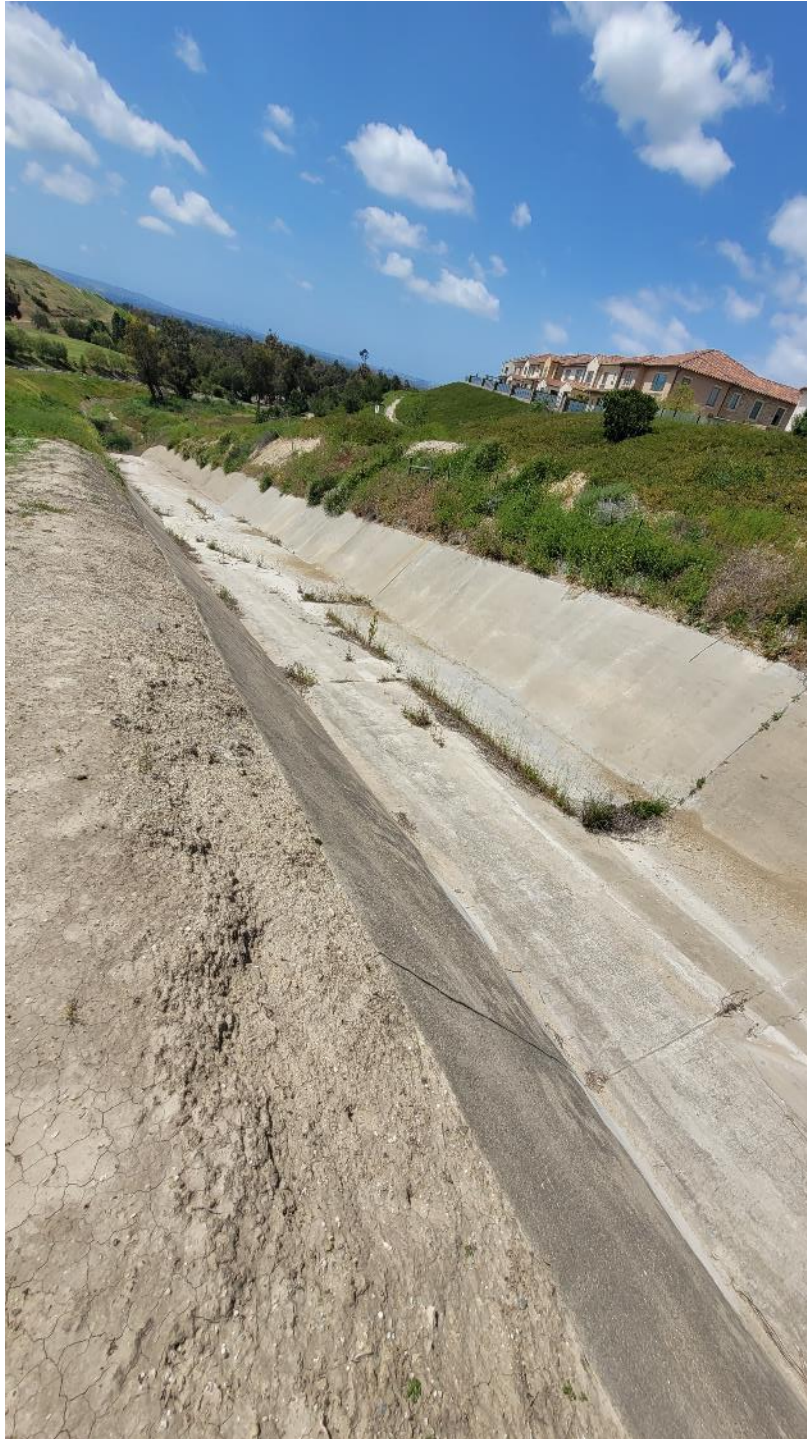
Photo 3: View of the vegetation growth in the cracks and joints of the spillway side channel.

- All valves were fully cycled during this inspection with no issues.
- The owner needs to increase rodent control efforts and collapse, backfill, and compact the rodent holes with suitable material as they appear.
- The owner needs to complete the following by July 1, 2024:
 - Remove the vegetation and seal the cracks and joints of the spillway side channel.
 - Remove the dense vegetation buildup at the exit of the spillway side channel.
- For future instrumentation reports, rain data needs to be incorporated into the piezometer data plots.

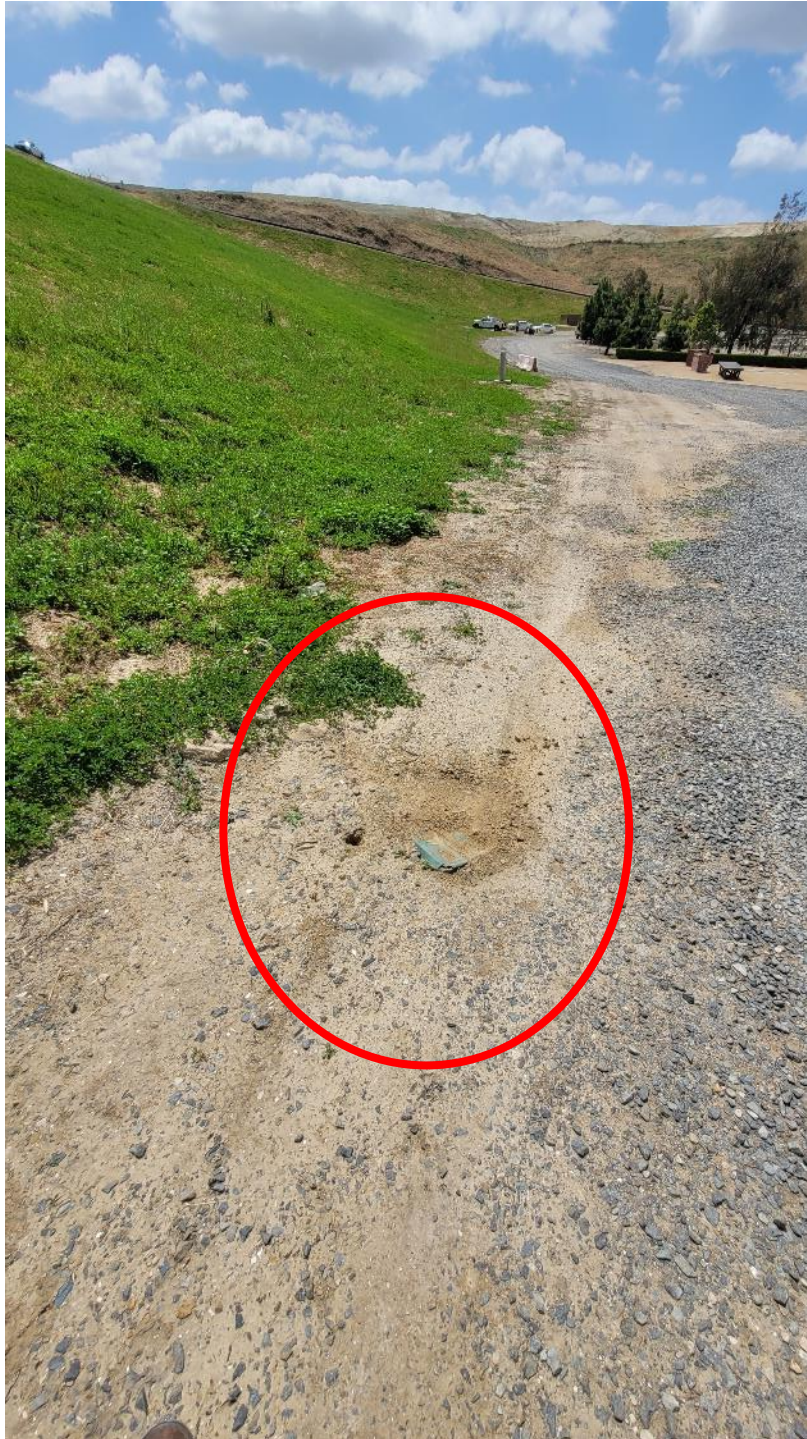
Photo 4: View of the rodent trap buried next to a rodent hole.
