DAM SAFETY PROGRAM

Guidelines & Governance

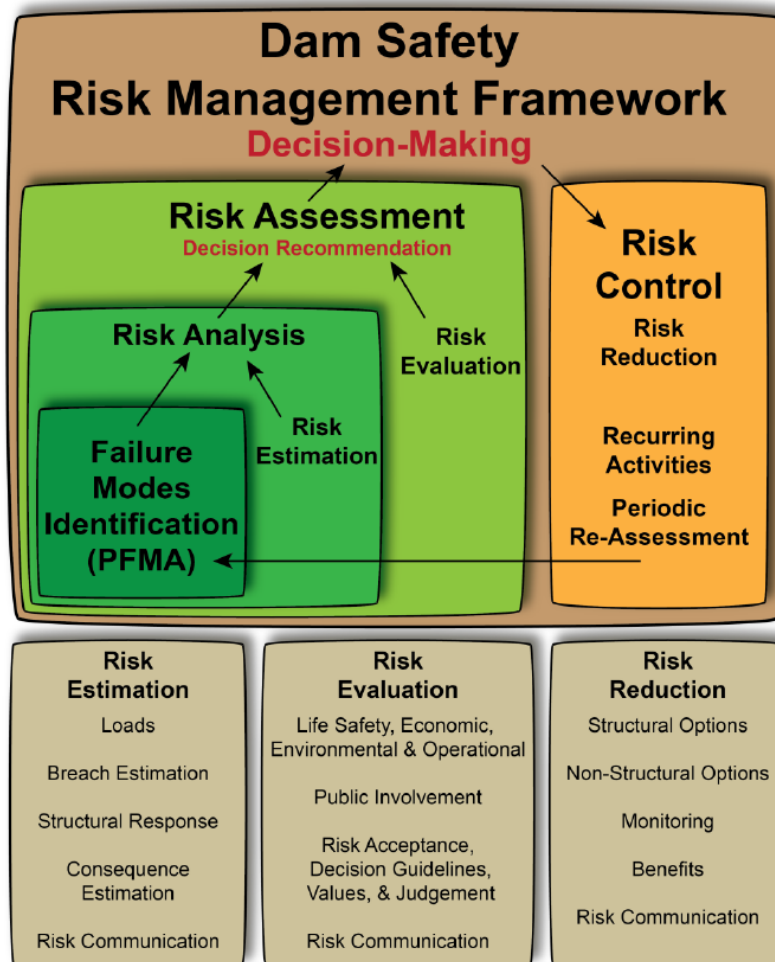
Figure 1: Dam Safety Risk Management Framework (FEMA 2015)

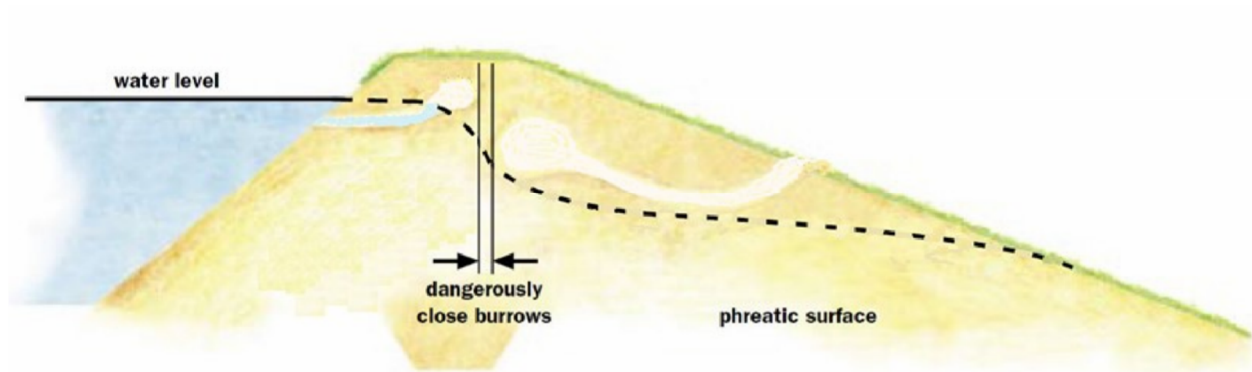
Figure 2: Section View of Dam with Animal Burrowing Activity (FEMA 473).

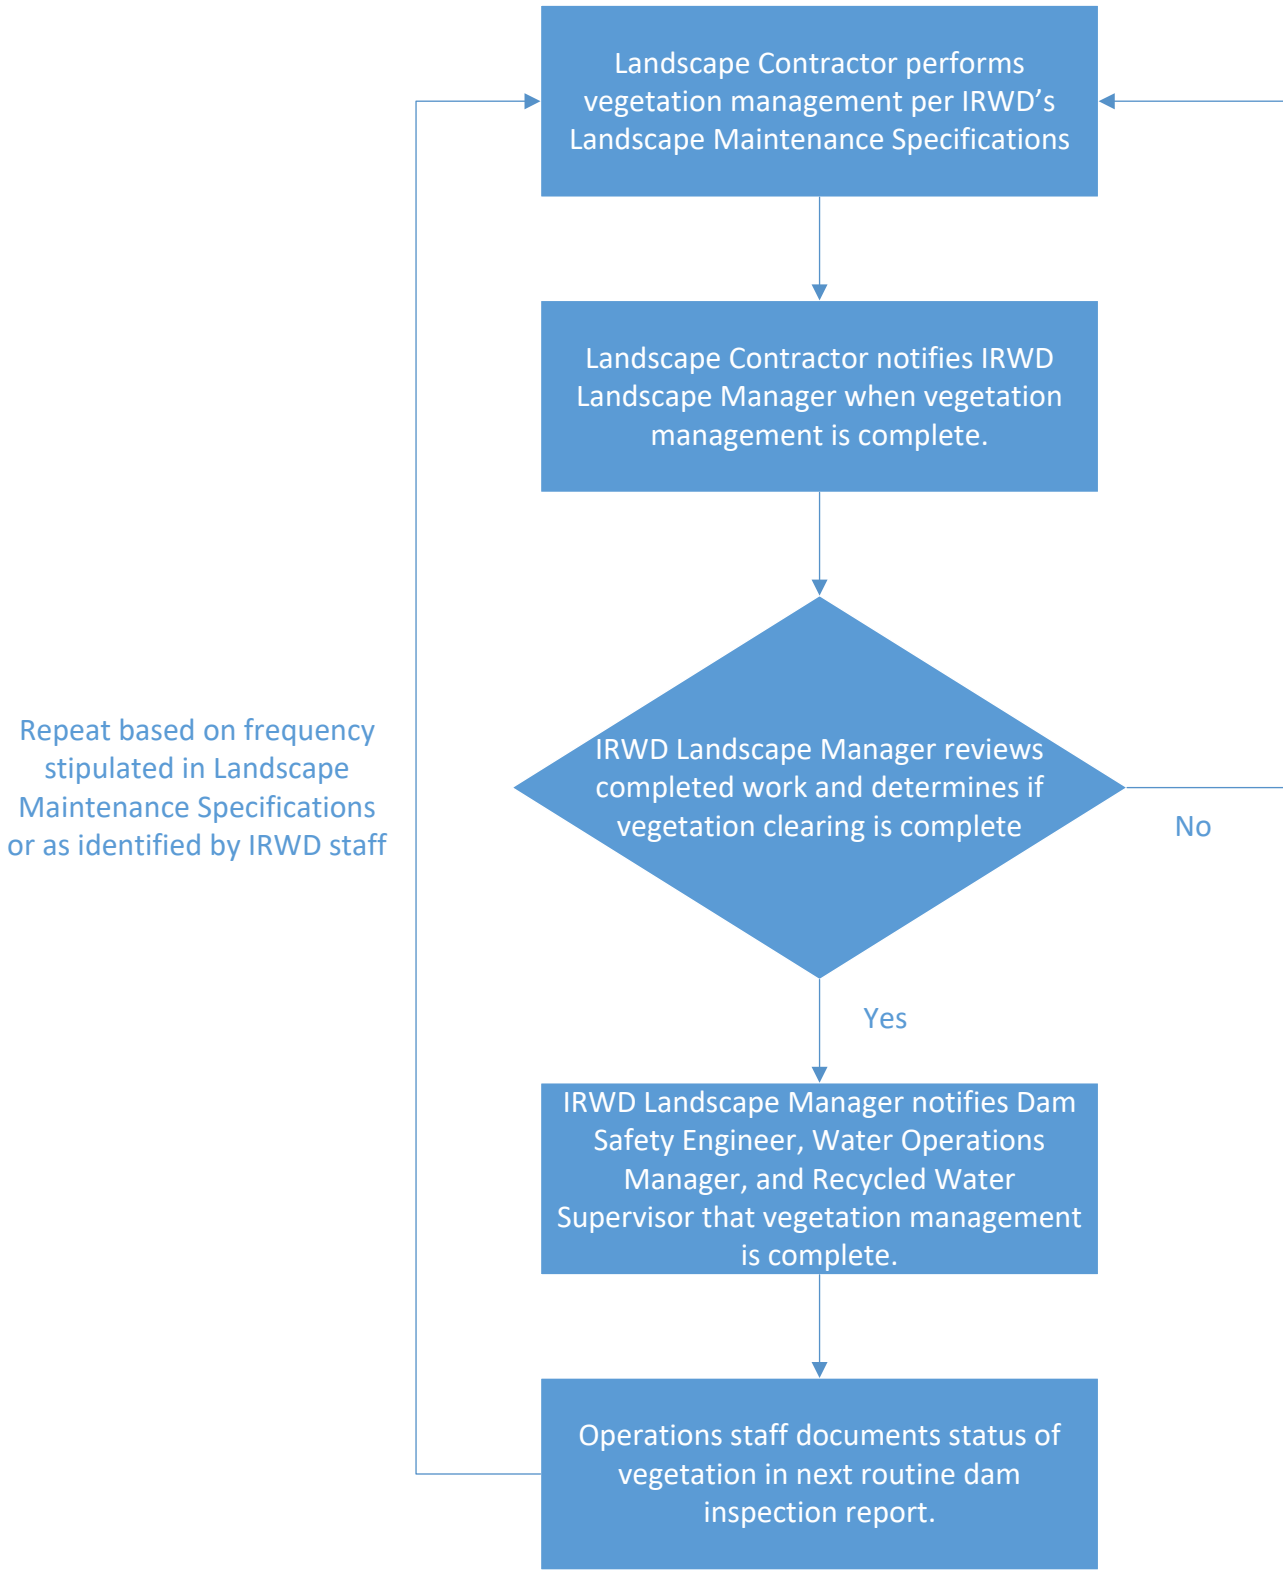
Figure 1: Vegetation Management Notification and Review Process for IRWD's Dams

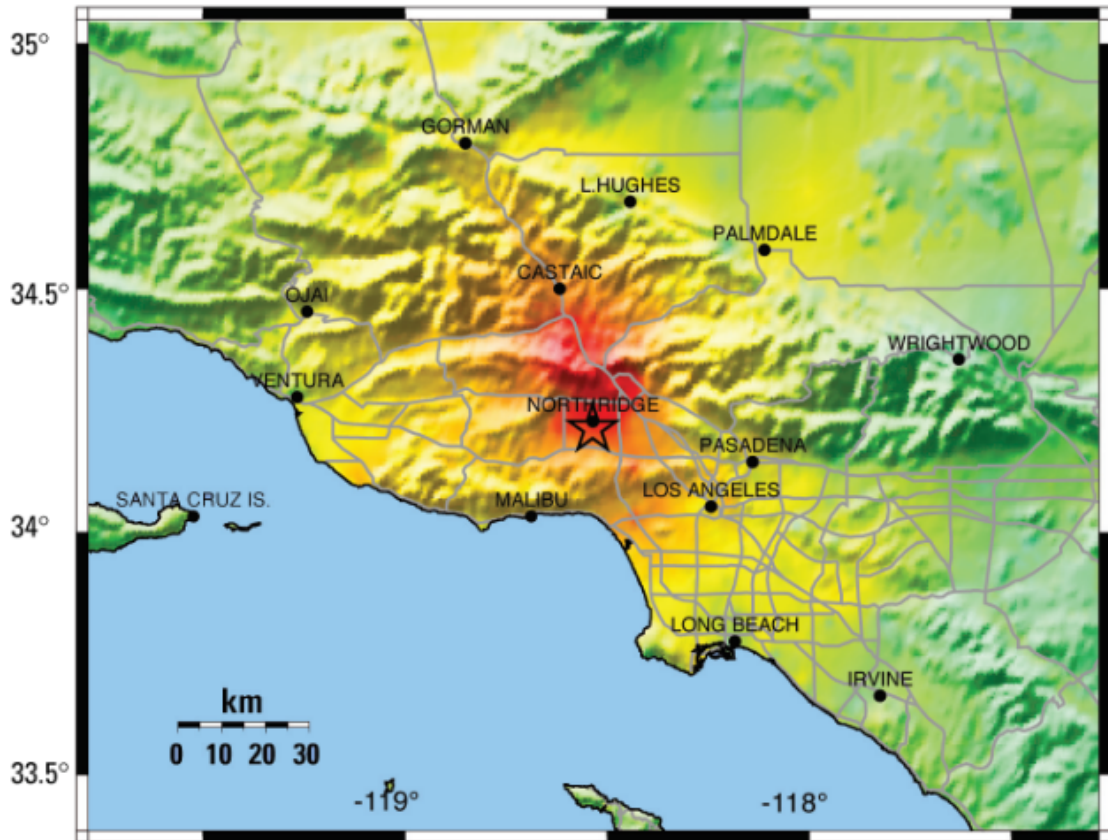
PERCEIVED SHAKING	Not felt	Weak	Light	Moderate	Strong	Very strong	Severe	Violent	Extreme
POTENTIAL DAMAGE	none	none	none	Very light	Light	Moderate	Moderate/Heavy	Heavy	Very Heavy
PEAK ACC.(%g)	<.17	.17-14	1.4-39	3.9-92	9.2-18	18-34	34-65	65-124	>124
PEAK VEL.(cm/s)	<0.1	0.1-1.1	1.1-3.4	3.4-8.1	8.1-16	16-31	31-60	60-116	>116
INSTRUMENTAL INTENSITY	I	II-III	IV	V	VI	VII	VIII	IX	X+

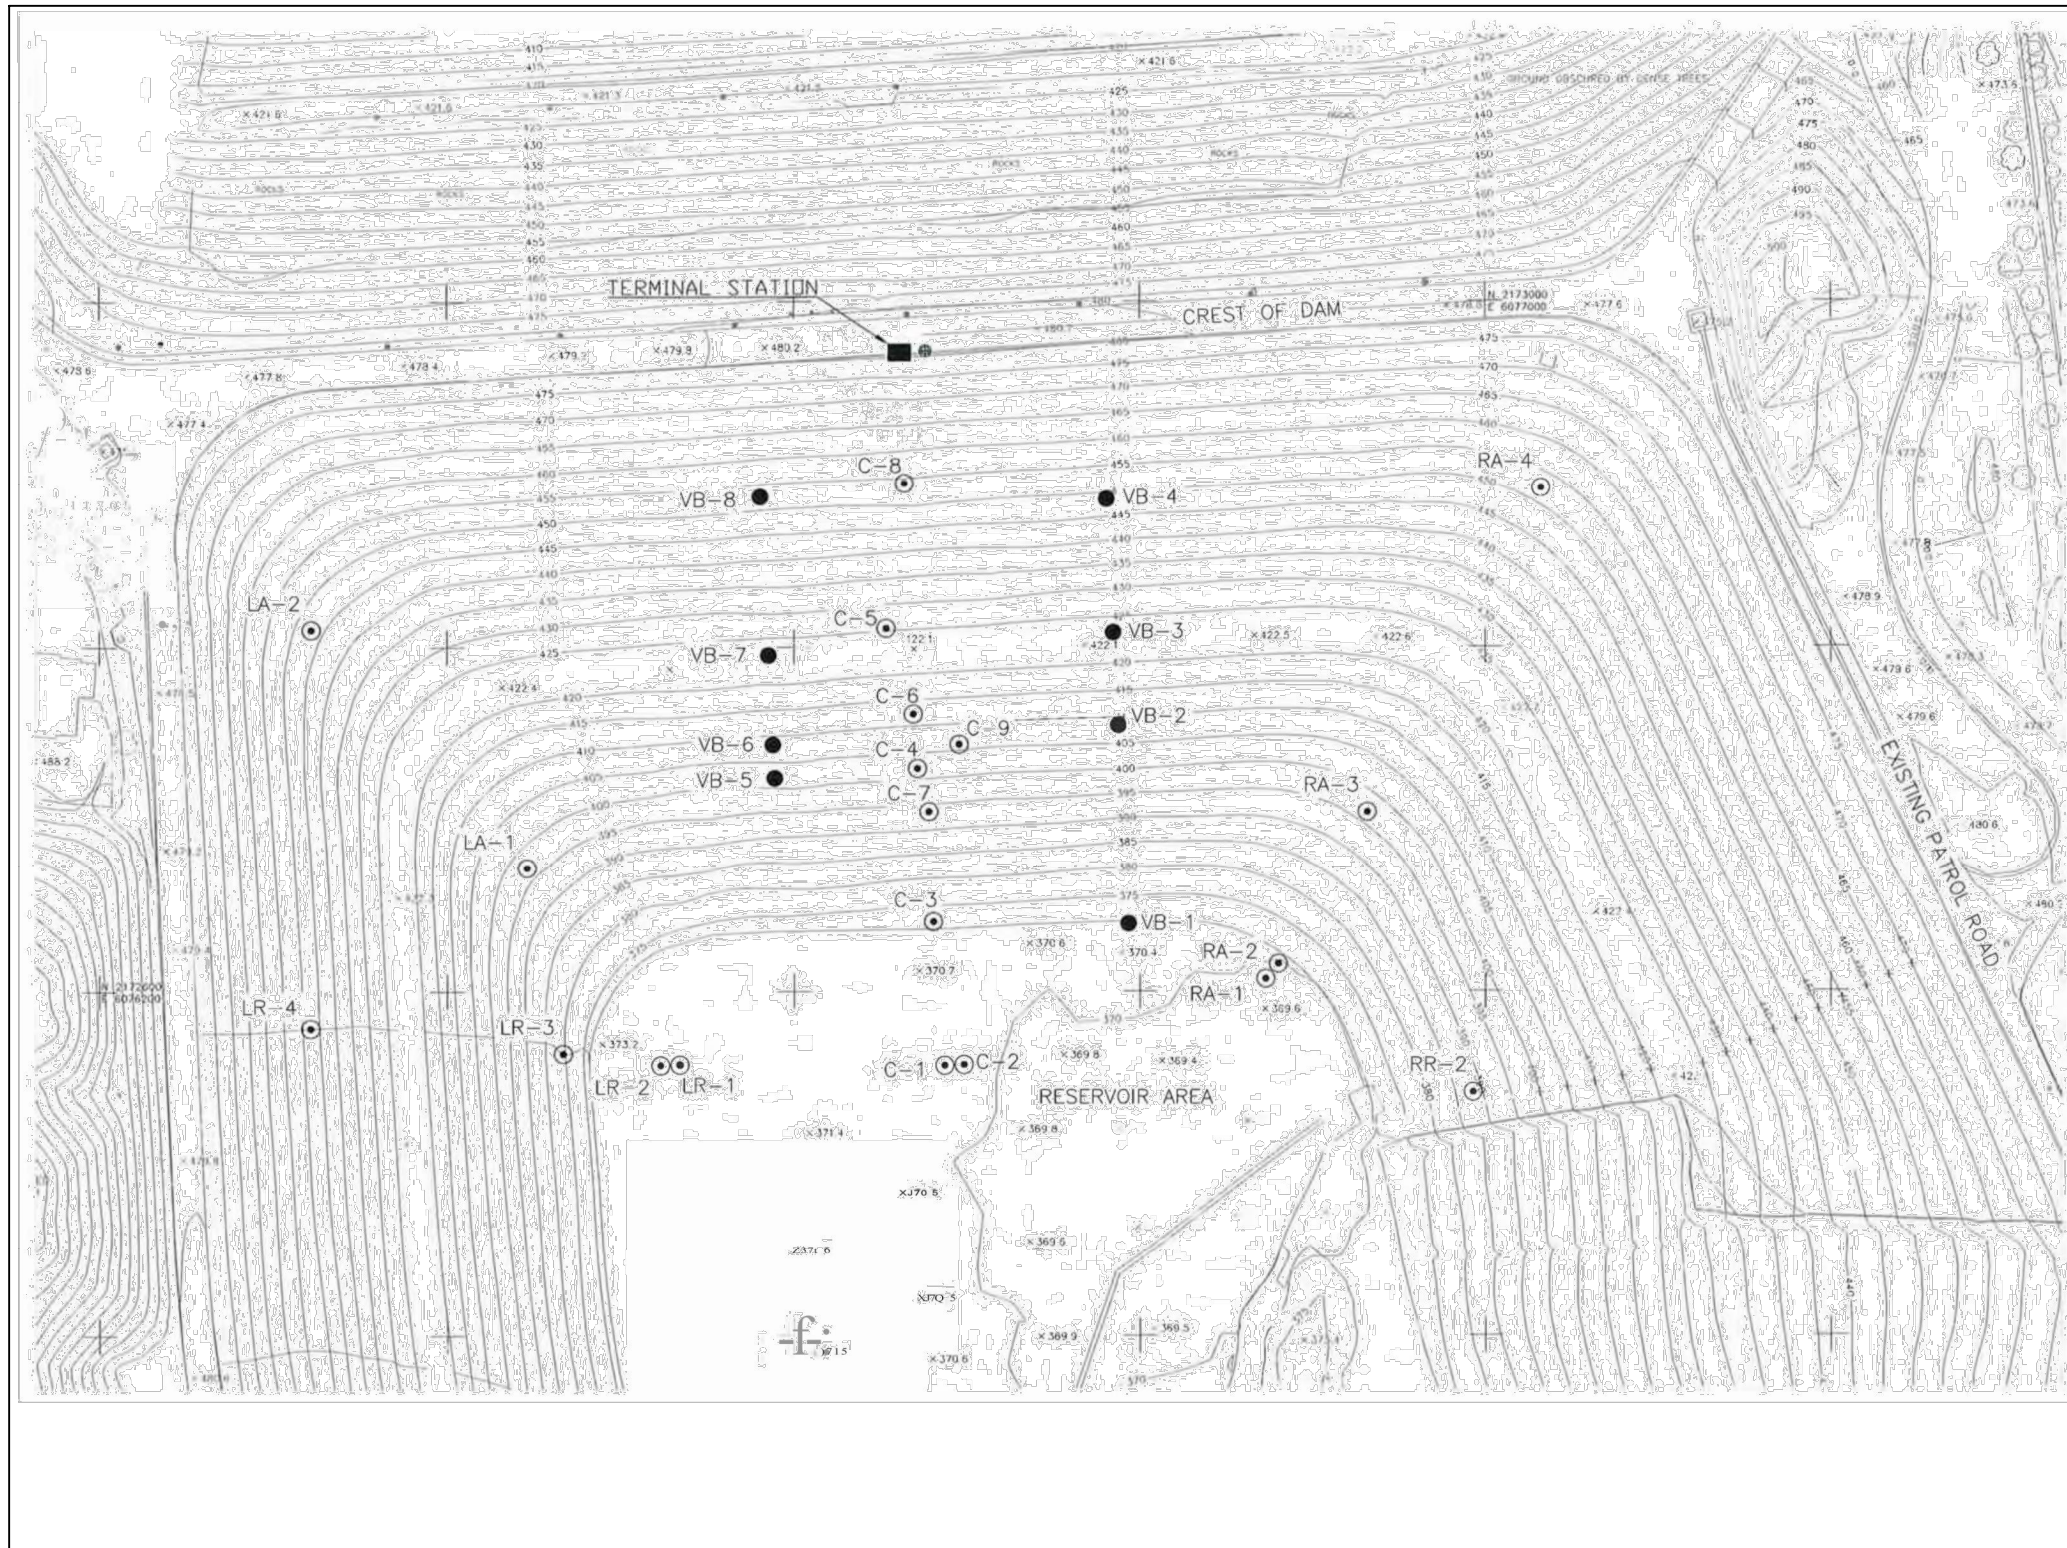
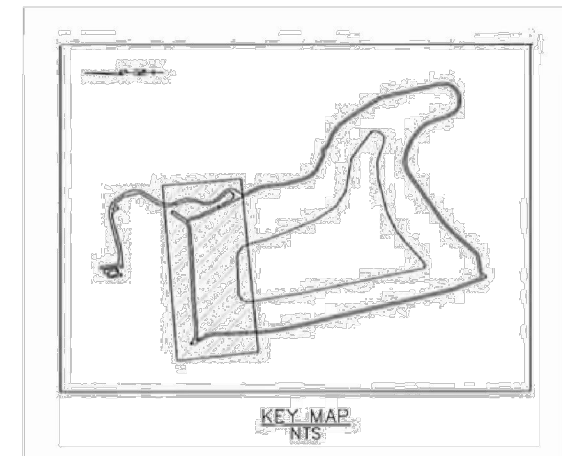
- 6.3 Genterra, “Technical Memorandum Identification of Instrumentation Thresholds and Action Levels at Rattlesnake Dam”, March 22, 2023.
- 6.4 GEI, “Instrumentation Evaluation and Upgrade Recommendation”, October 31, 2022.

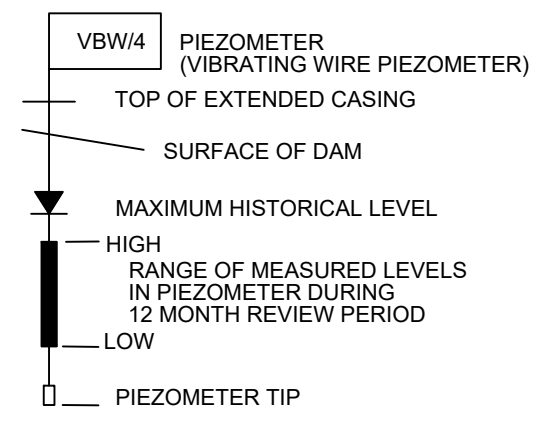
**SECTION A-A'
(MAXIMUM SECTION)**

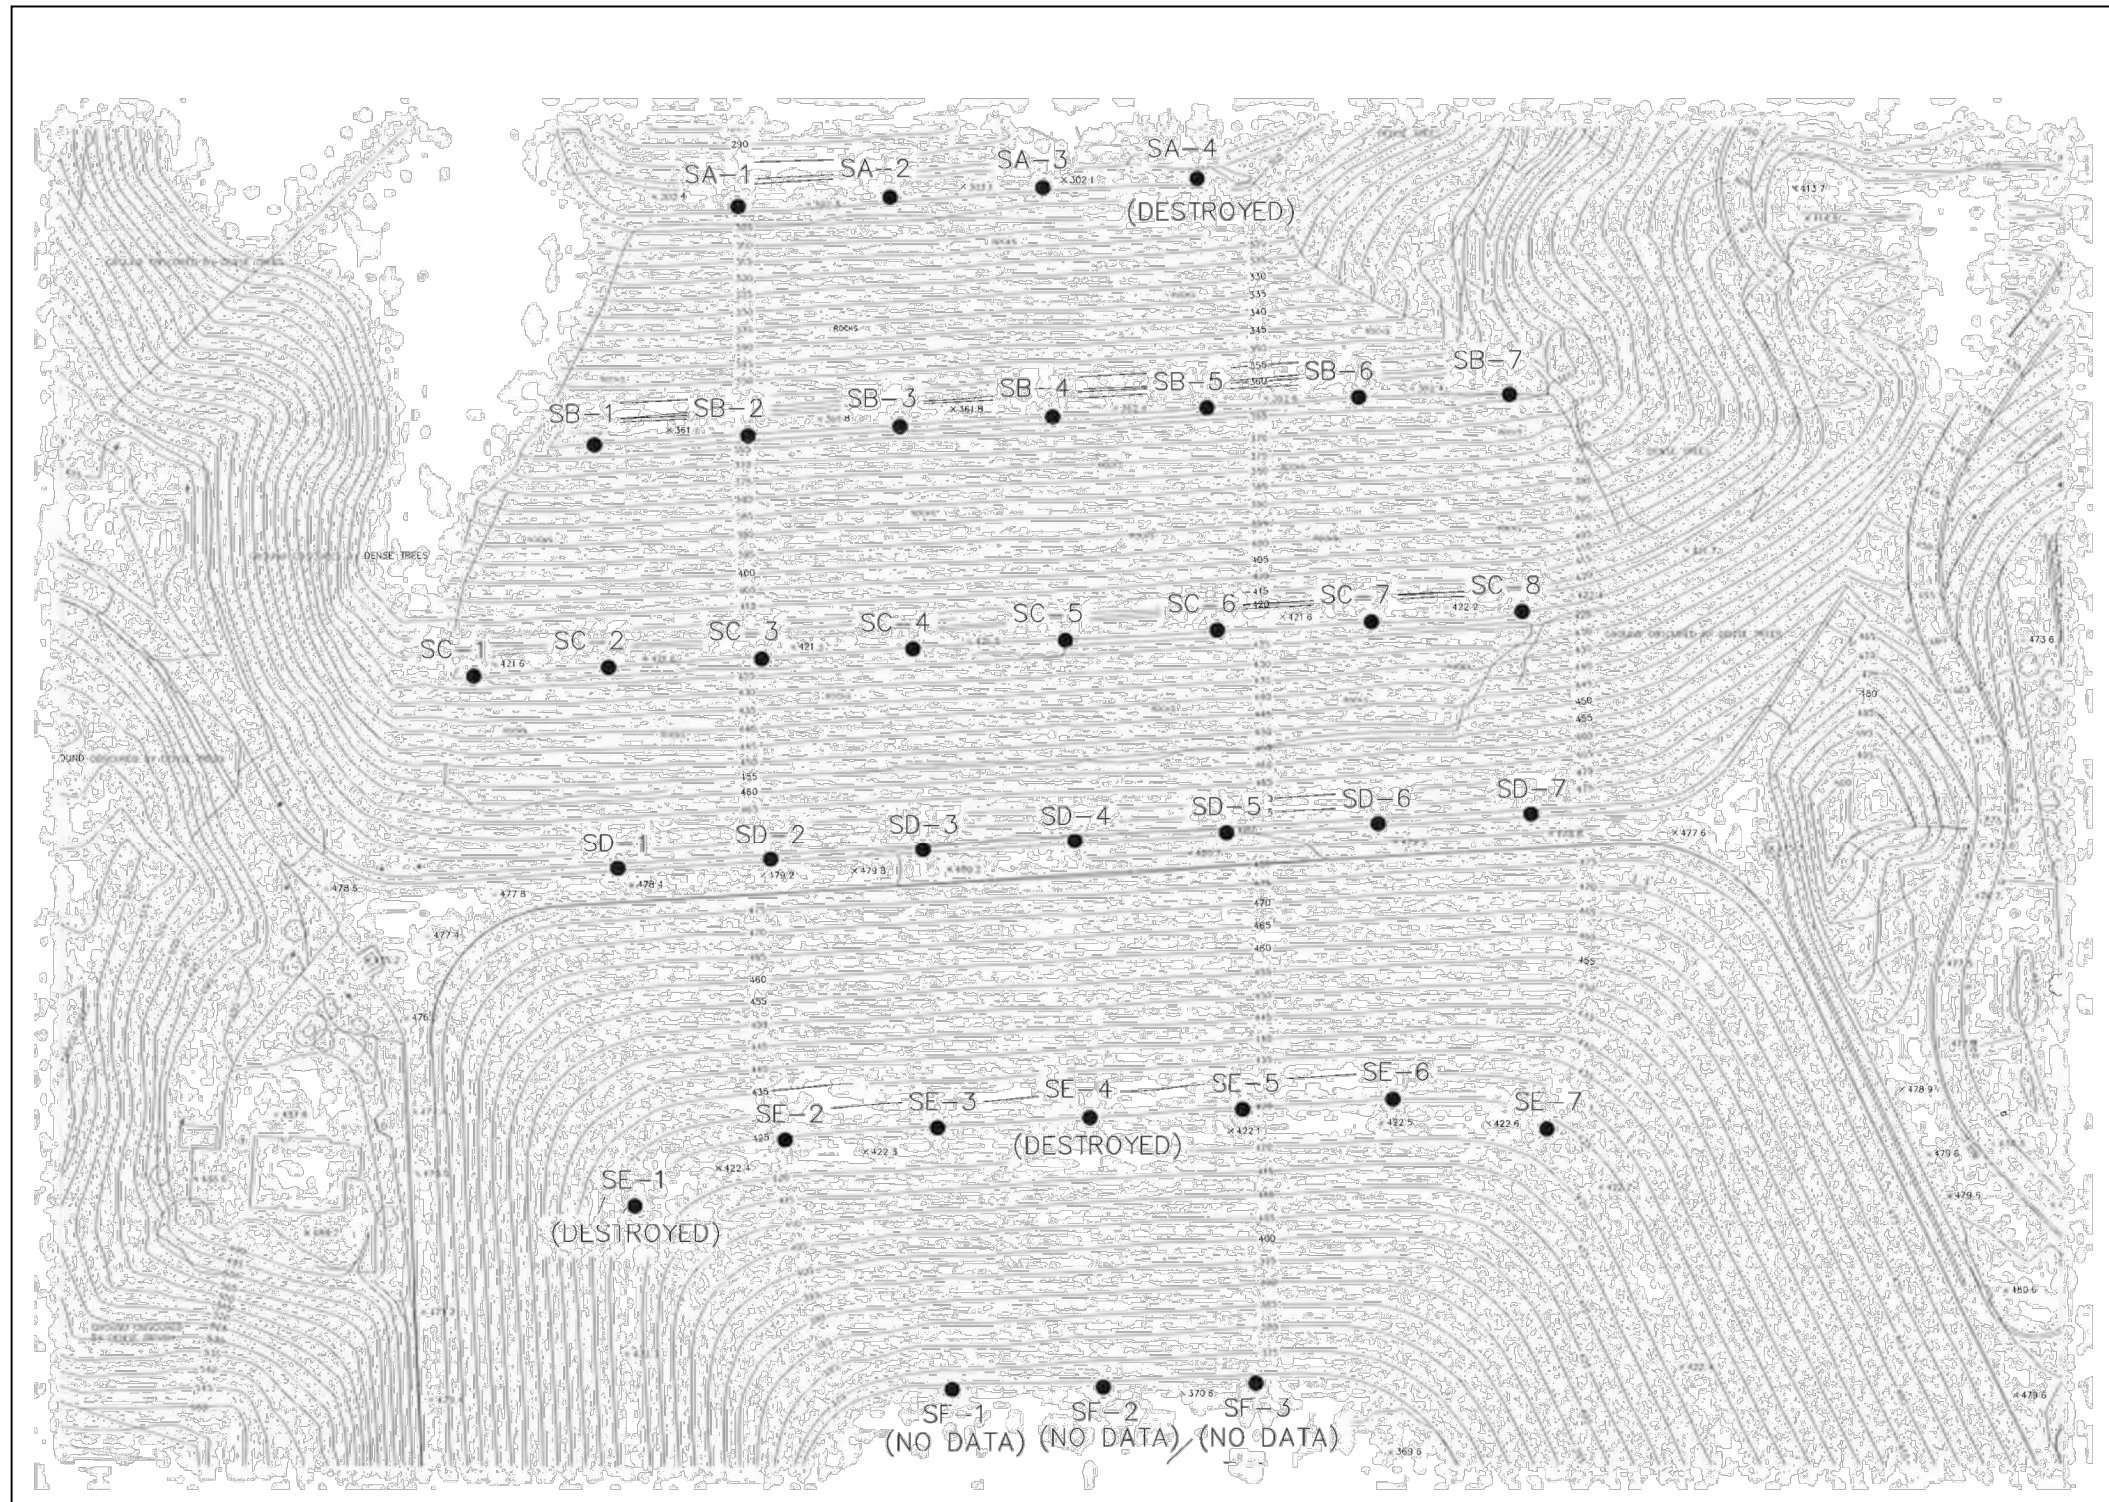
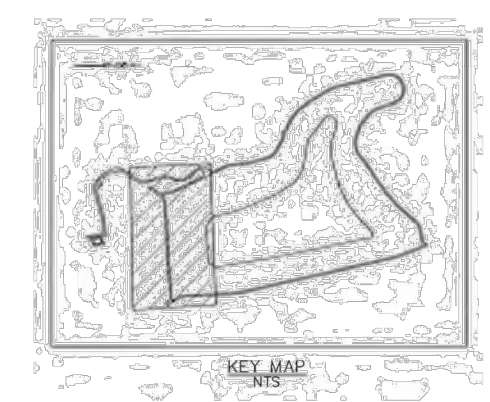
- 7.1 Genterra, “Technical Memorandum Identification of Instrumentation Thresholds and Action Levels at San Joaquin Dam”, January 13, 2023.
- 7.2 Genterra, “Technical Memorandum Identification of Instrumentation Thresholds and Action Levels at Sand Canyon Dam”, March 24, 2023.
- 7.3 Genterra, “Technical Memorandum Identification of Instrumentation Thresholds and Action Levels at Rattlesnake Dam”, March 22, 2023.
- 7.4 GEI, “Instrumentation Evaluation and Upgrade Recommendation”, October 31, 2022.

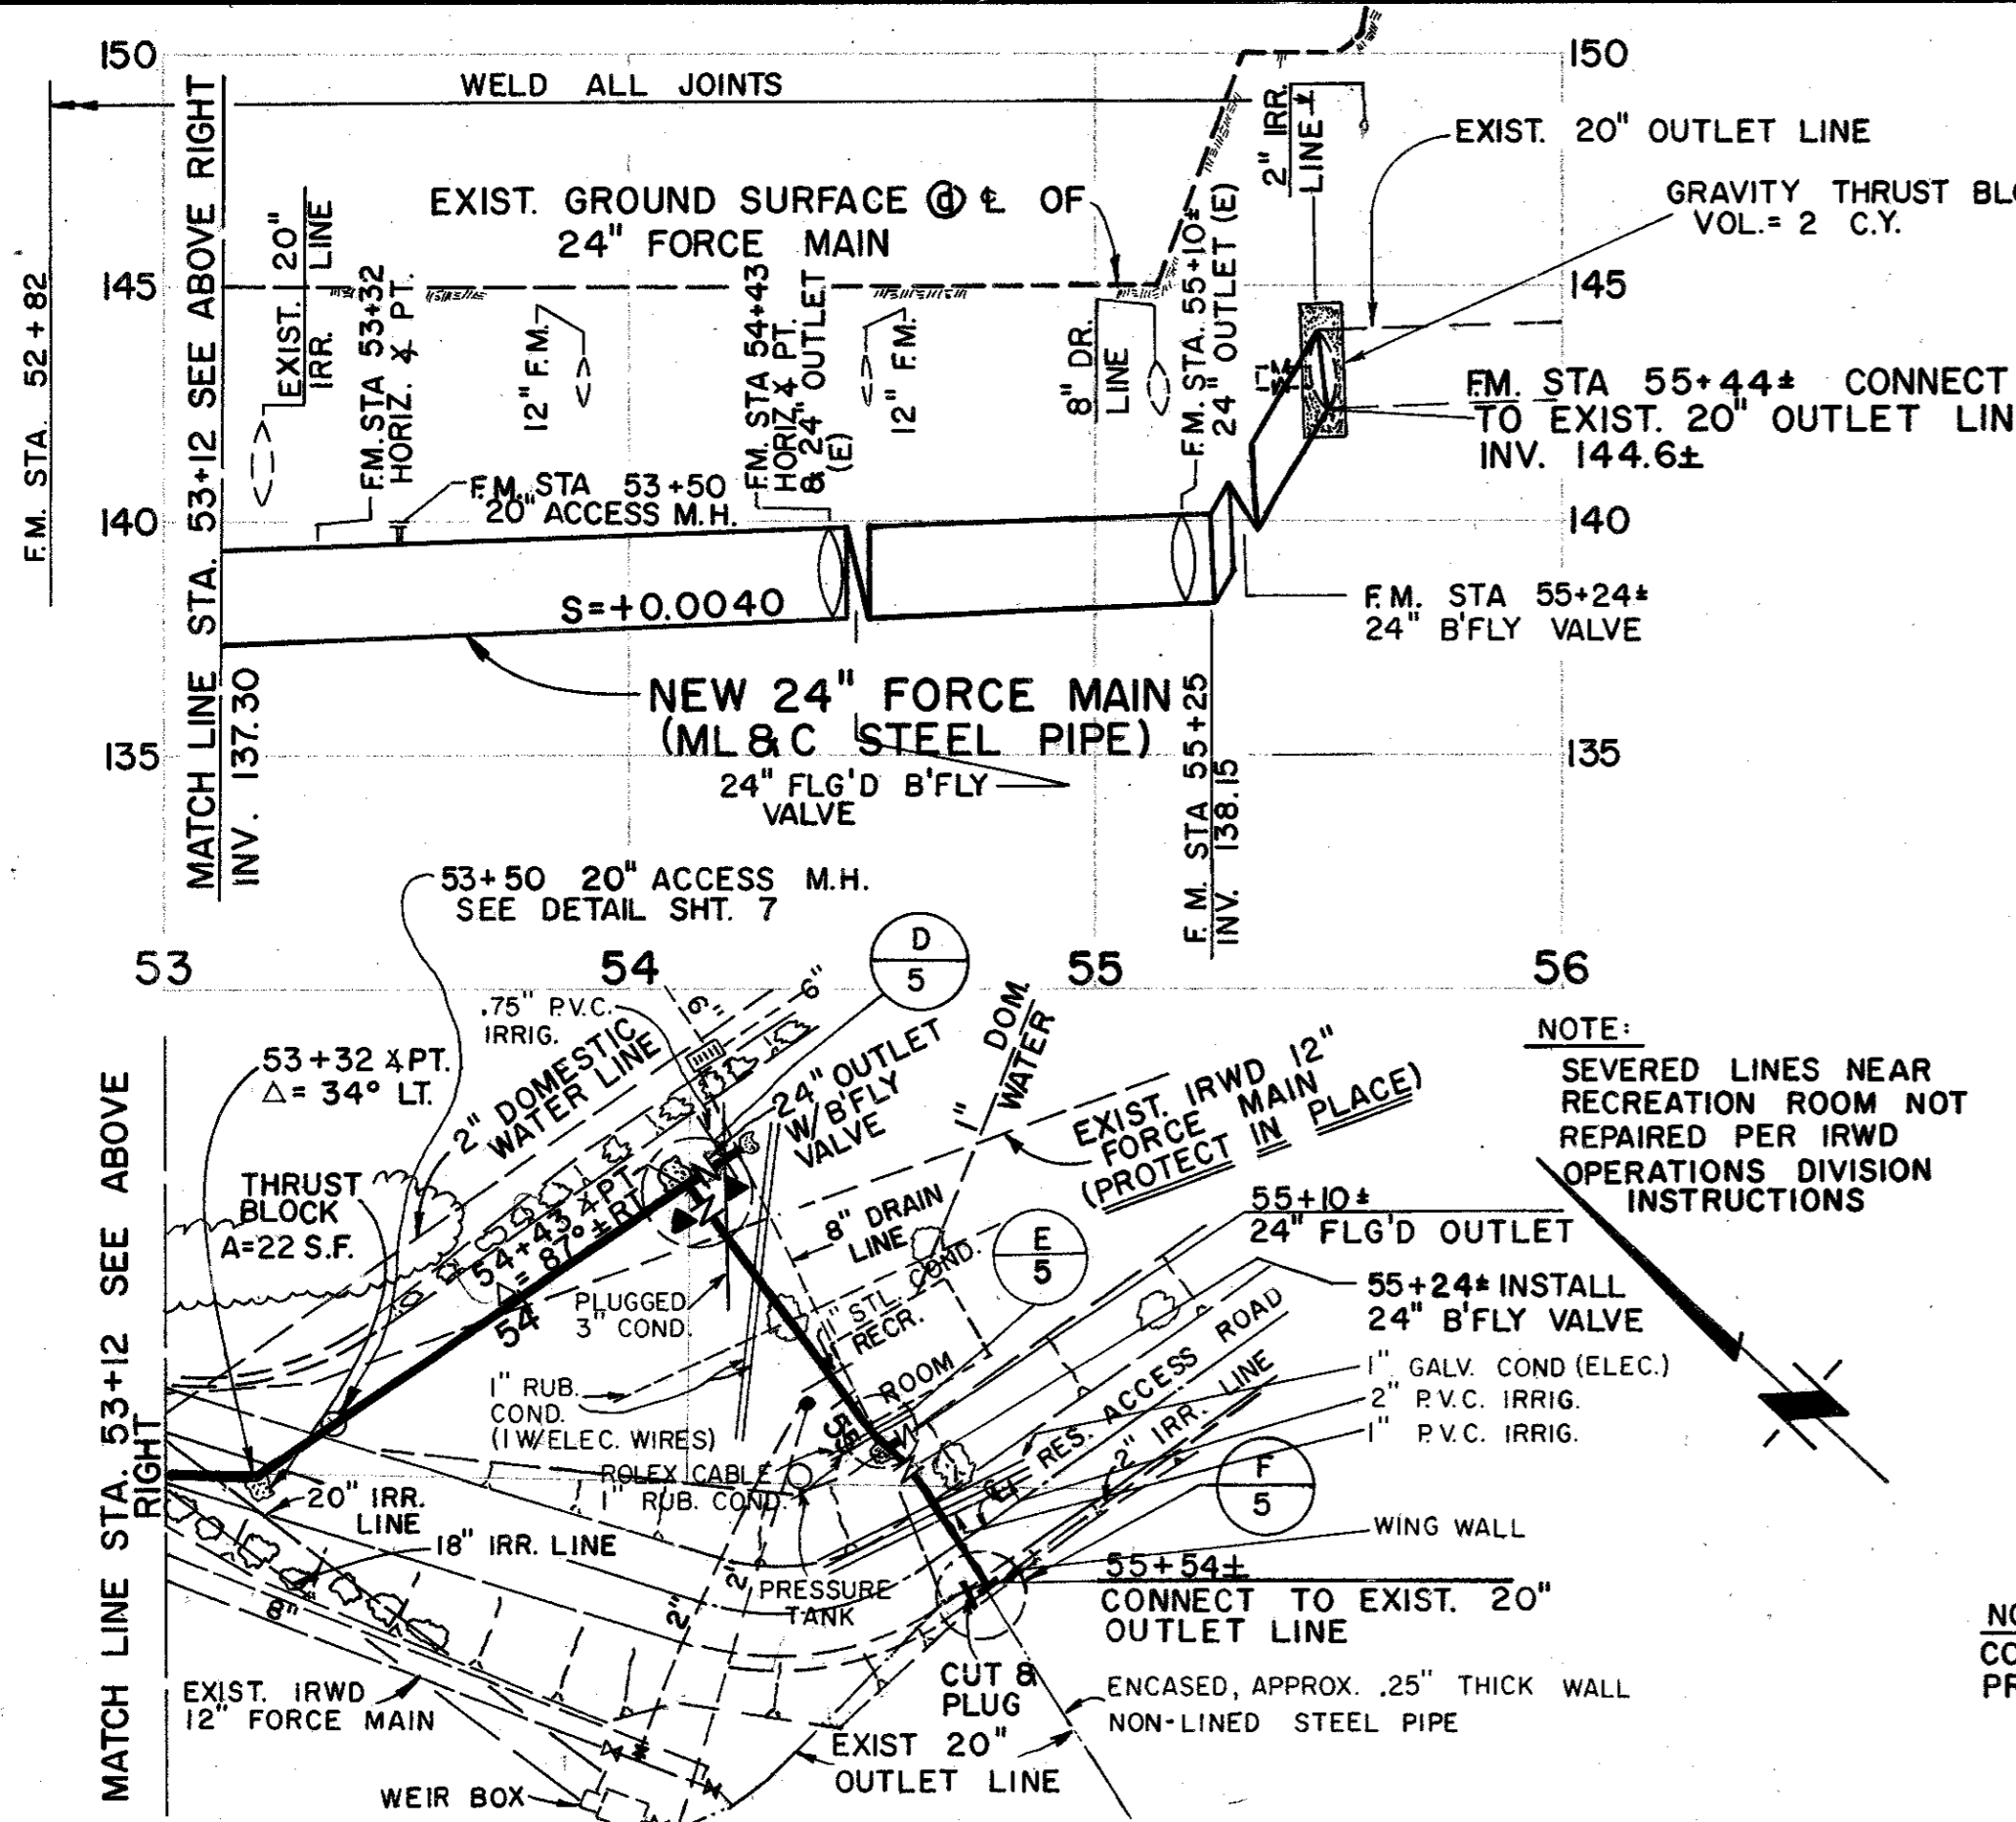
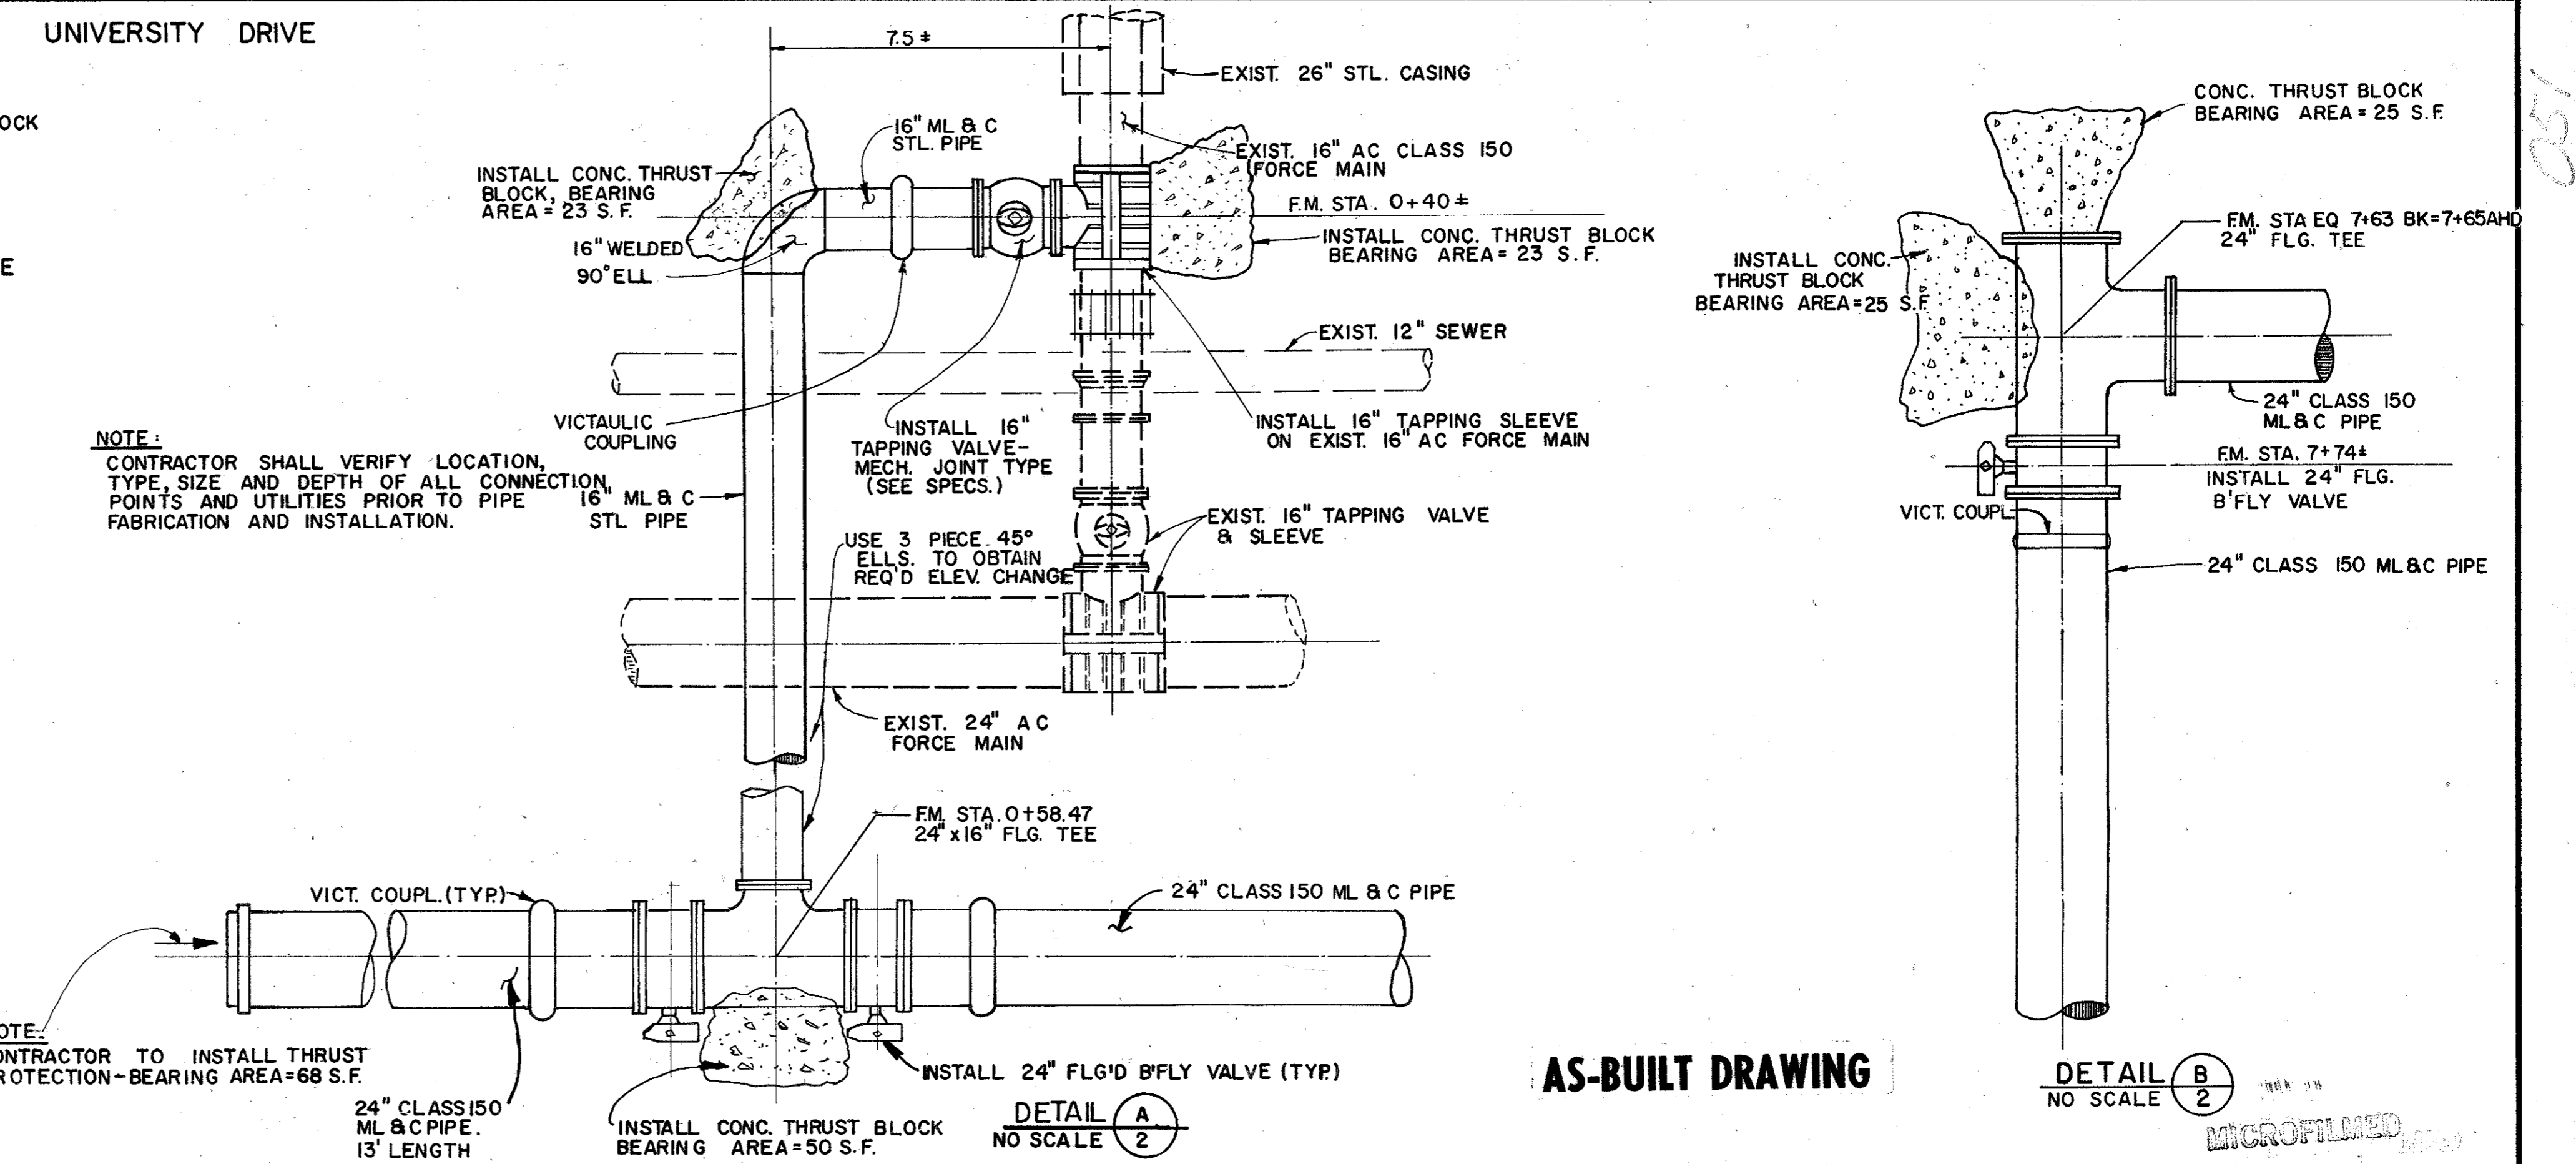
NOTE: CONTRACTOR SHALL VERIFY LOCATION, TYPE, SIZE AND DEPTH OF ALL CONNECTION, POINTS AND UTILITIES PRIOR TO PIPE FABRICATION AND INSTALLATION.

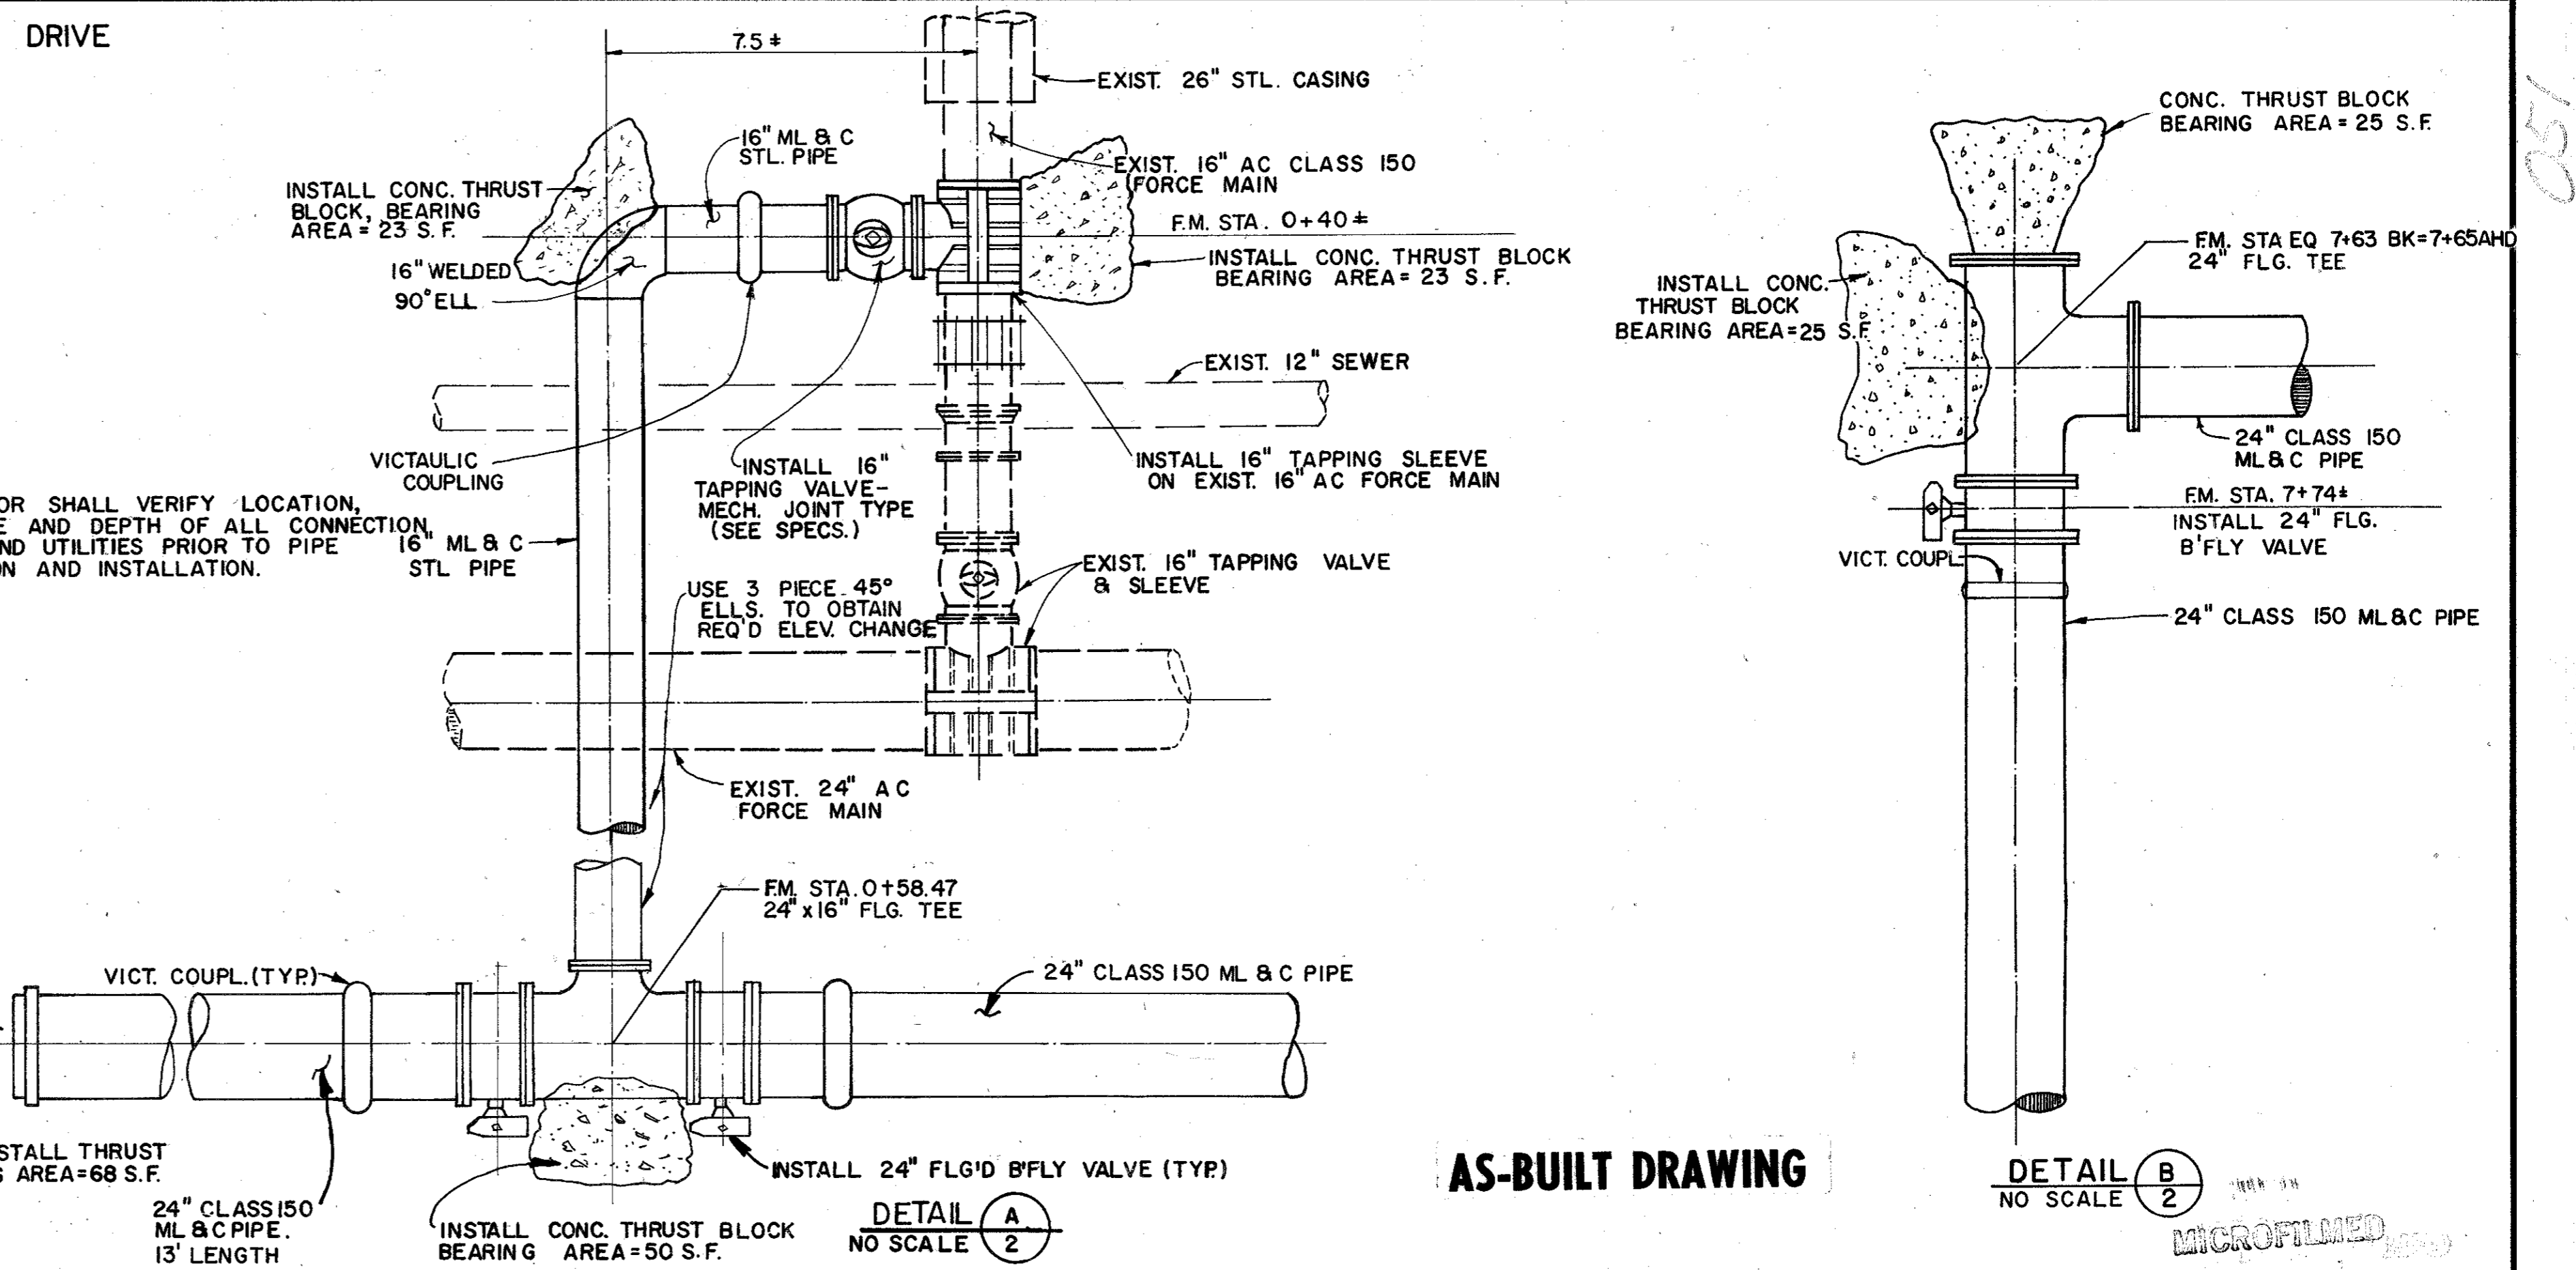
NOTE: CONTRACTOR TO INSTALL THRUST PROTECTION-BEARING AREA=68 S.F.

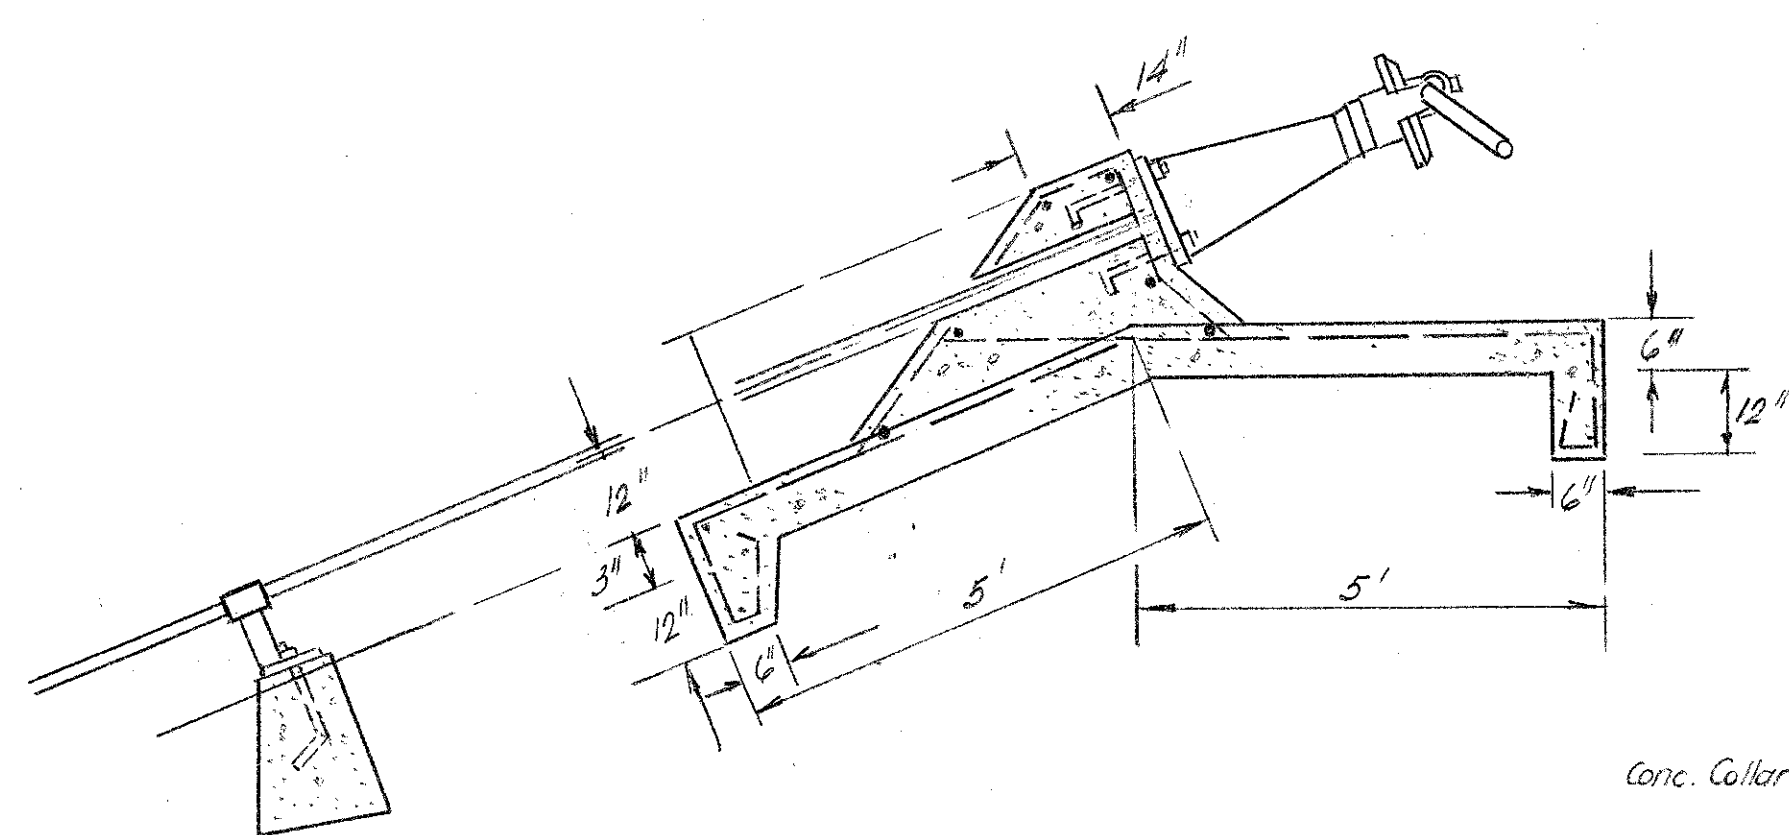
EXISTING LIFT ASSEMBLY FOUNDATION
