DAM SAFETY PROGRAM

Guidelines & Governance

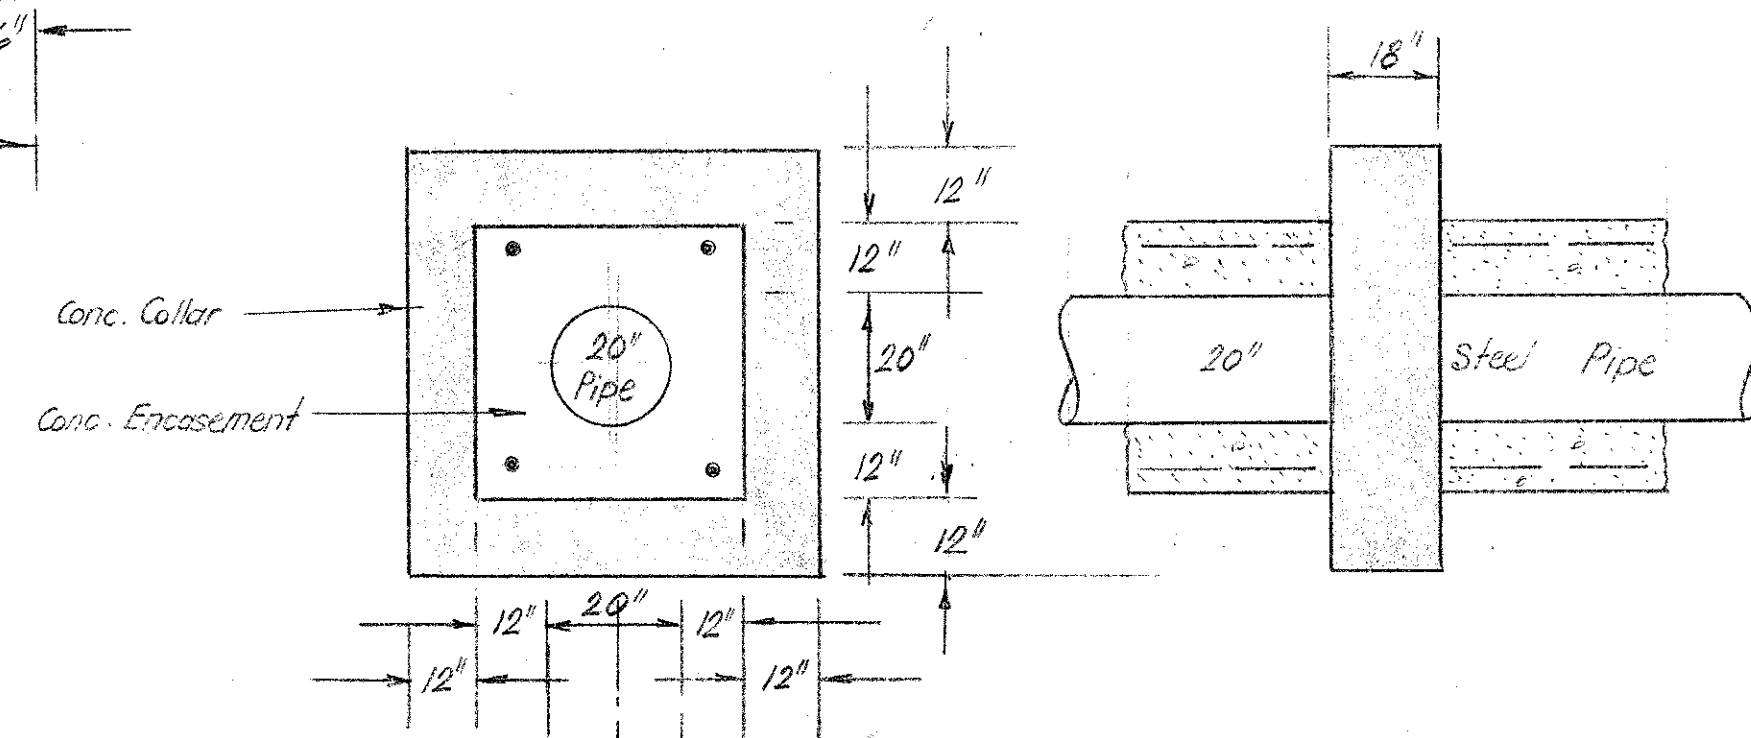
EXISTING CUTOFF COLLAR DETAIL - Outlet Pipe

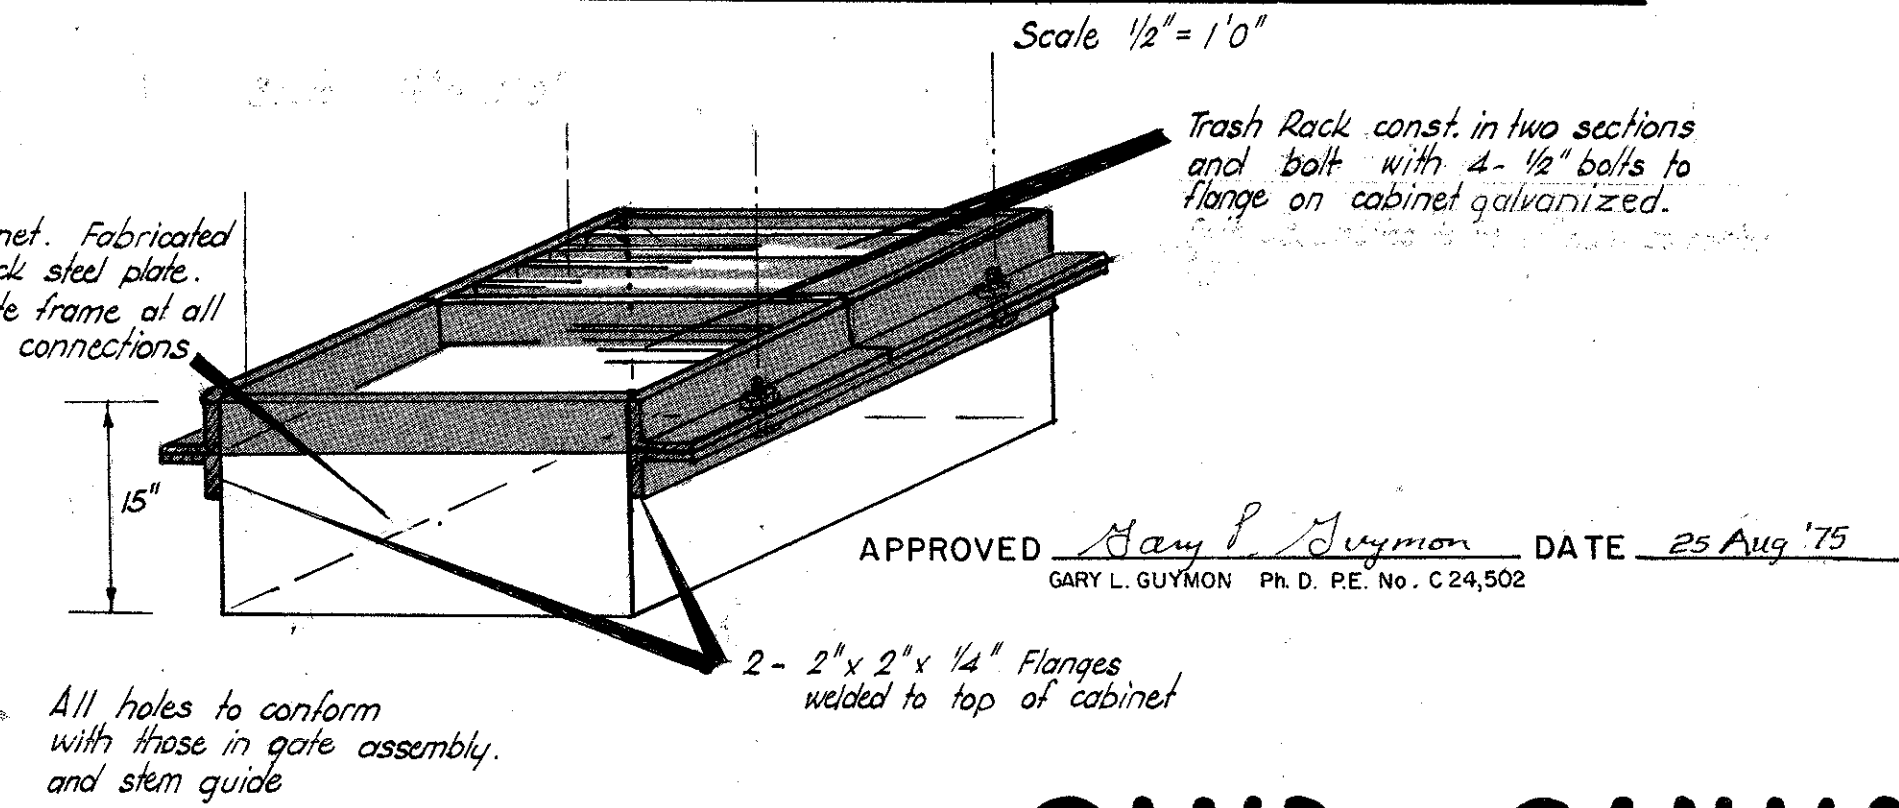
TEMPLATE for POSITIONING HANDWHEEL LIFTS

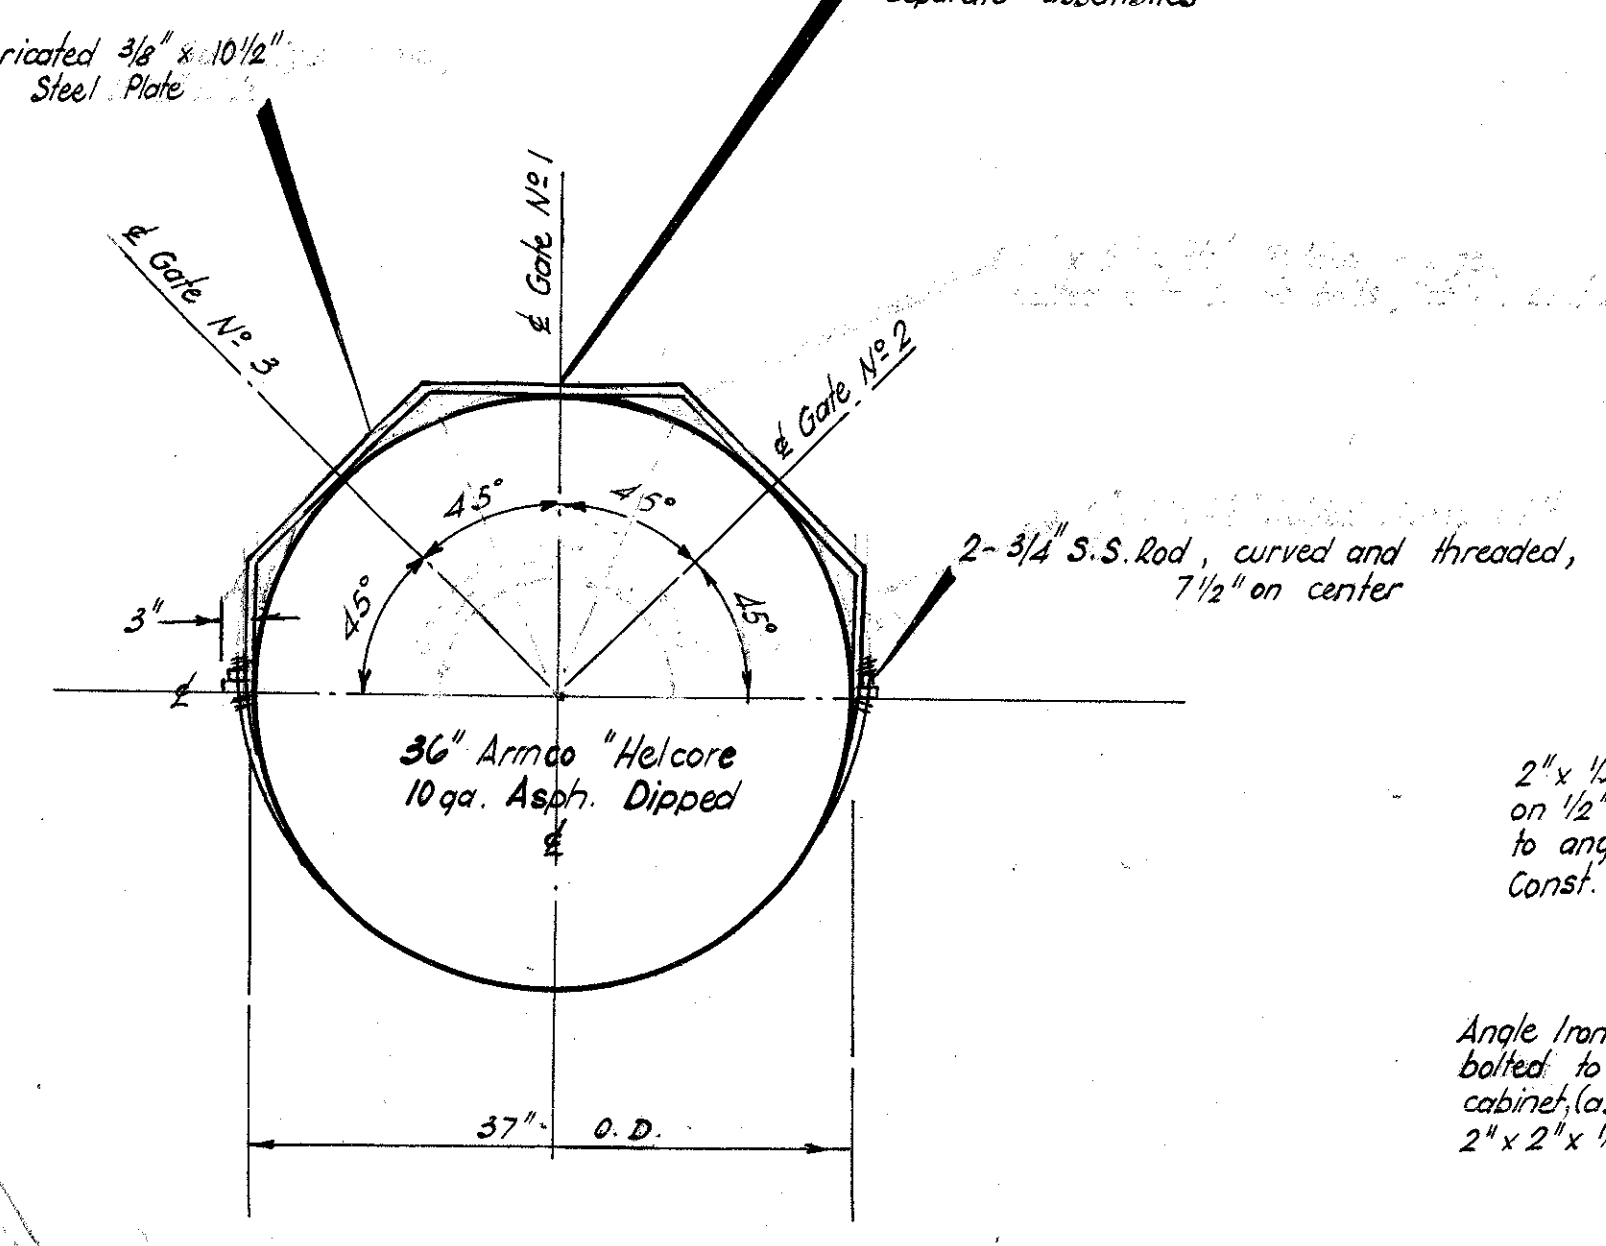
DETAIL of TRASH RACK at GATED OPENINGS

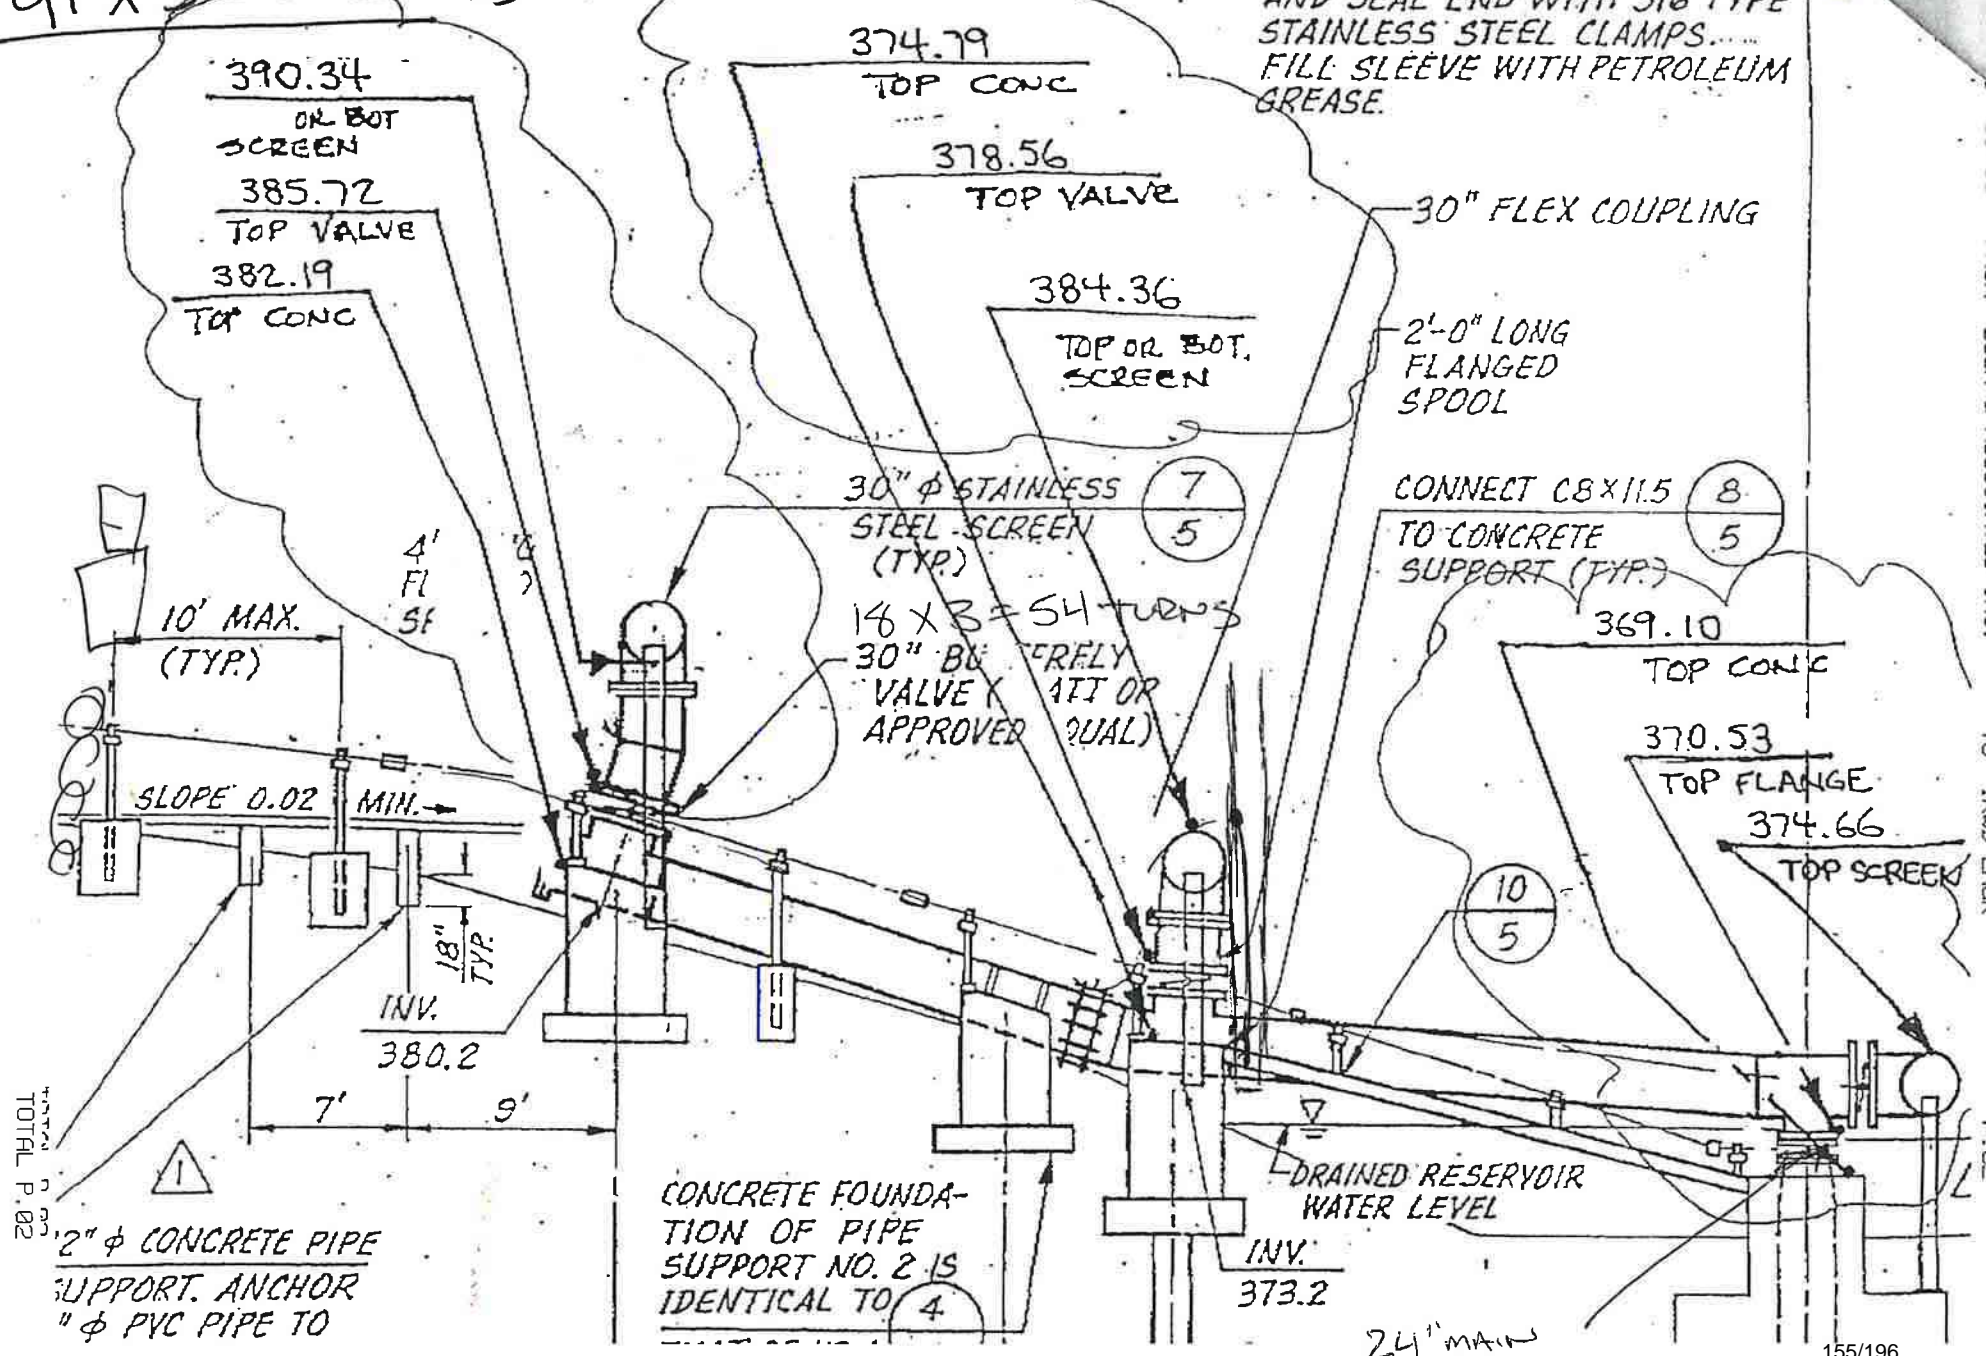
TOTAL P. 02
 2" ϕ CONCRETE PIPE
 SUPPORT. ANCHOR
 " ϕ PVC PIPE TO

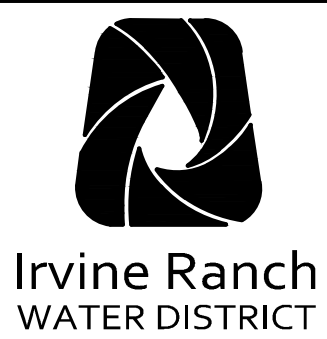
IRVINE RANCH WATER DISTRICT
RATTLESNAKE RESERVOIR OUTLET FLOW METER REPLACEMENT
PROJECT NO. 11566

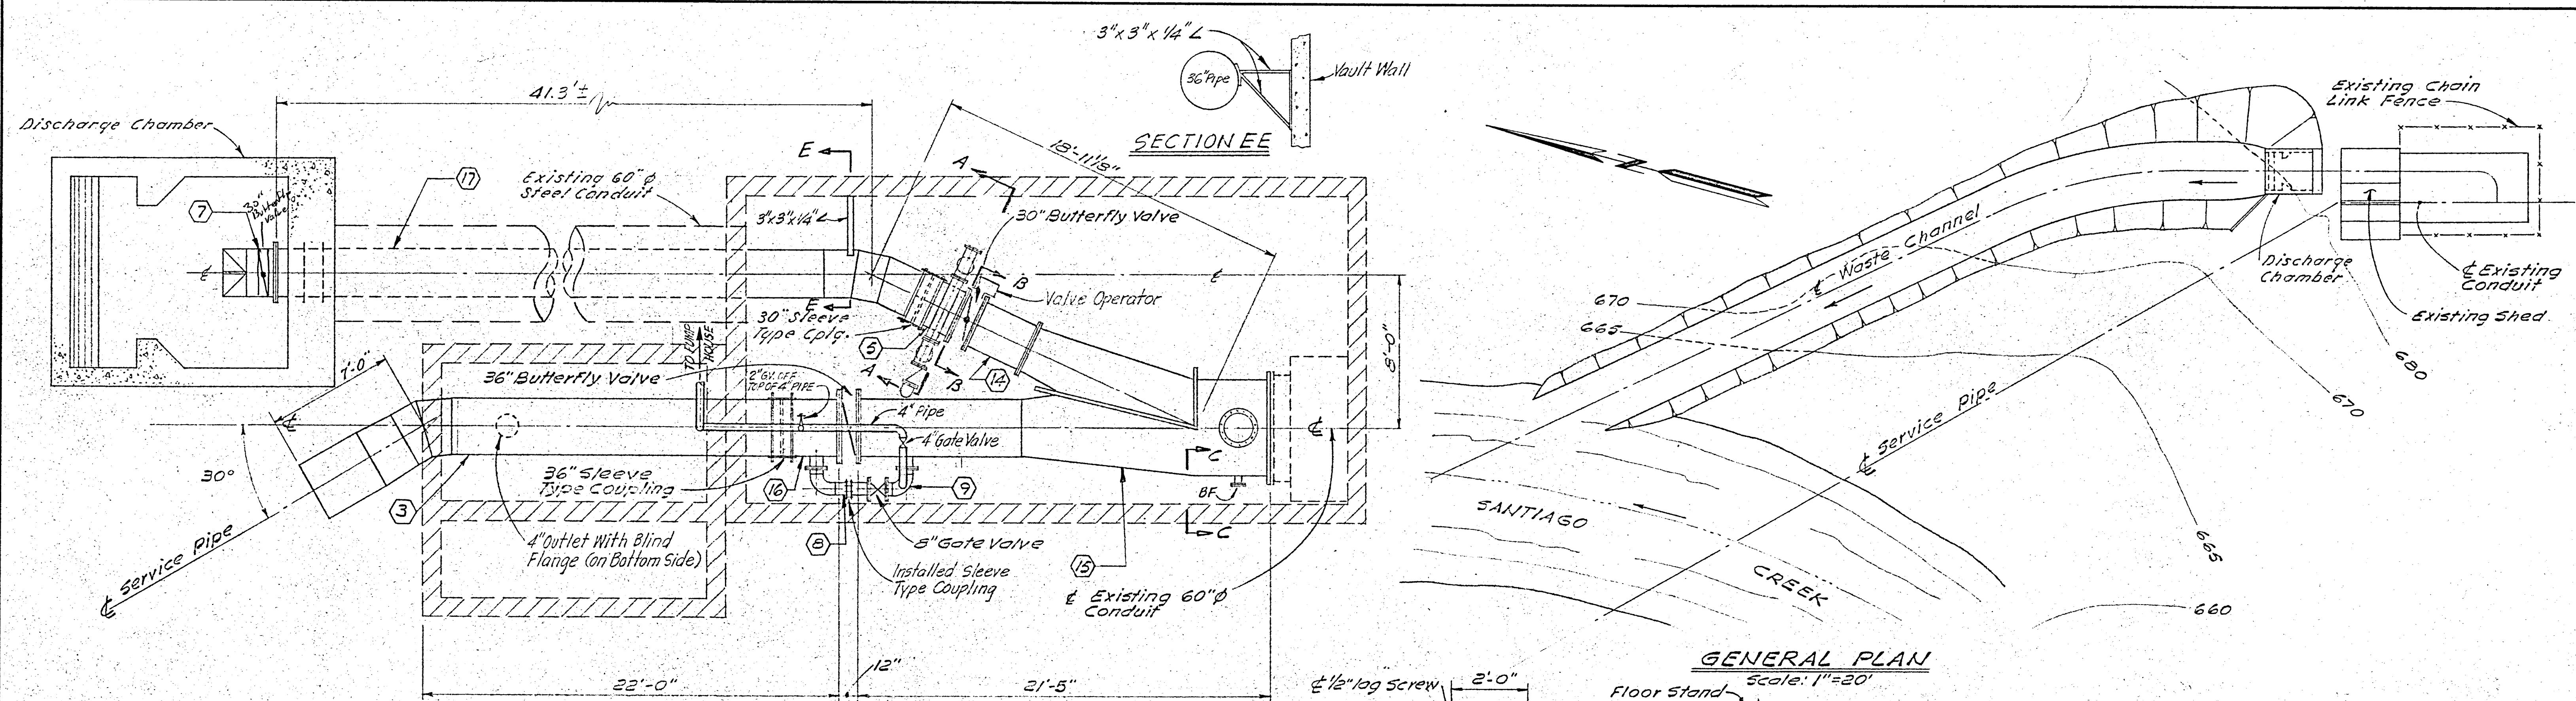
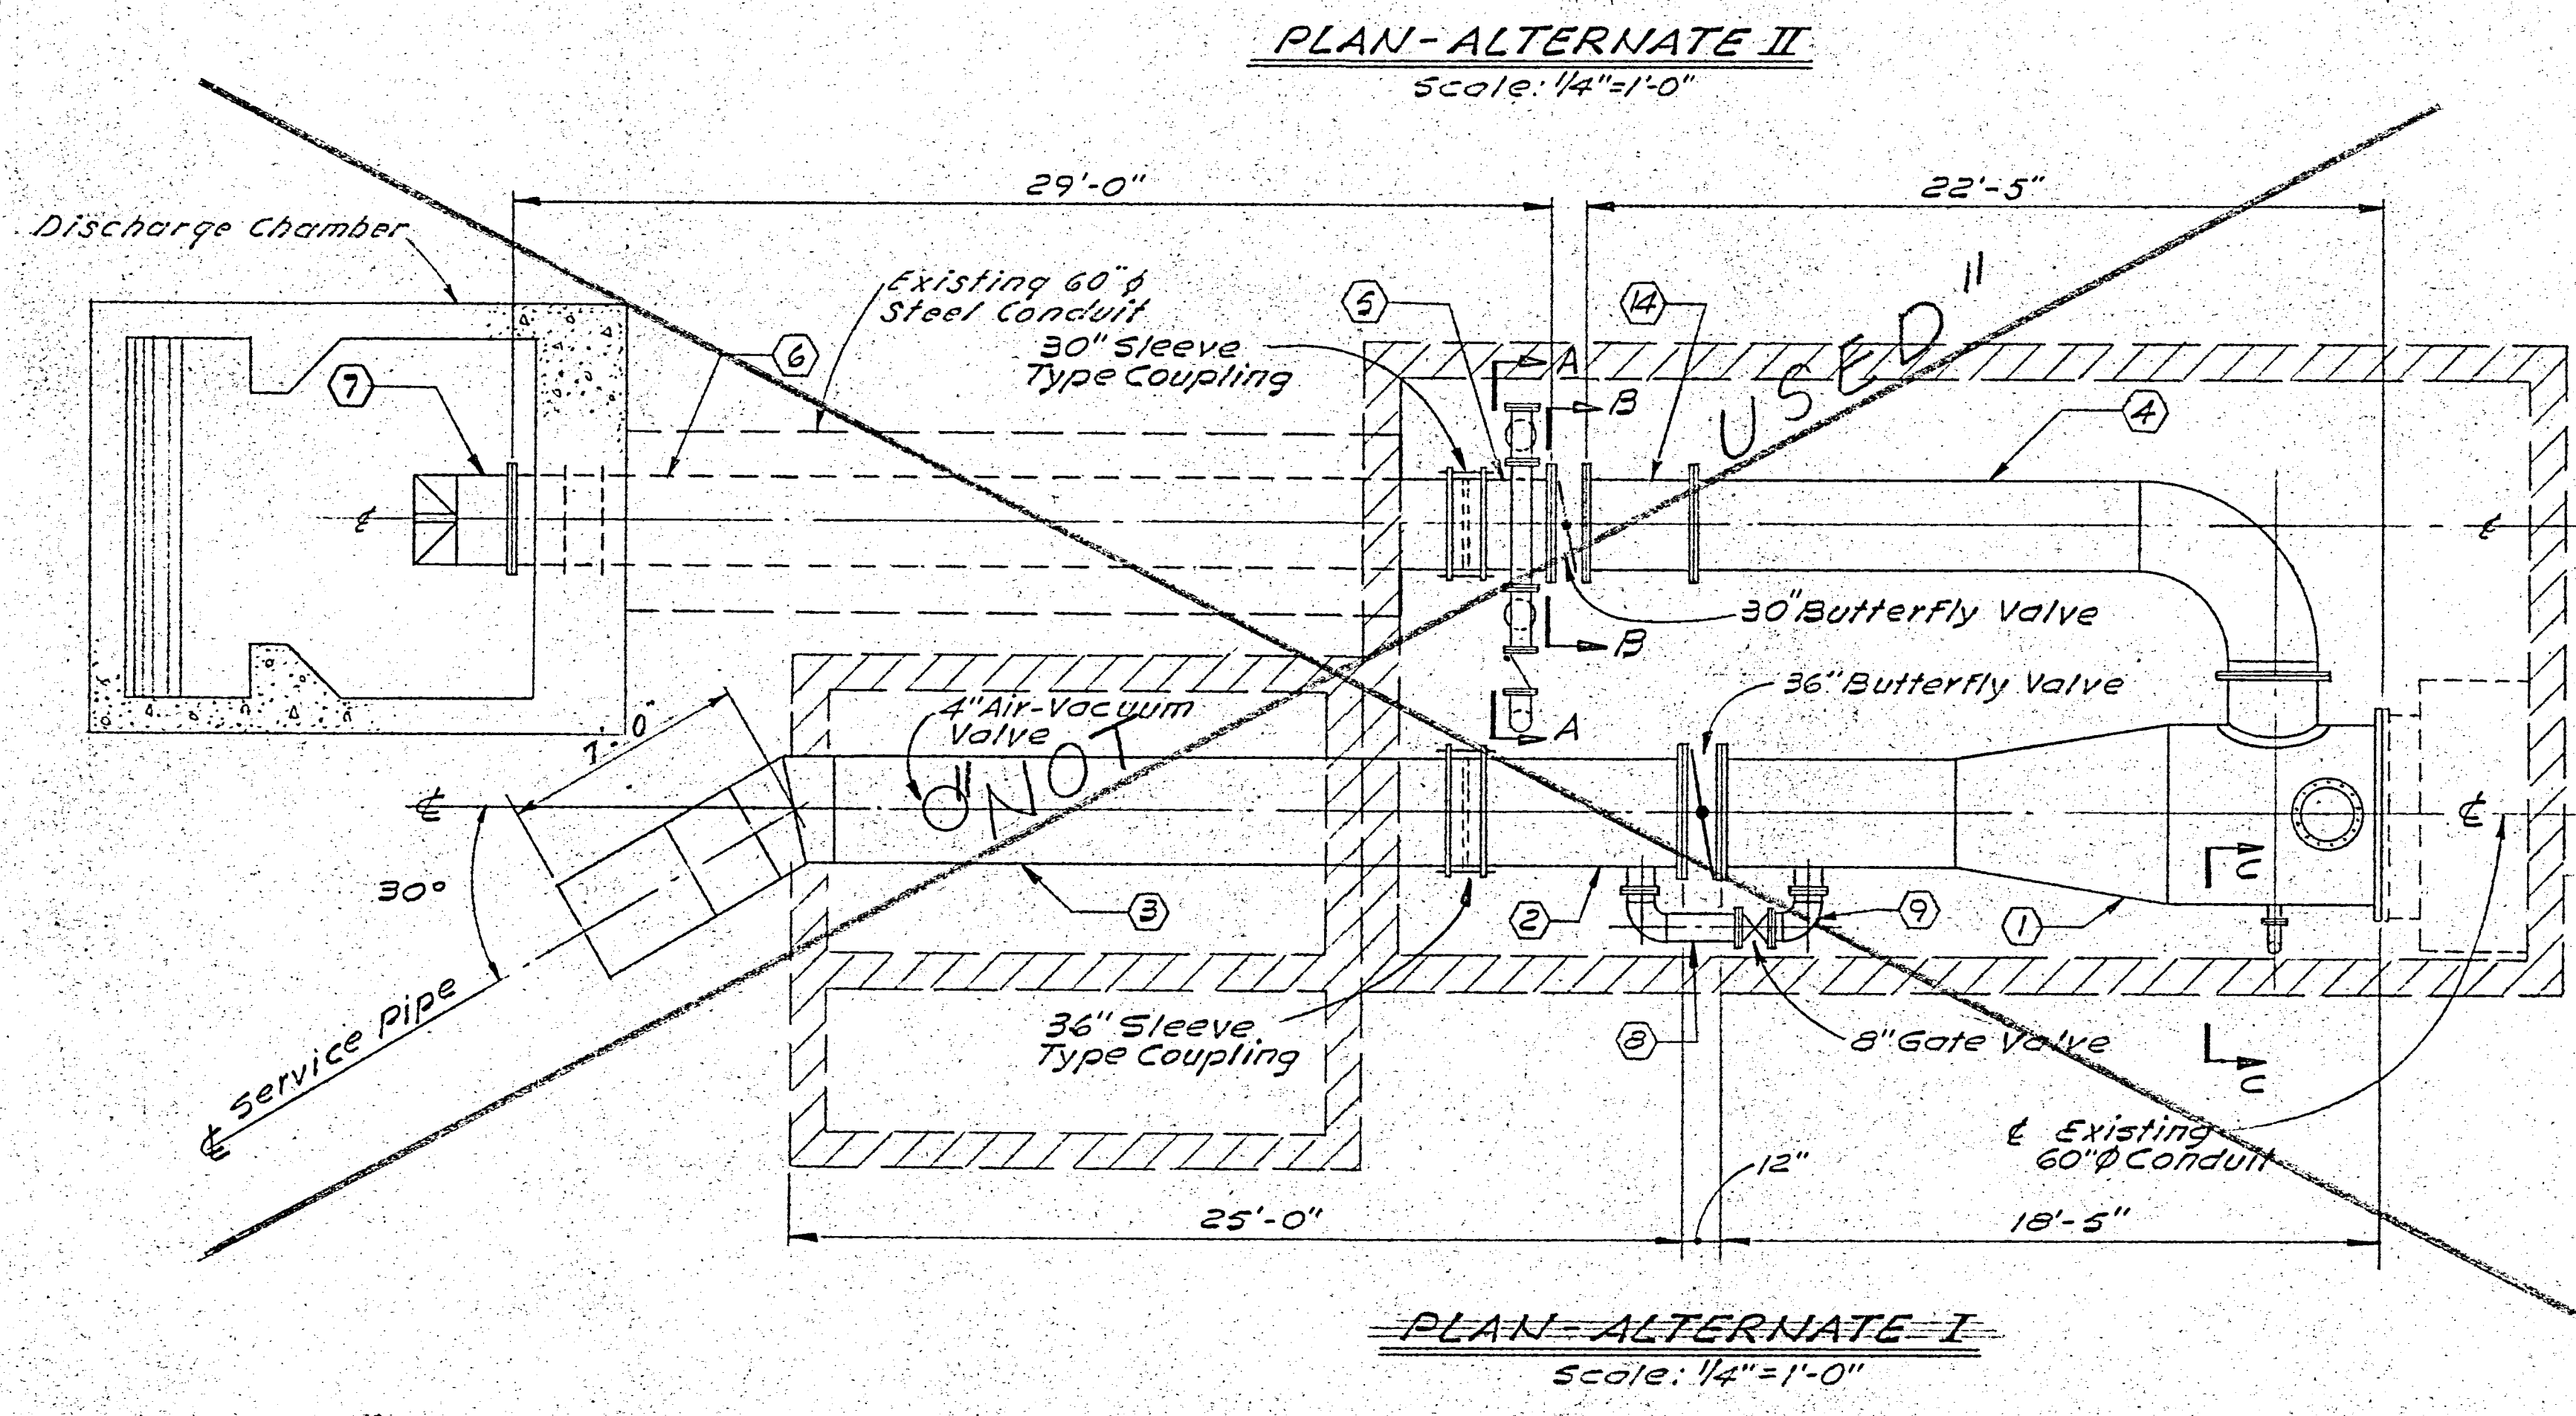
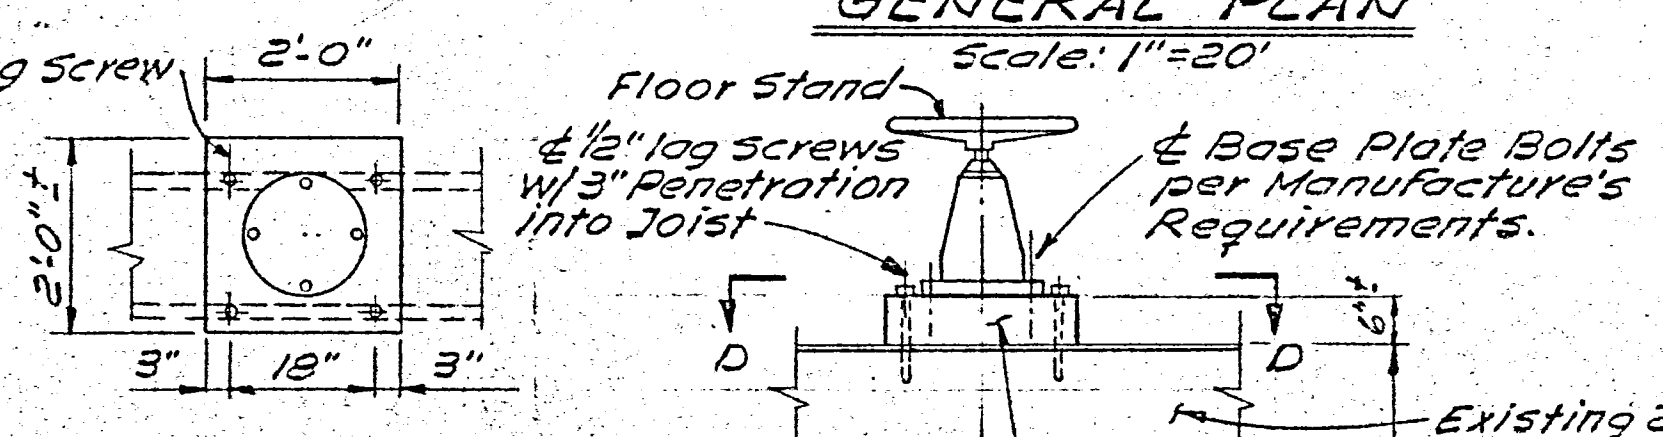
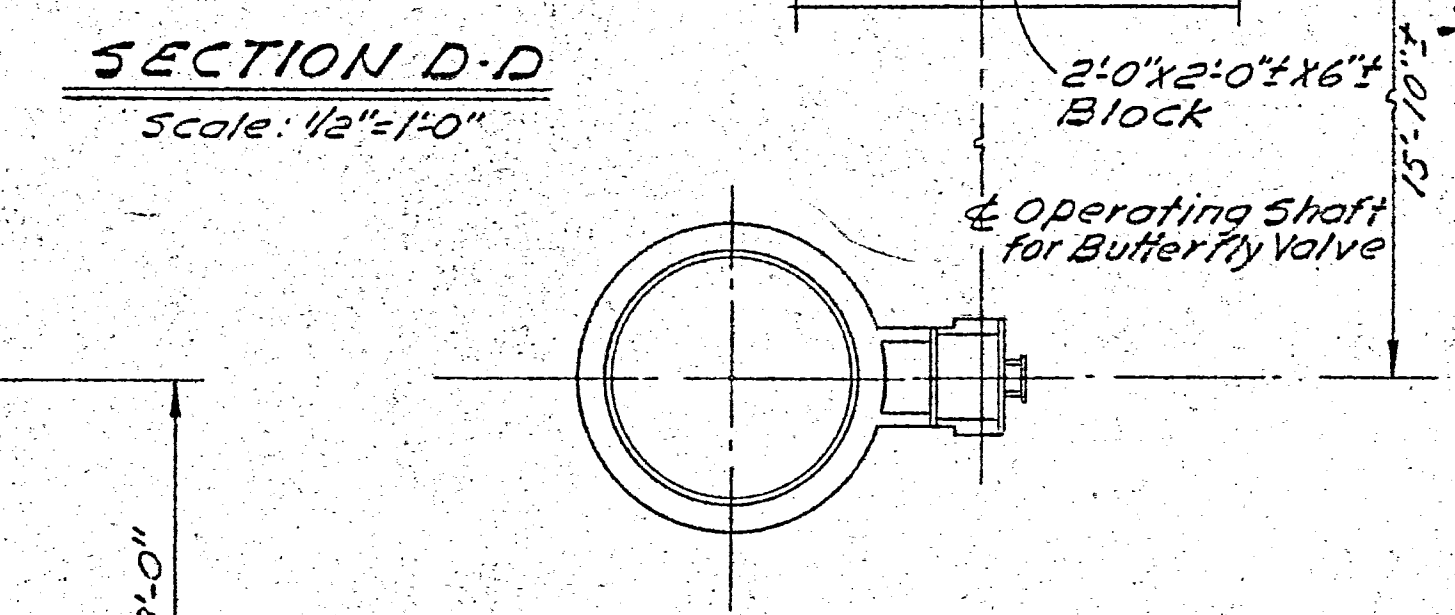
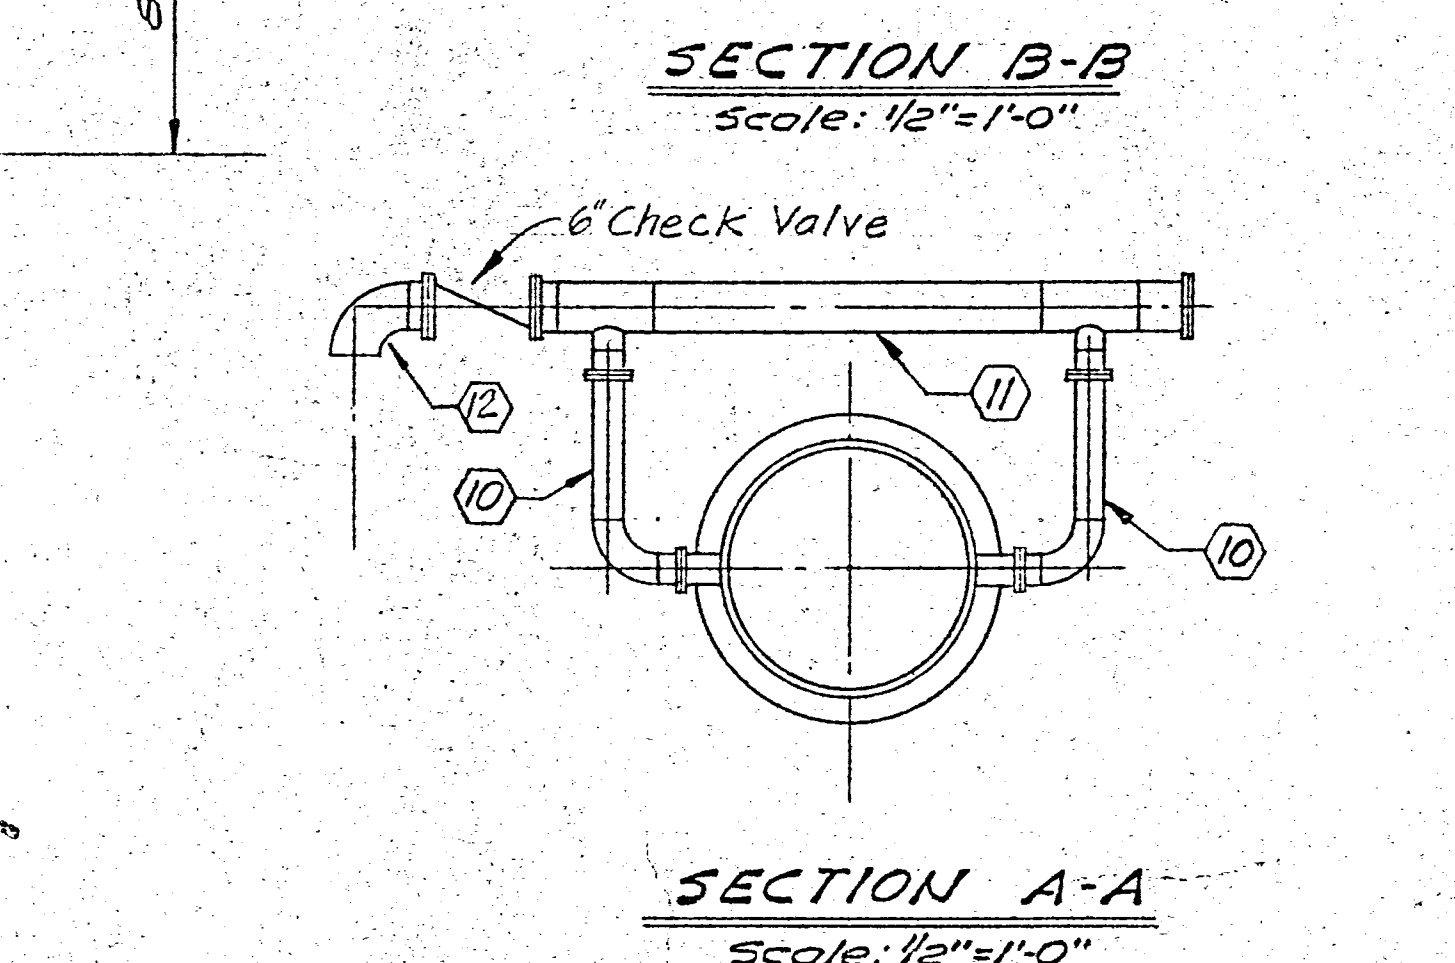
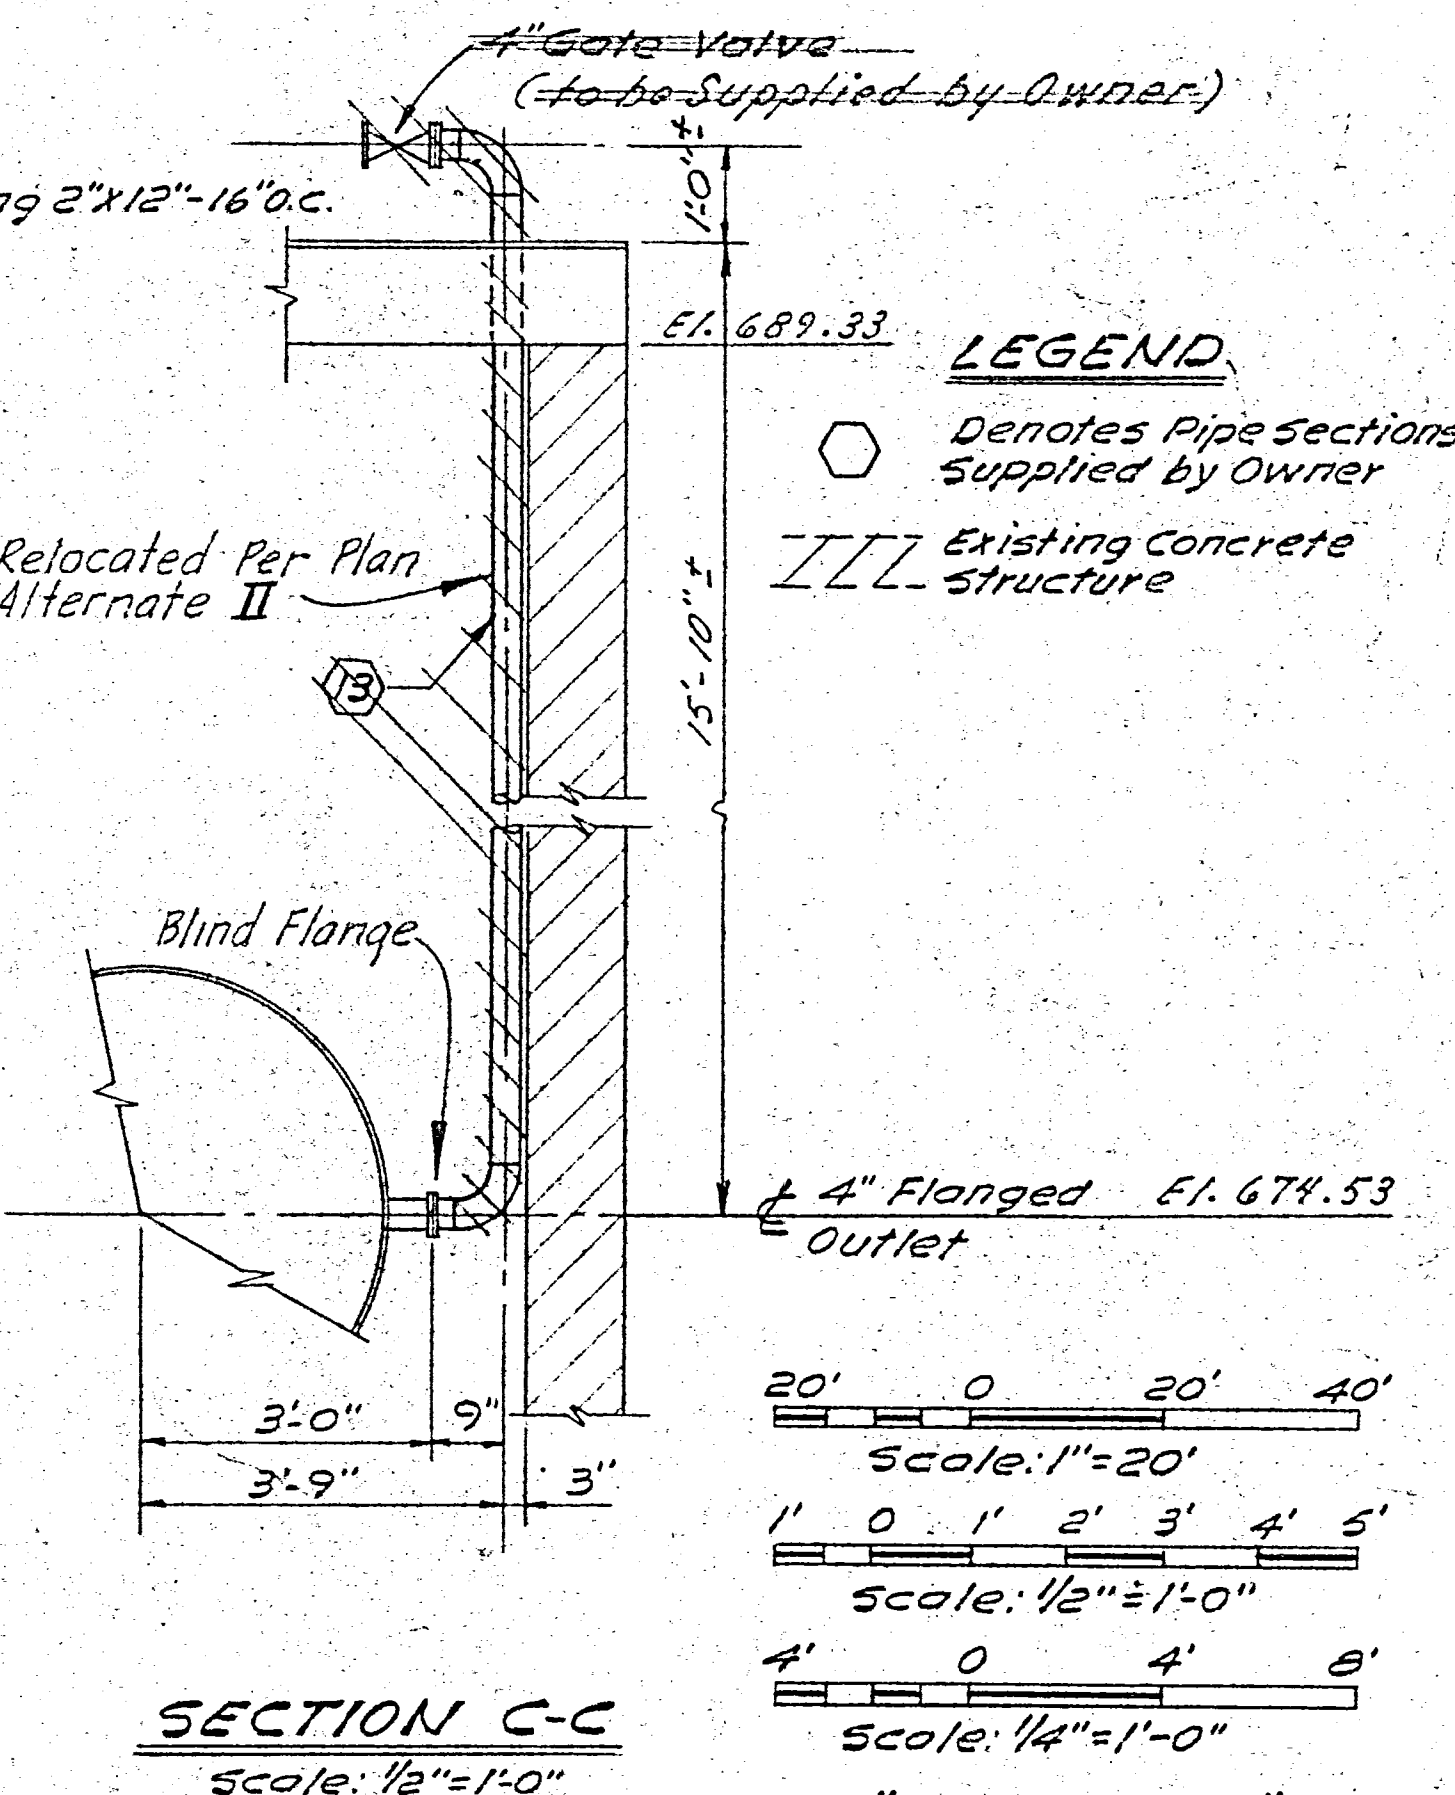
LEGEND
 ○ Denotes Pipe Sections Supplied by Owner
 ▨ Existing Concrete Structure
