DAM SAFETY PROGRAM

Guidelines & Governance

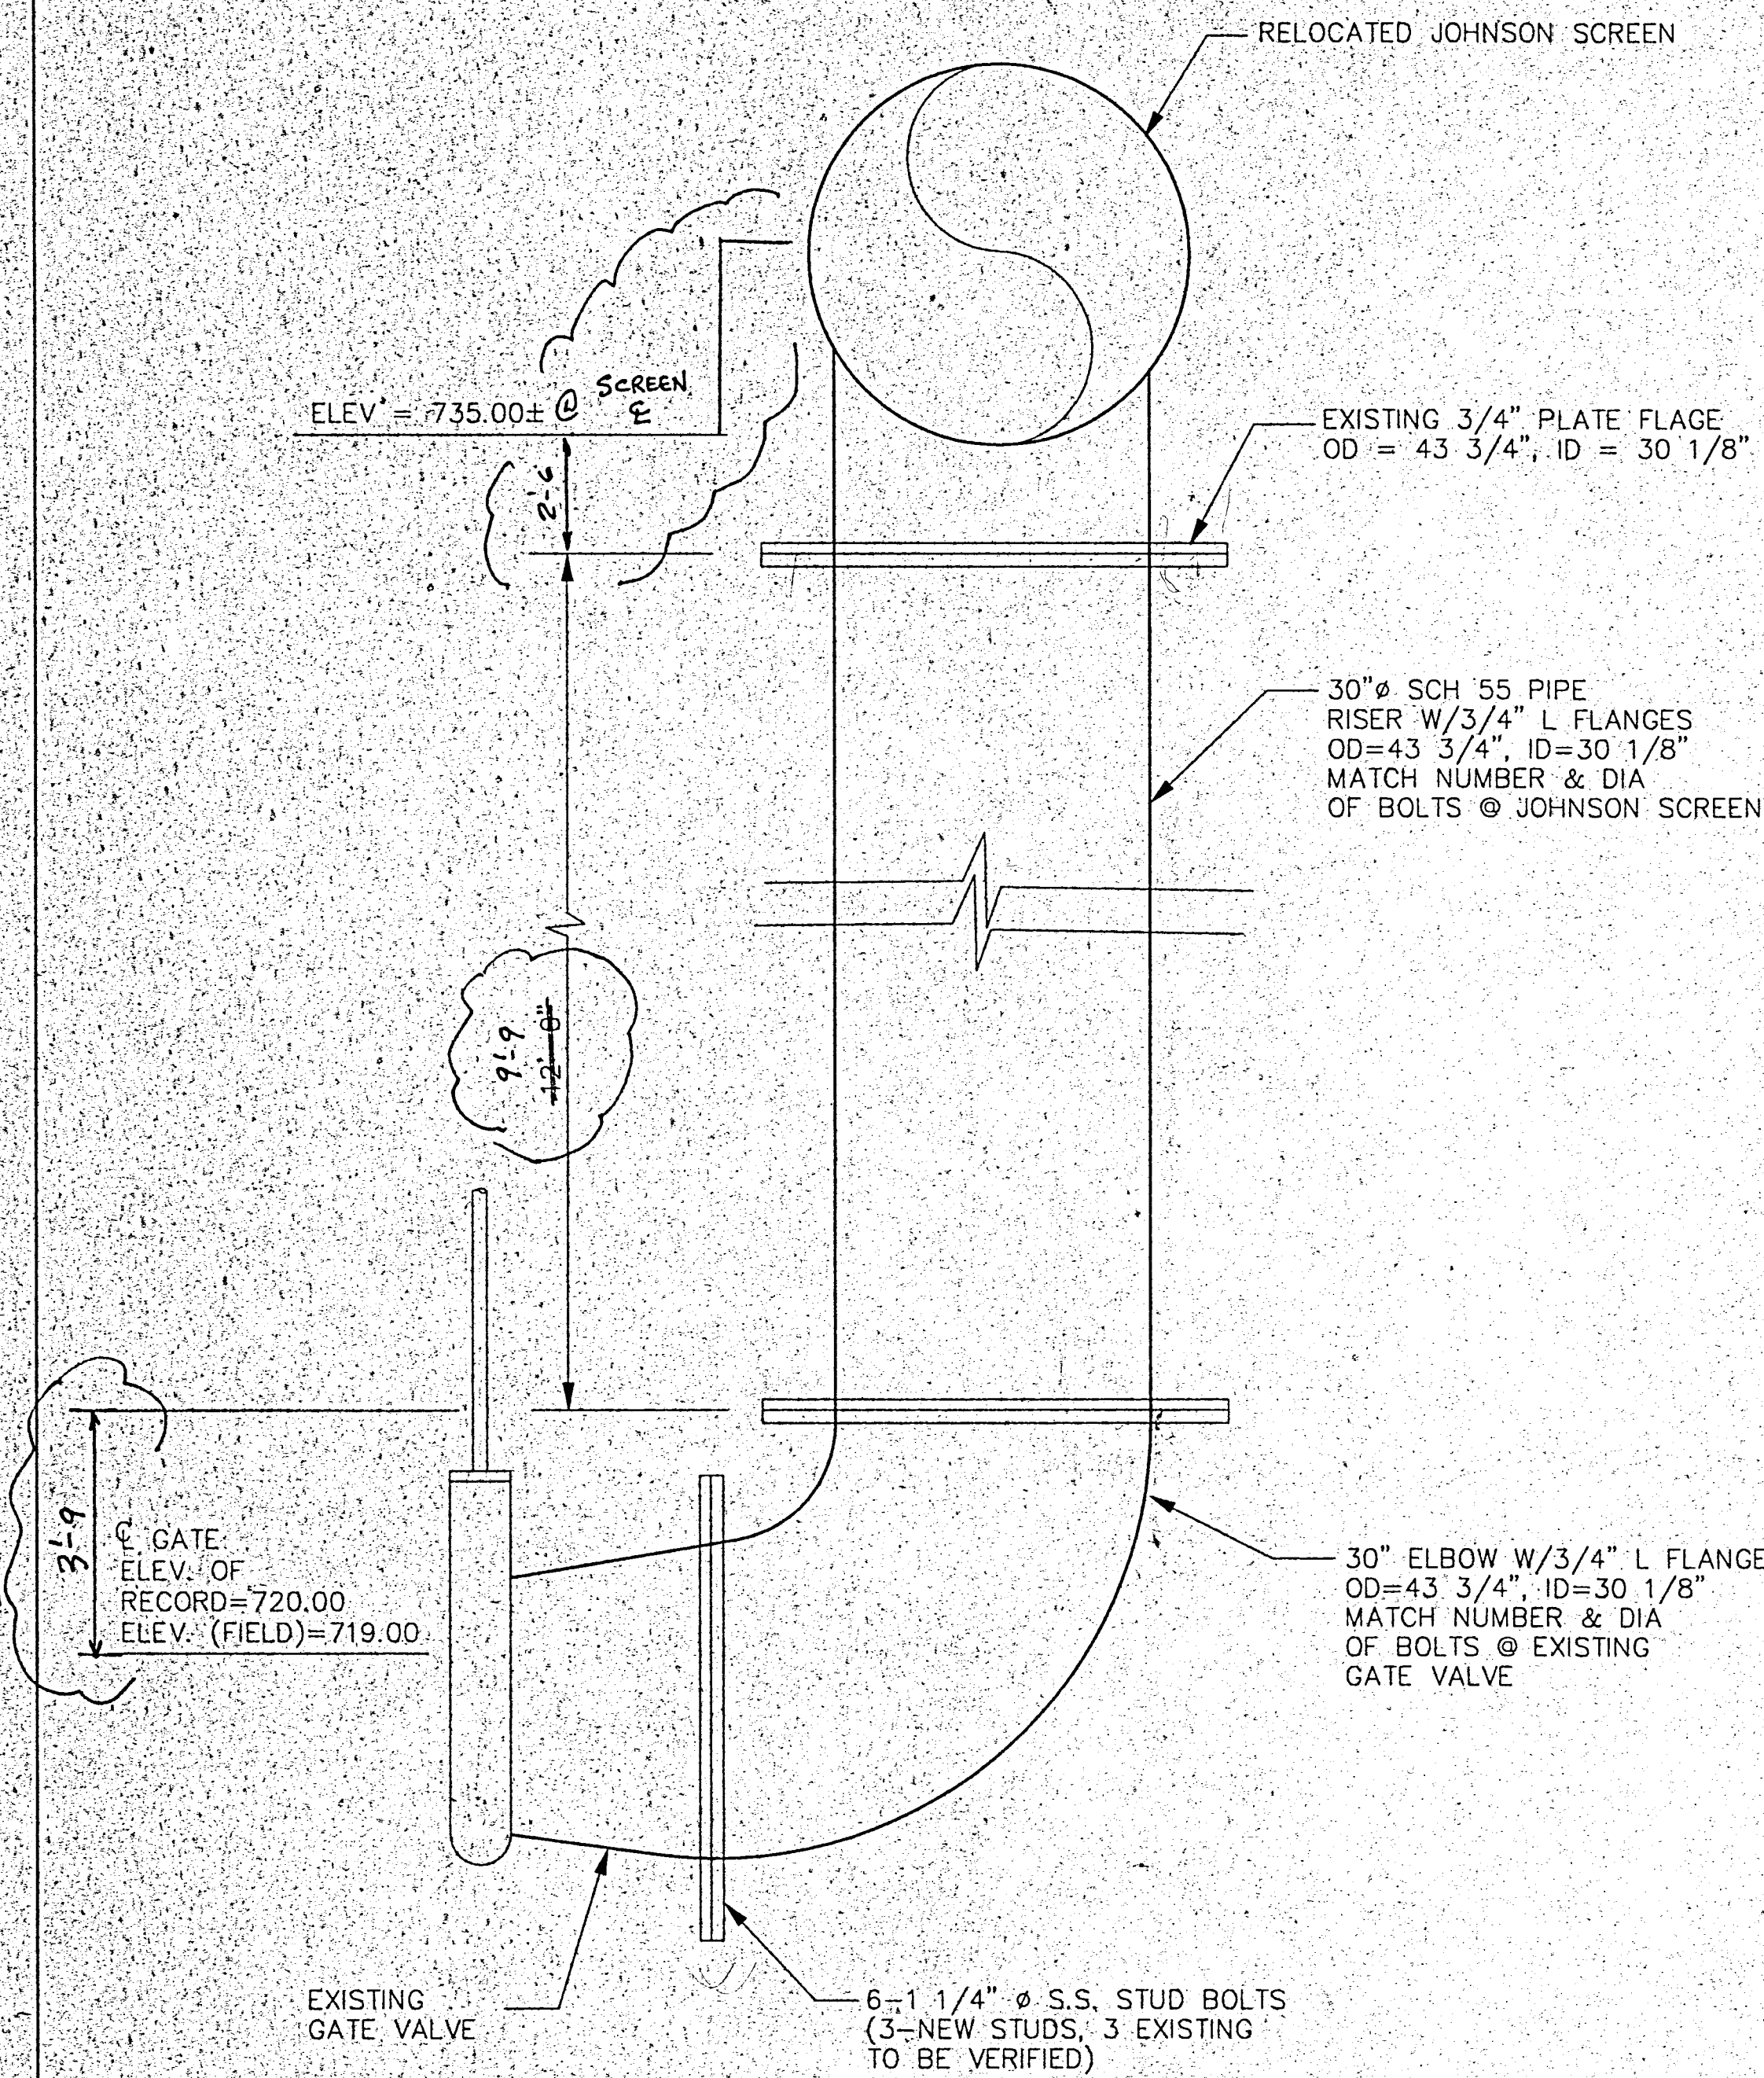
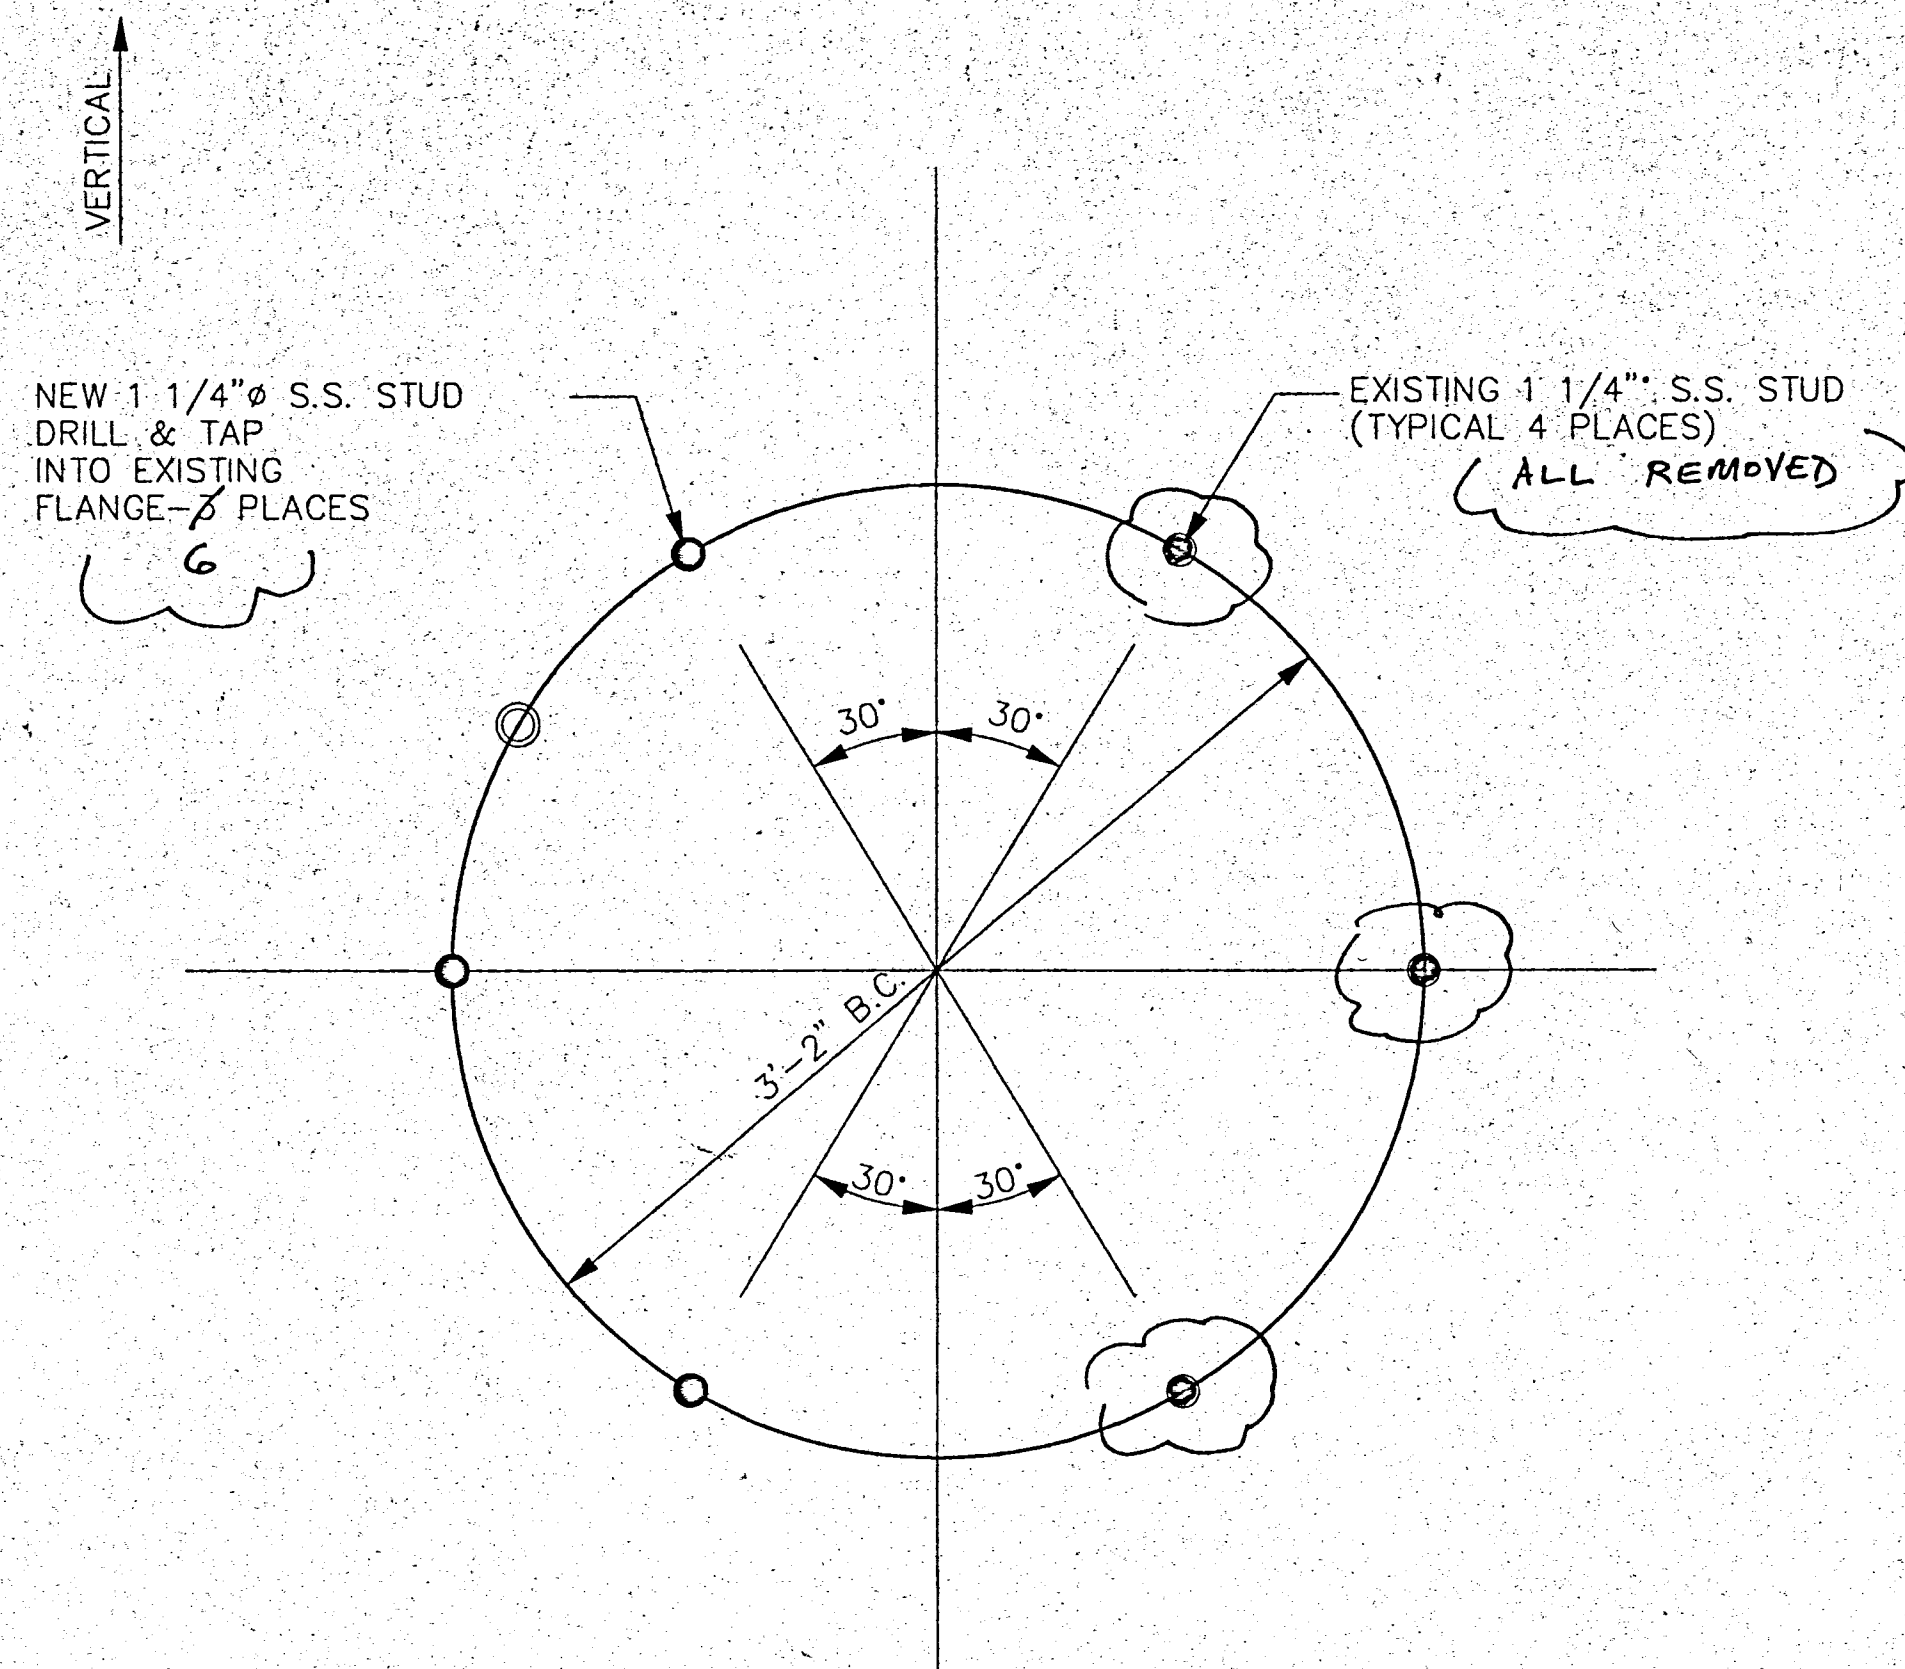
NO EXISTING STUDS WERE RE-USED

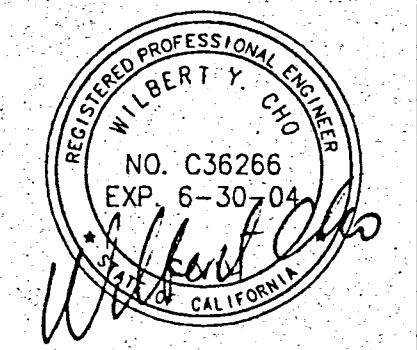
NO.	BY	REVISIONS	DATE	APPROVED	DRAWN	IRVINE RANCH WATER DISTRICT Irvine, California		Wilbert Cho WILBERT Y. CHO RCE NO 36266 PROJECT ENGINEER 6/21/01	Prepared By: CHD DESIGN ASSOCIATES, INC. 3001 REDHILL AVE. Suite 6-206 COSTA MESA, CA 92626	SANTIAGO CREEK DAM-OUTLET TOWER EXTENSION PROJECT NO. 10216 DETAILS	SHEET 3 OF 3	
					IRVINE RANCH WATER DISTRICT							A. TAVAS R. RICE RCE No. 36993 PROJECT ENGINEER 7-2-01
					SCALE AS SHOWN							CARL V. BALLARD DIRECTOR OF WATER OPERATIONS

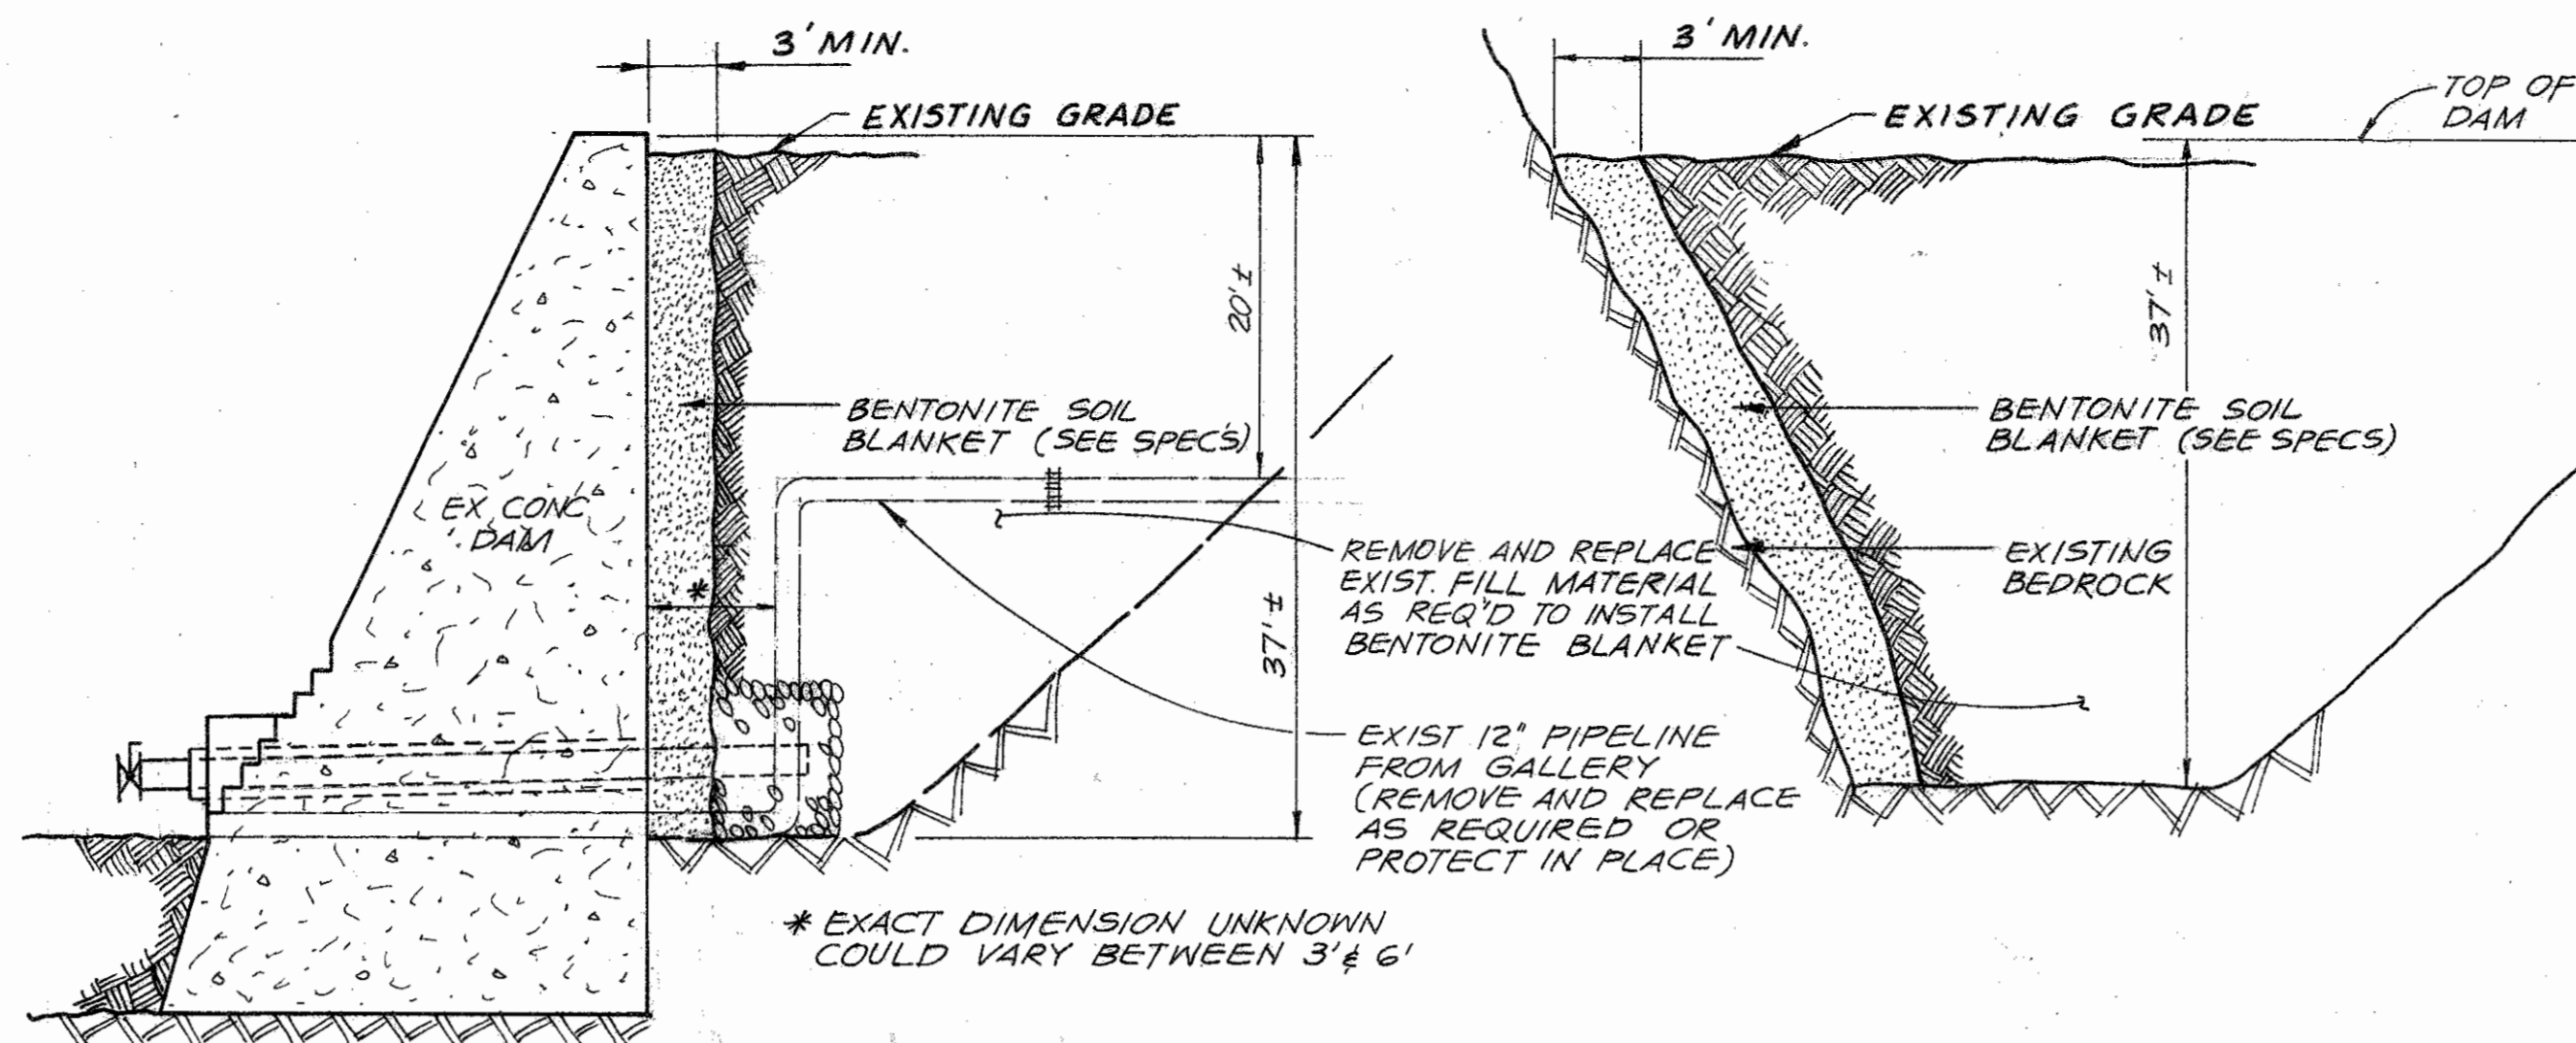
TYPICAL DAM SECTION (A)

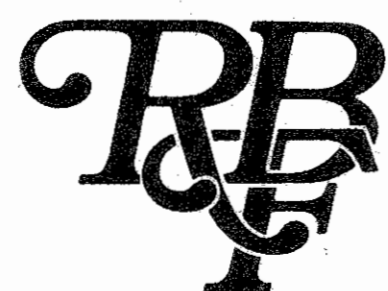
Robert Bein, William Frost & Associates
PROFESSIONAL ENVIRONMENTAL ENGINEERS & PLANNERS
P.O. BOX 2390 • 1401 QUAIL STREET, NEWPORT BEACH, CALIFORNIA 92663
(714) 833-0070

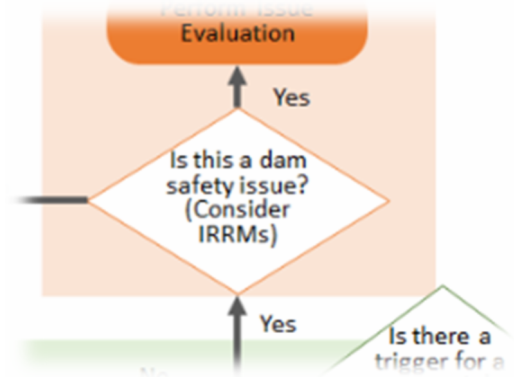
3.3 Perform Issue Evaluation

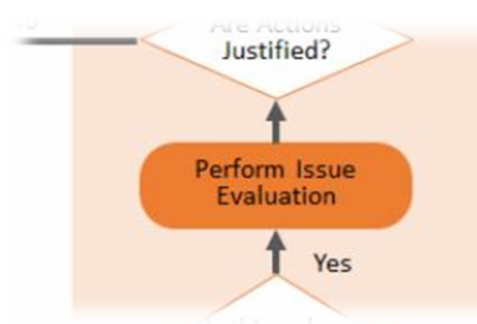
The Dam Safety Engineer is responsible for retaining the services of a Dam Engineering Consultant to conduct an Issue Evaluation Study (IES), when needed, to further understand if a dam safety issue exists, the extents of the concern, and offer recommendations. The IES should consider the Potential Failure Modes (PFM) that contribute to the dam safety issue, and where appropriate, risk analysis for the PFM based on findings in the IES. The risk analysis may take on a variety of forms including quantitative and qualitative.

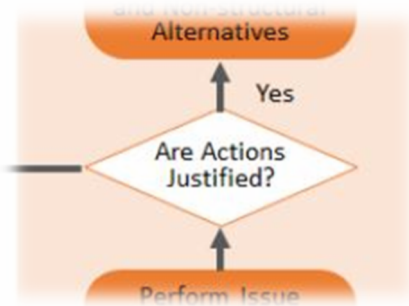
In general, the Dam Safety Engineer will present the risk estimates to the Executive Director of Technical Services, General Manager, and/or the Board for decision making based on the value of the improvements and in accordance with IRWD’s procurement policy. Several factors may be considered when making risk informed decisions including, but not limited to the following.

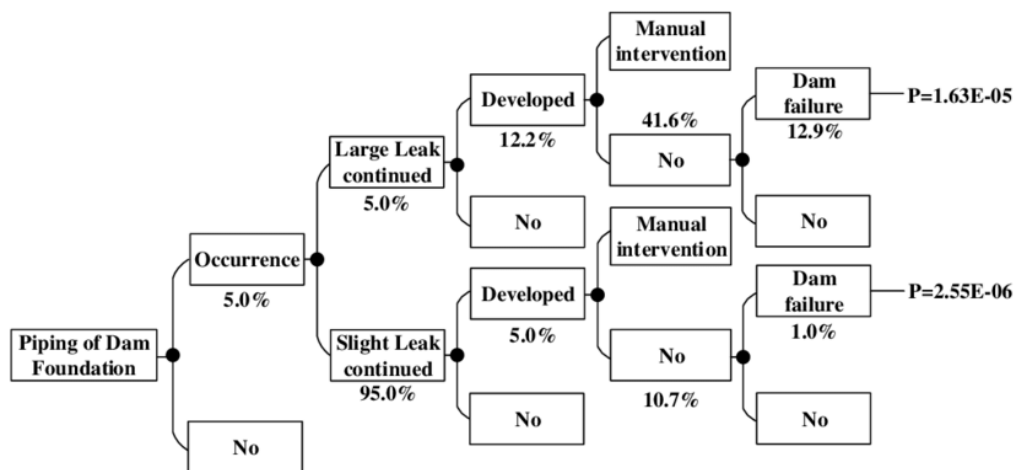
Figure 2: Sample event tree for a PFM from Army Corps of Engineers.

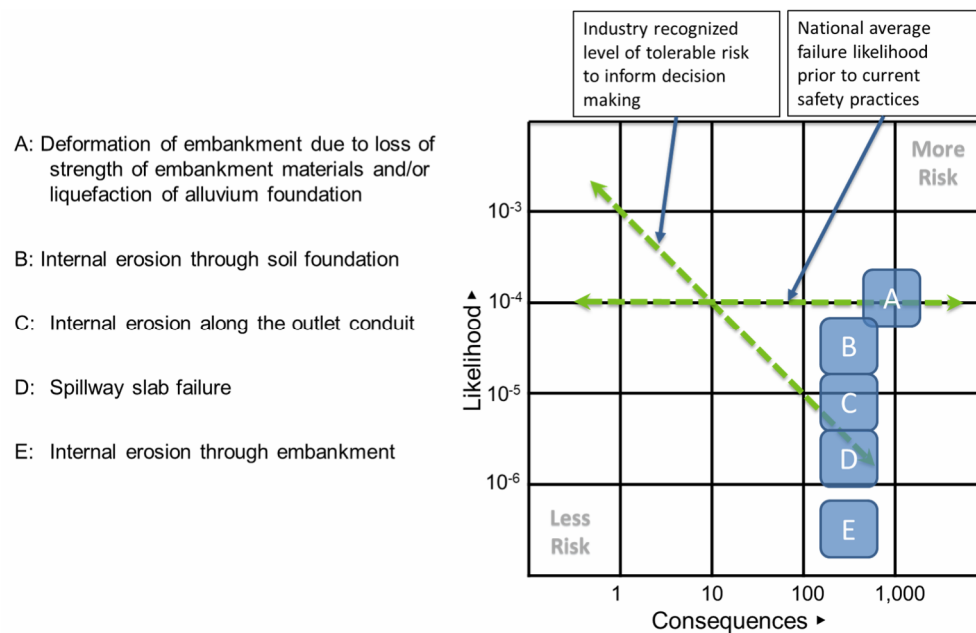
Figure 3: Sample Risk Matrix with risk estimates for various PFMs.

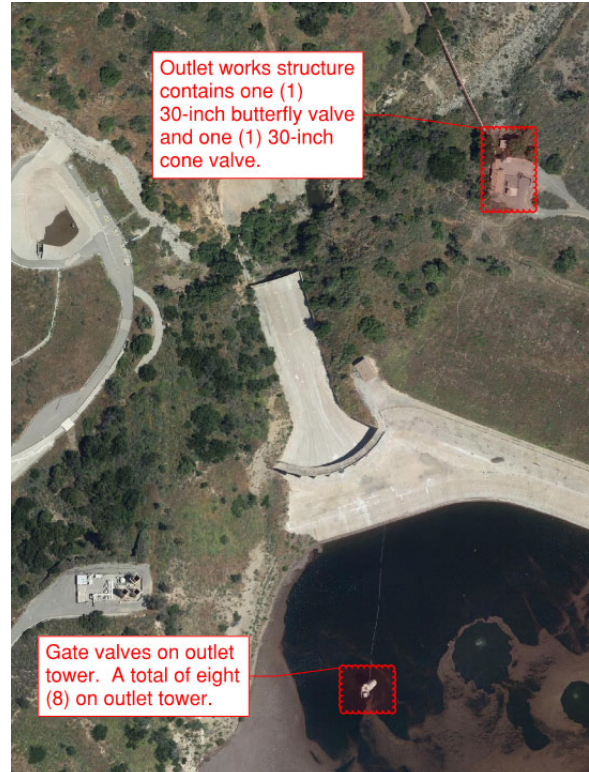
Figure 1: Santiago Reservoir valve locations for releasing water to Santiago Creek.

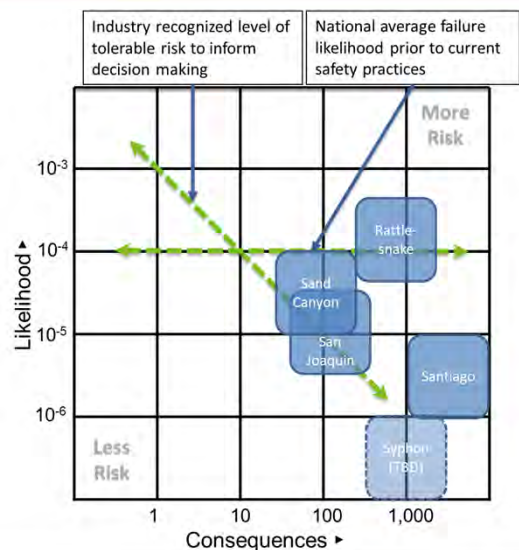
Irvine Ranch Water District

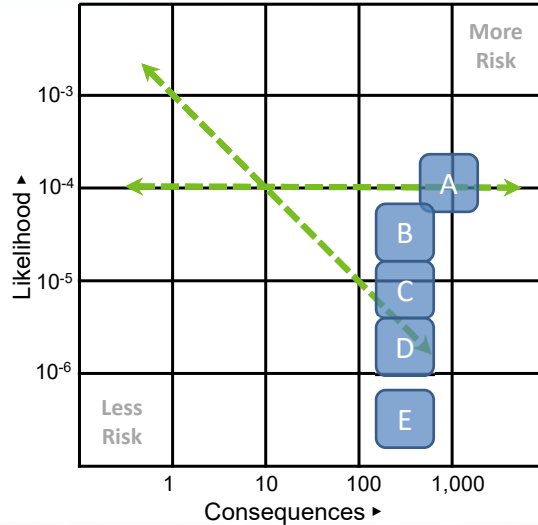
- A: Deformation of embankment due to loss of strength of embankment materials and/or liquefaction of alluvium foundation
- B: Internal erosion through soil foundation
- C: Internal erosion along the outlet conduit
- D: Spillway slab failure
- E: Internal erosion through embankment

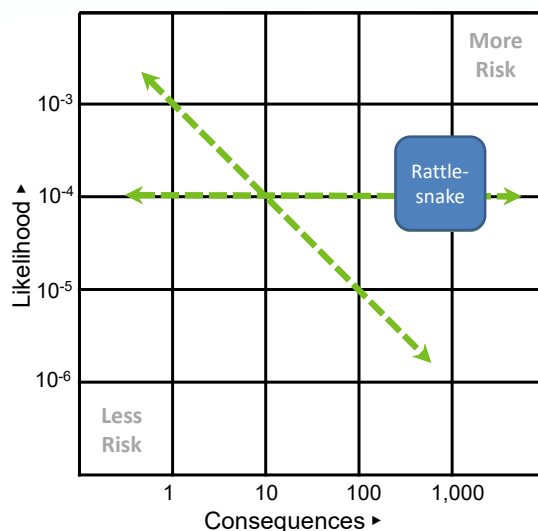
- Previous studies indicate presence of alluvium foundation material, potential for liquefaction of foundation, and a wide range of material strengths.
- Additional geotechnical investigations and evaluations are needed to characterize extent and strengths of liquefiable materials.
- Permitted operating level of 406-ft may not provide adequate risk reduction.
- Preliminary slope stability analysis indicates significant risk reduction by operating at or below elevation 395-ft.
