# **DAM SAFETY PROGRAM**

## **Guidelines & Governance**

**Irvine Ranch  
Water District**

**July 2023**

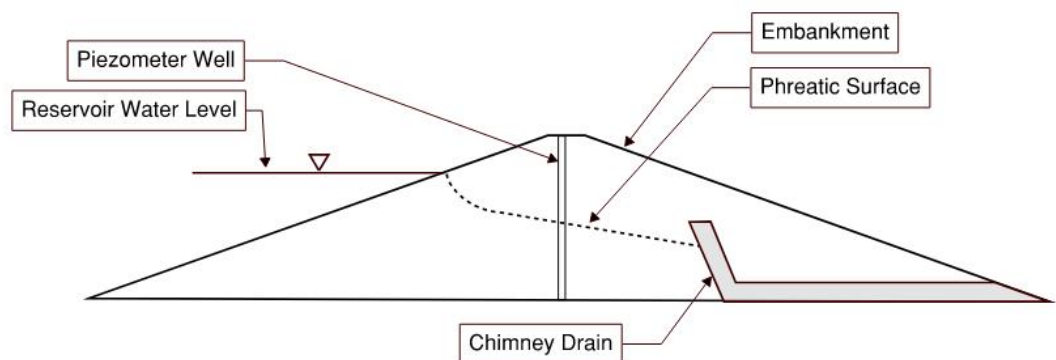
Figure 1: Embankment Features Related to Seepage

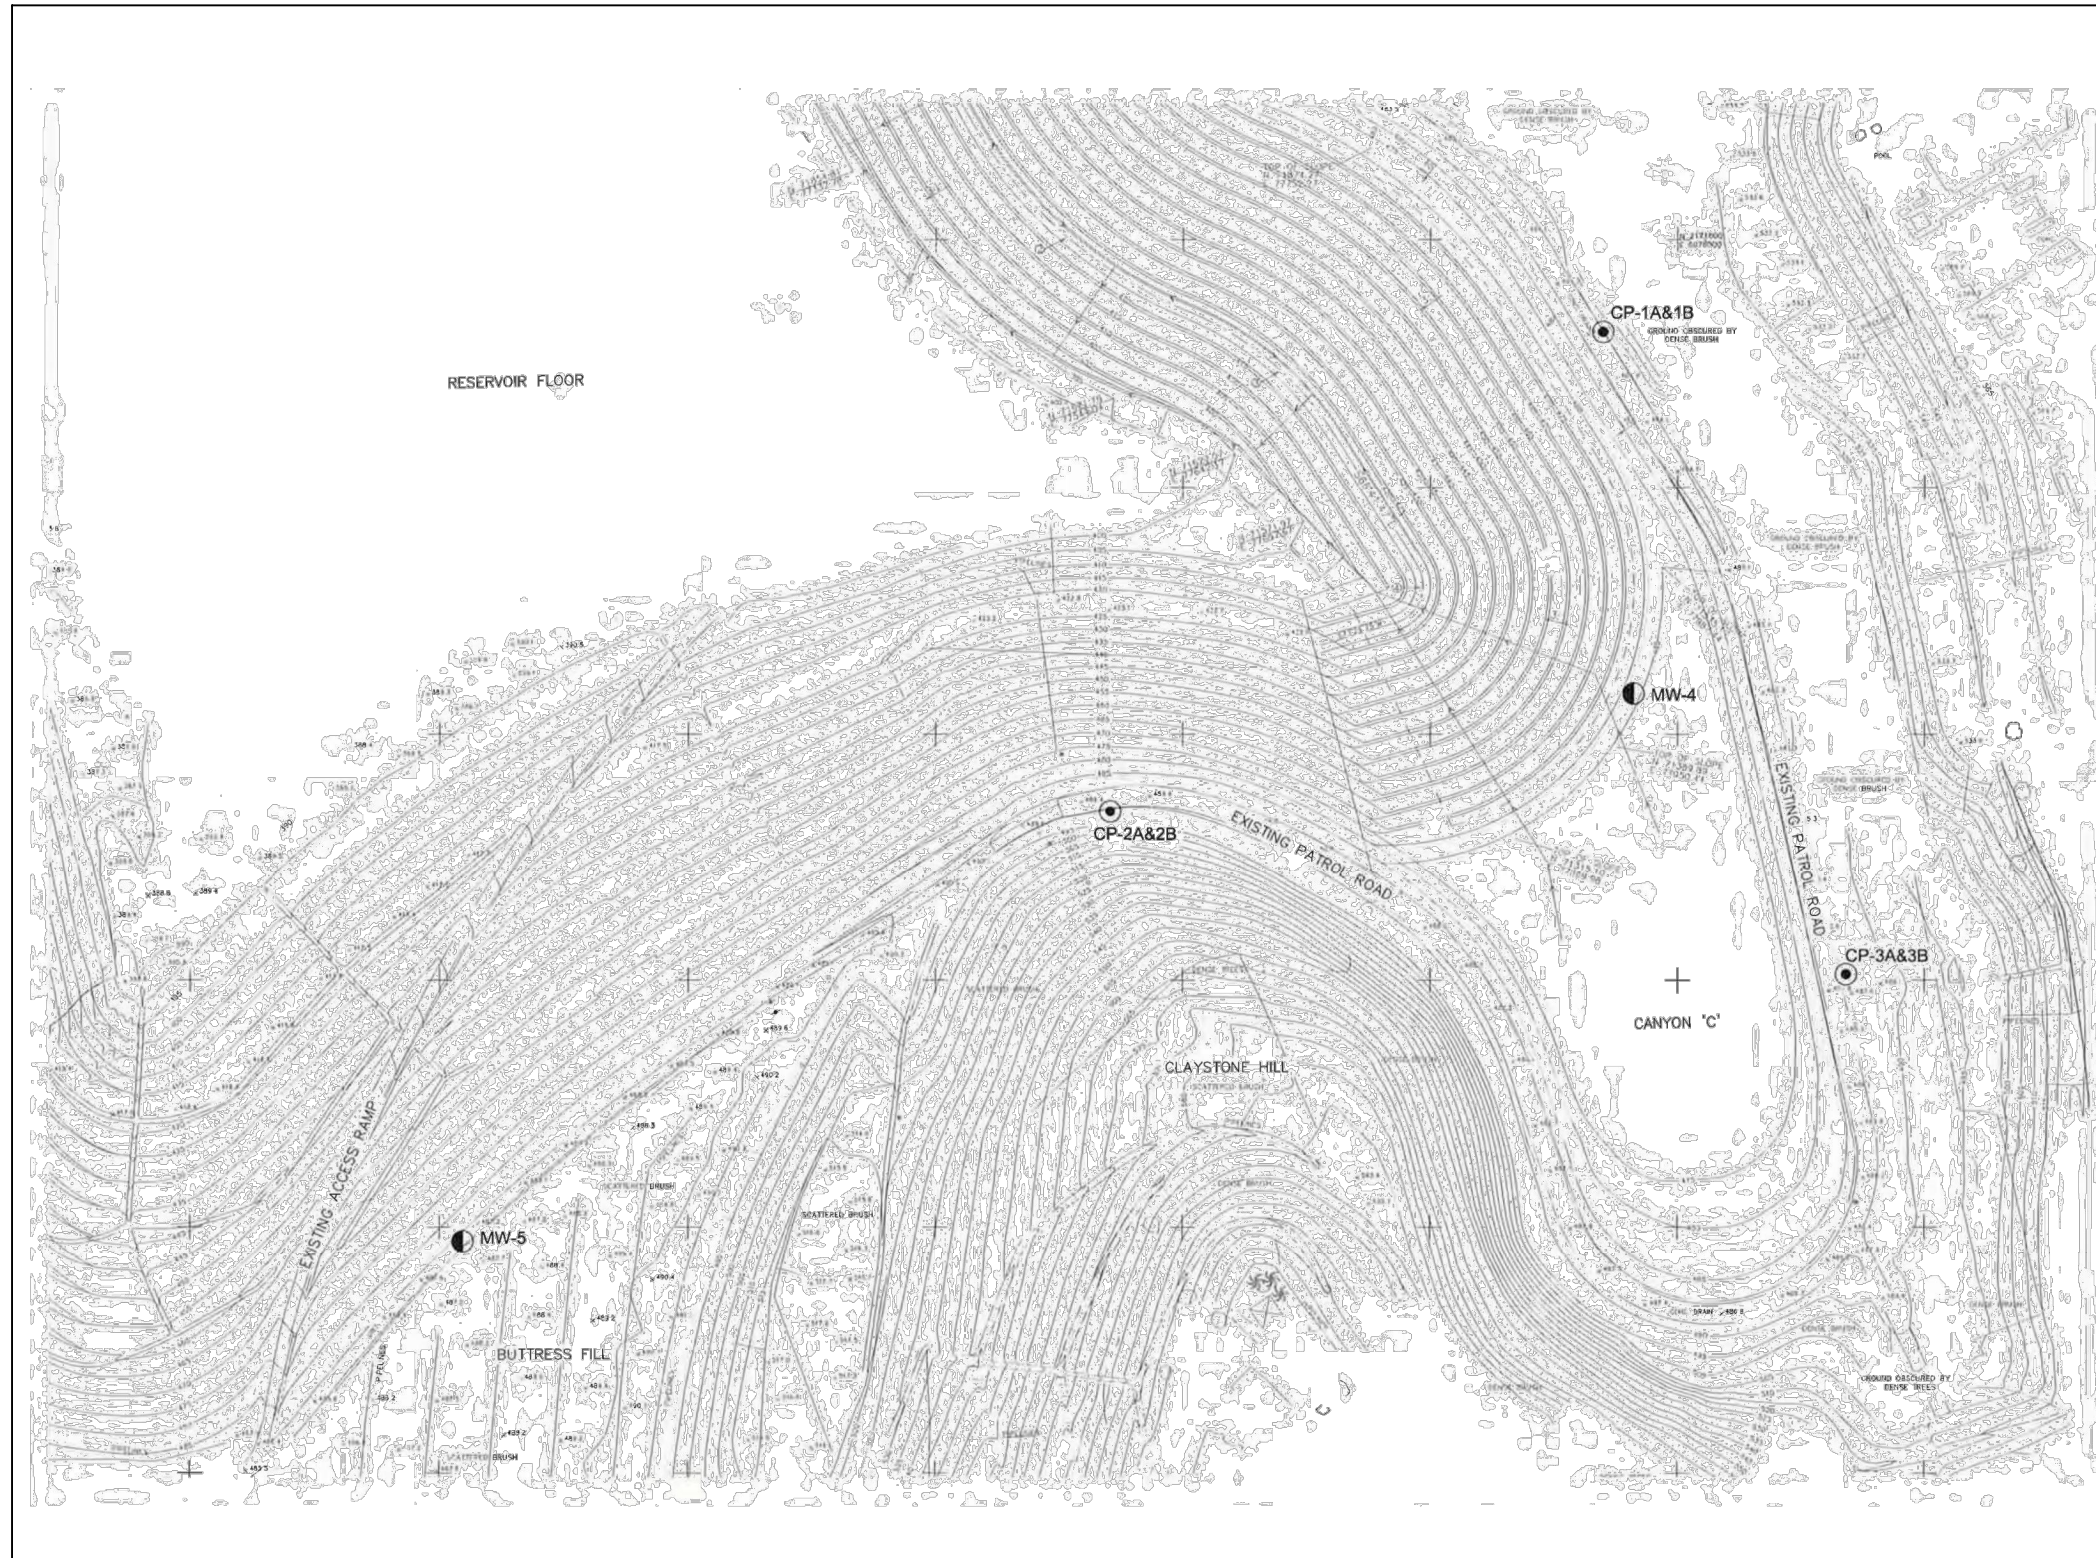
Exhibit 5.1 - Site and Instrumentation Plan for San Joaquin Dam

DAM EMBANKMENT AND  
 ABUTMENT LOCATIONS  
 Project 1901888 September 2022 Fig. 3

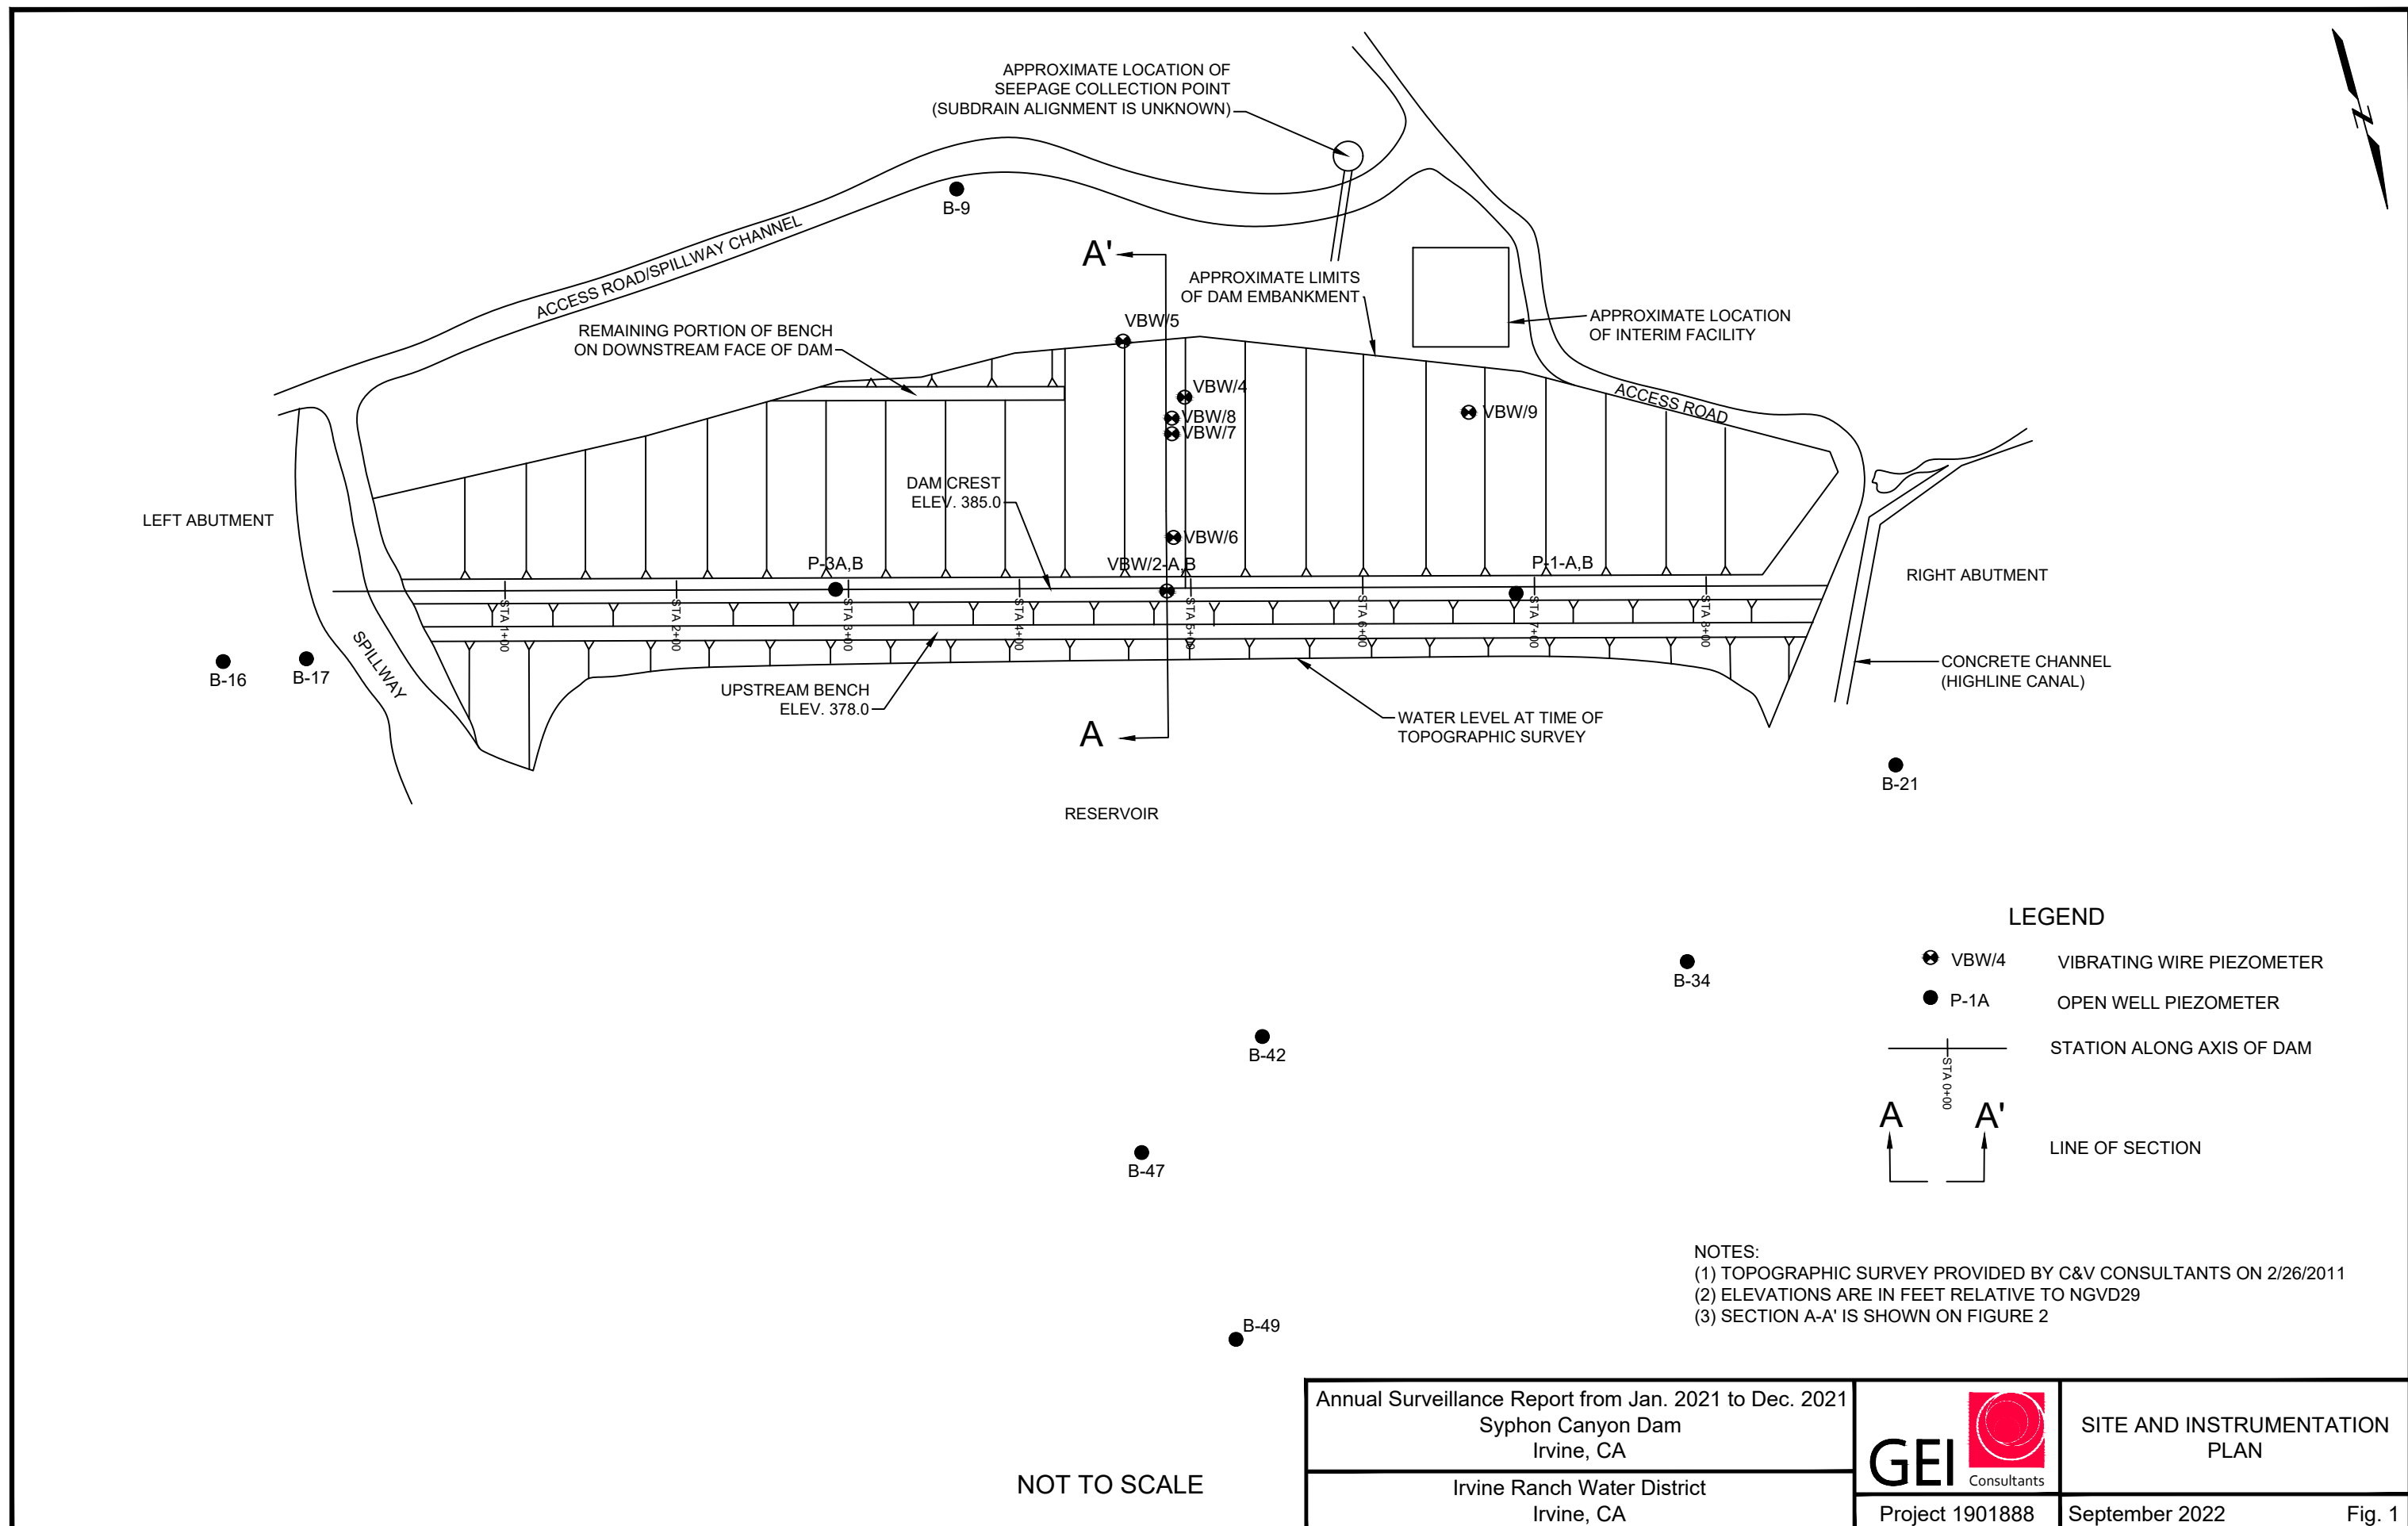
Exhibit 5.3 - Site and Instrumentation Plan for Syphon Dam

SITE AND INSTRUMENTATION PLAN  
 Project 1901888  
 September 2022  
 Fig. 1

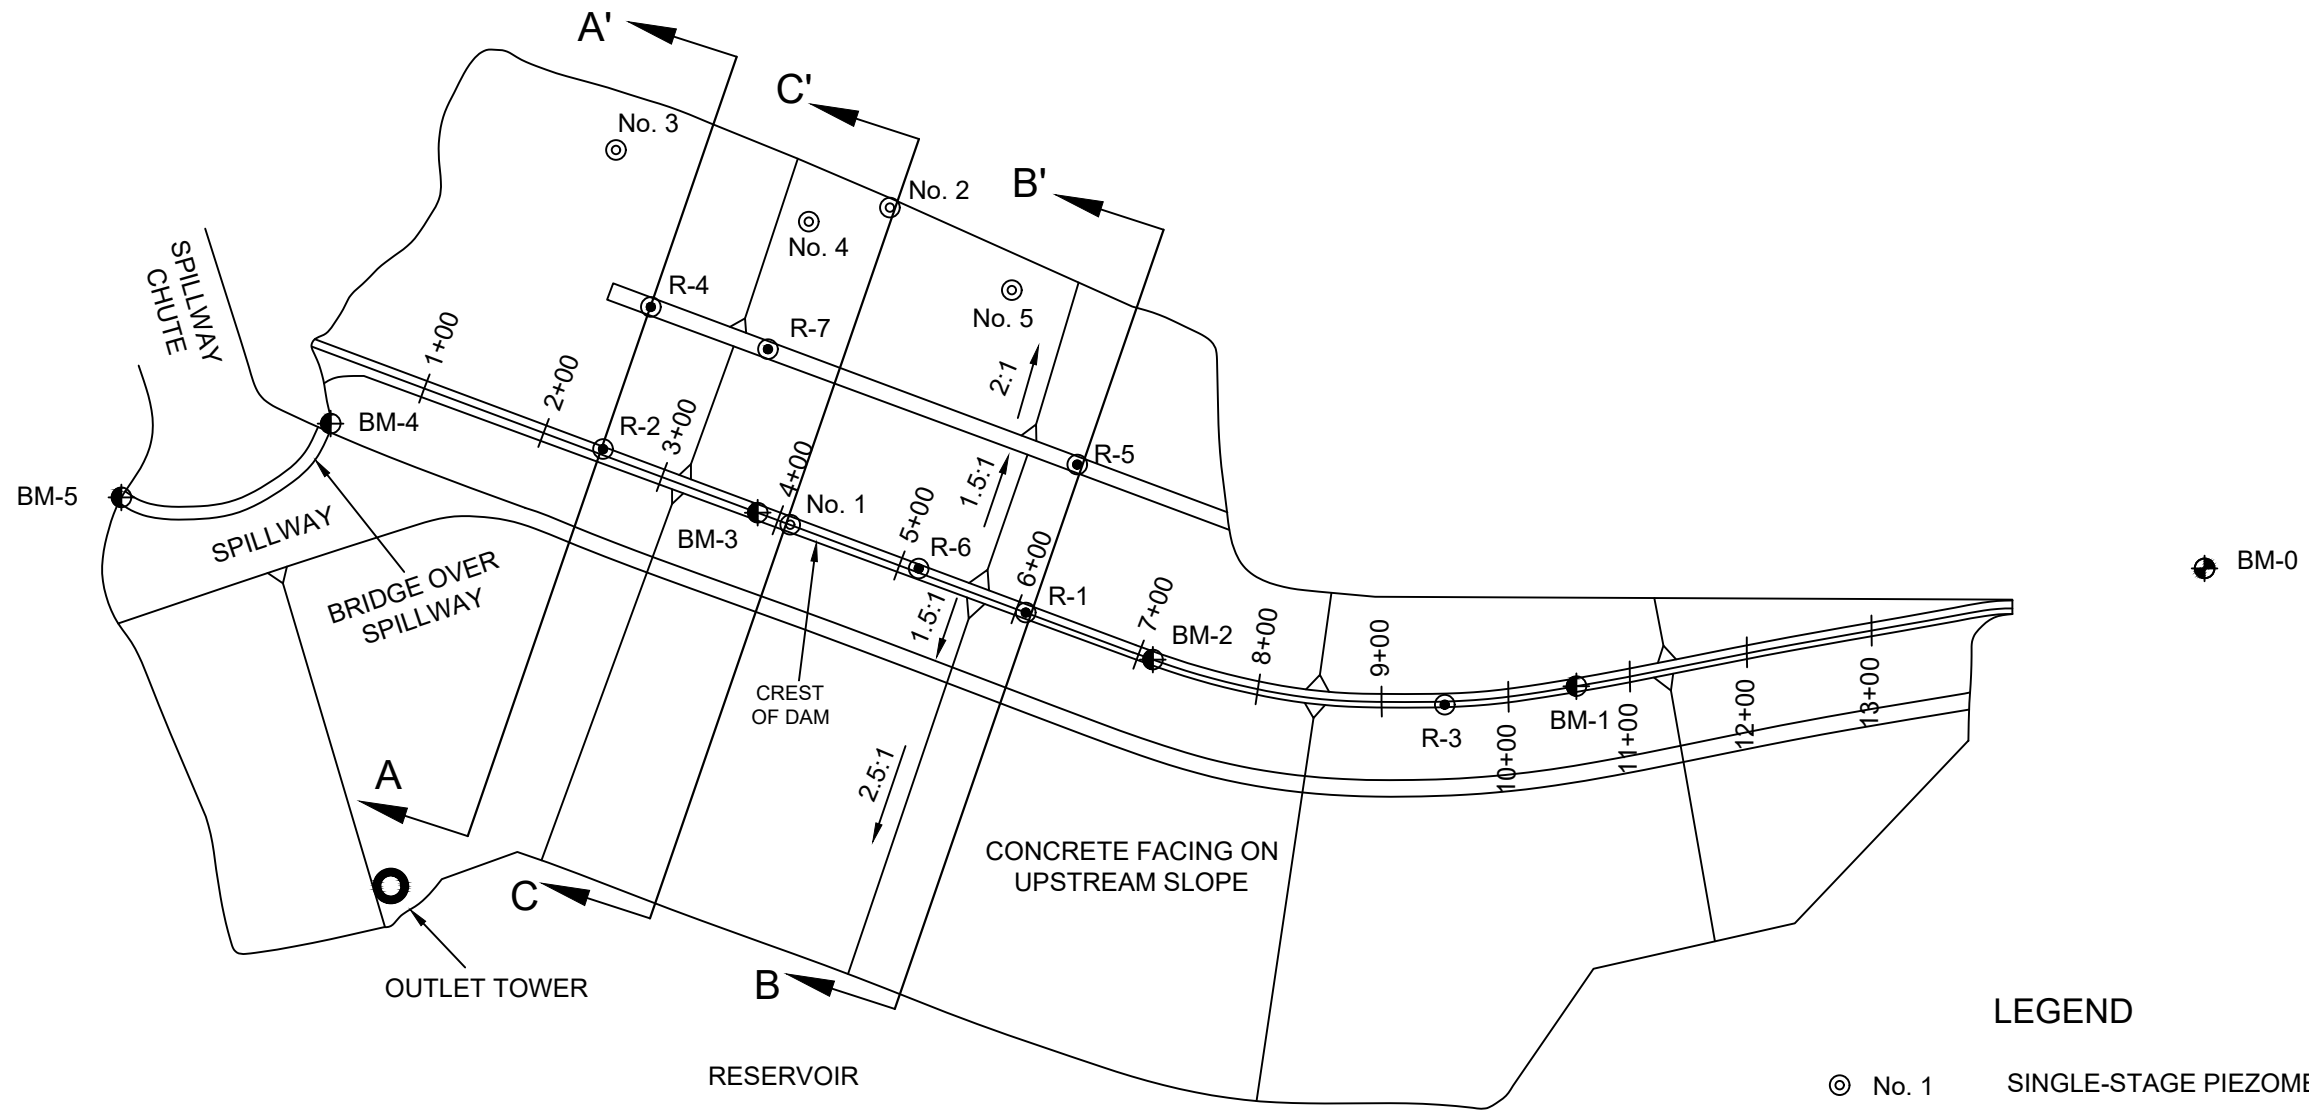
Exhibit 5.5 - Site and Instrumentation Plan for Santiago Creek Dam

- ⊙ No. 1 SINGLE-STAGE PIEZOMETER
- ⊙ R-2 MULTI-STAGE PIEZOMETER
- ⊕ BM-5 SURVEY MONUMENTS
- ⊕ BM-0 BENCHMARK

SITE AND INSTRUMENTATION PLAN	
Irvine Ranch Water District Irvine, CA			Project 1901888

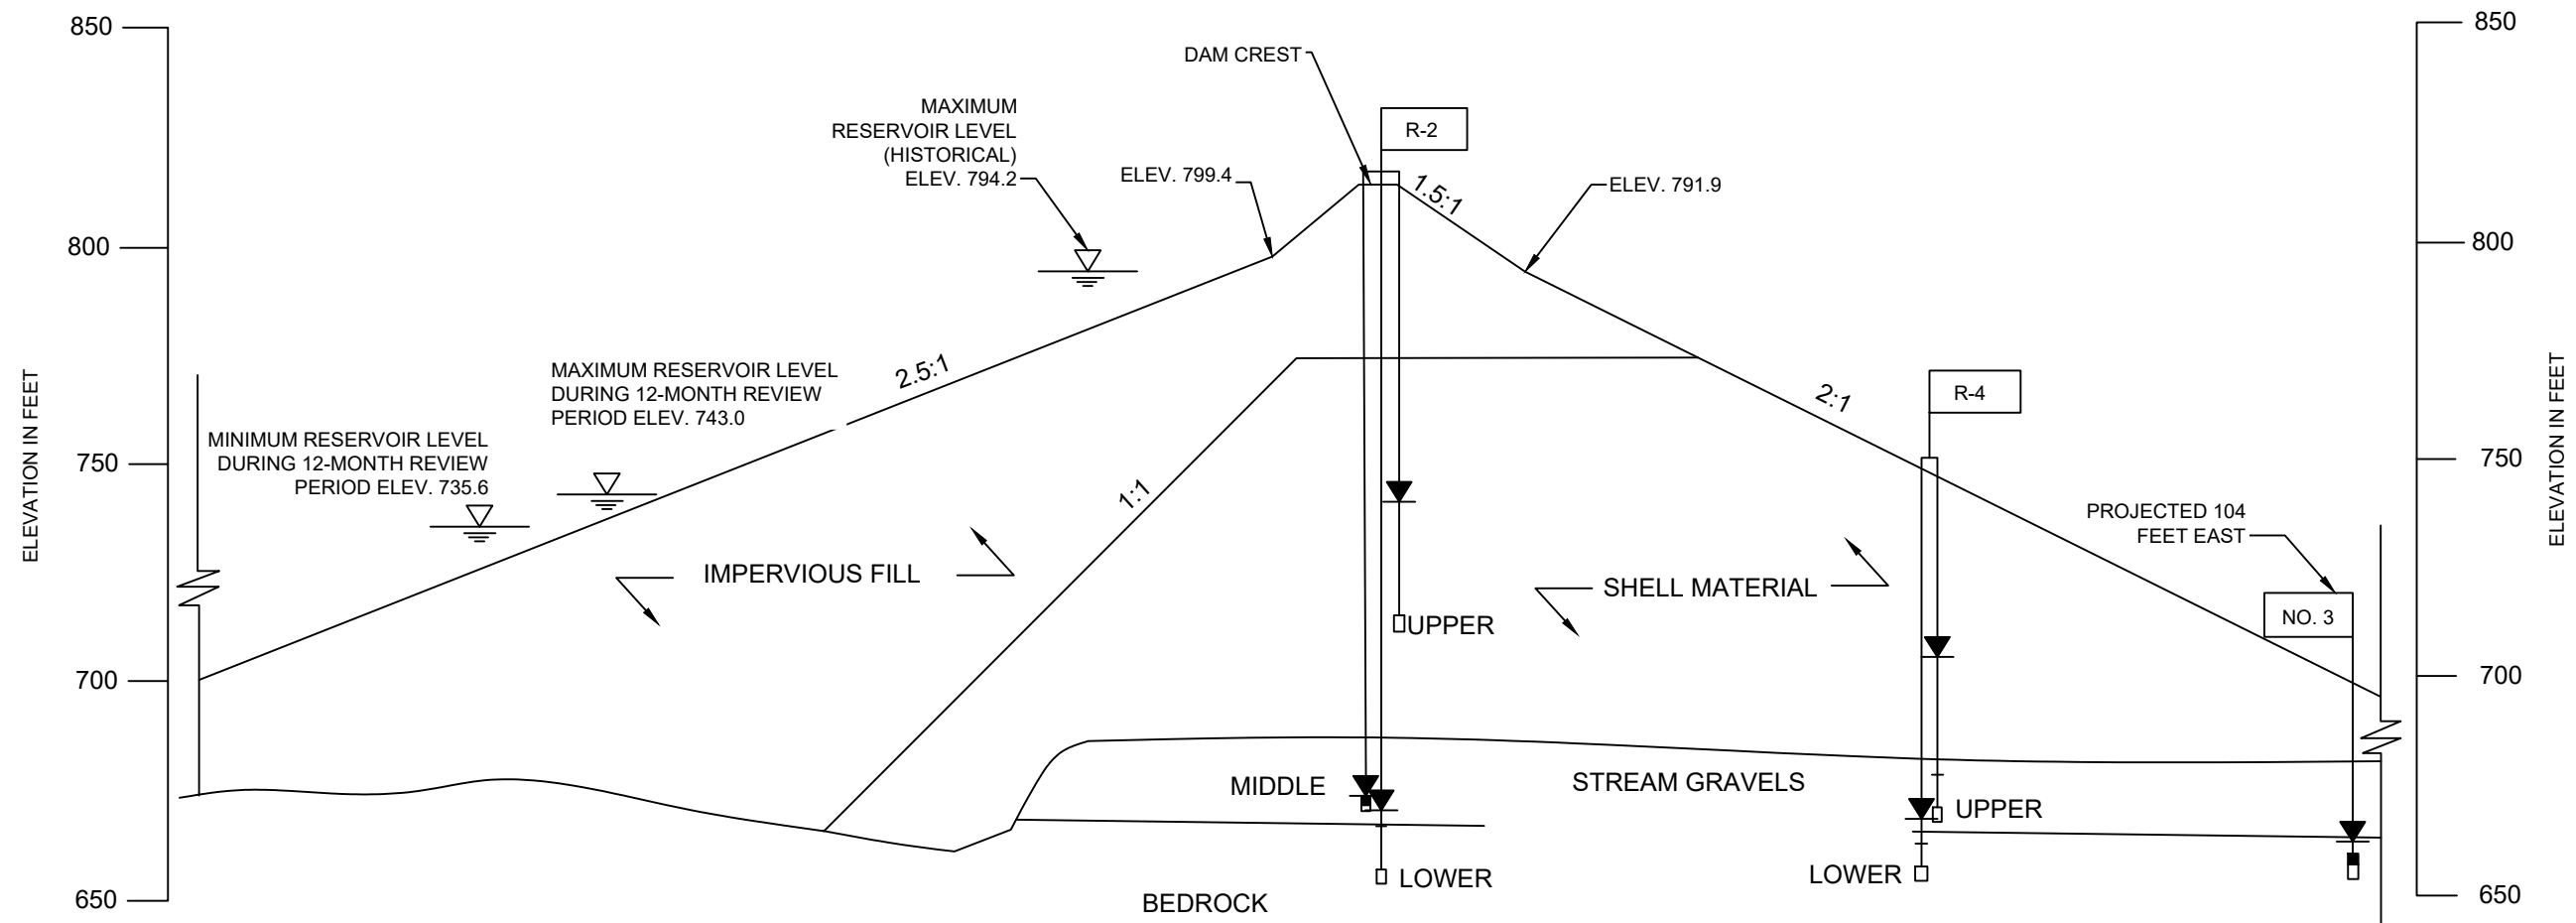
**SECTION A-A'**  
**MAXIMUM SECTION**  
**(APPROX. STA 2+50)**

- NOTES:**
- (1) SEE FIGURE 1 FOR LOCATION OF SECTION
  - (2) QUESTIONABLE READINGS ARE NOT SHOWN

SECTION A-A'	
Irvine Ranch Water District Irvine, CA		Project 1901888	September 2022

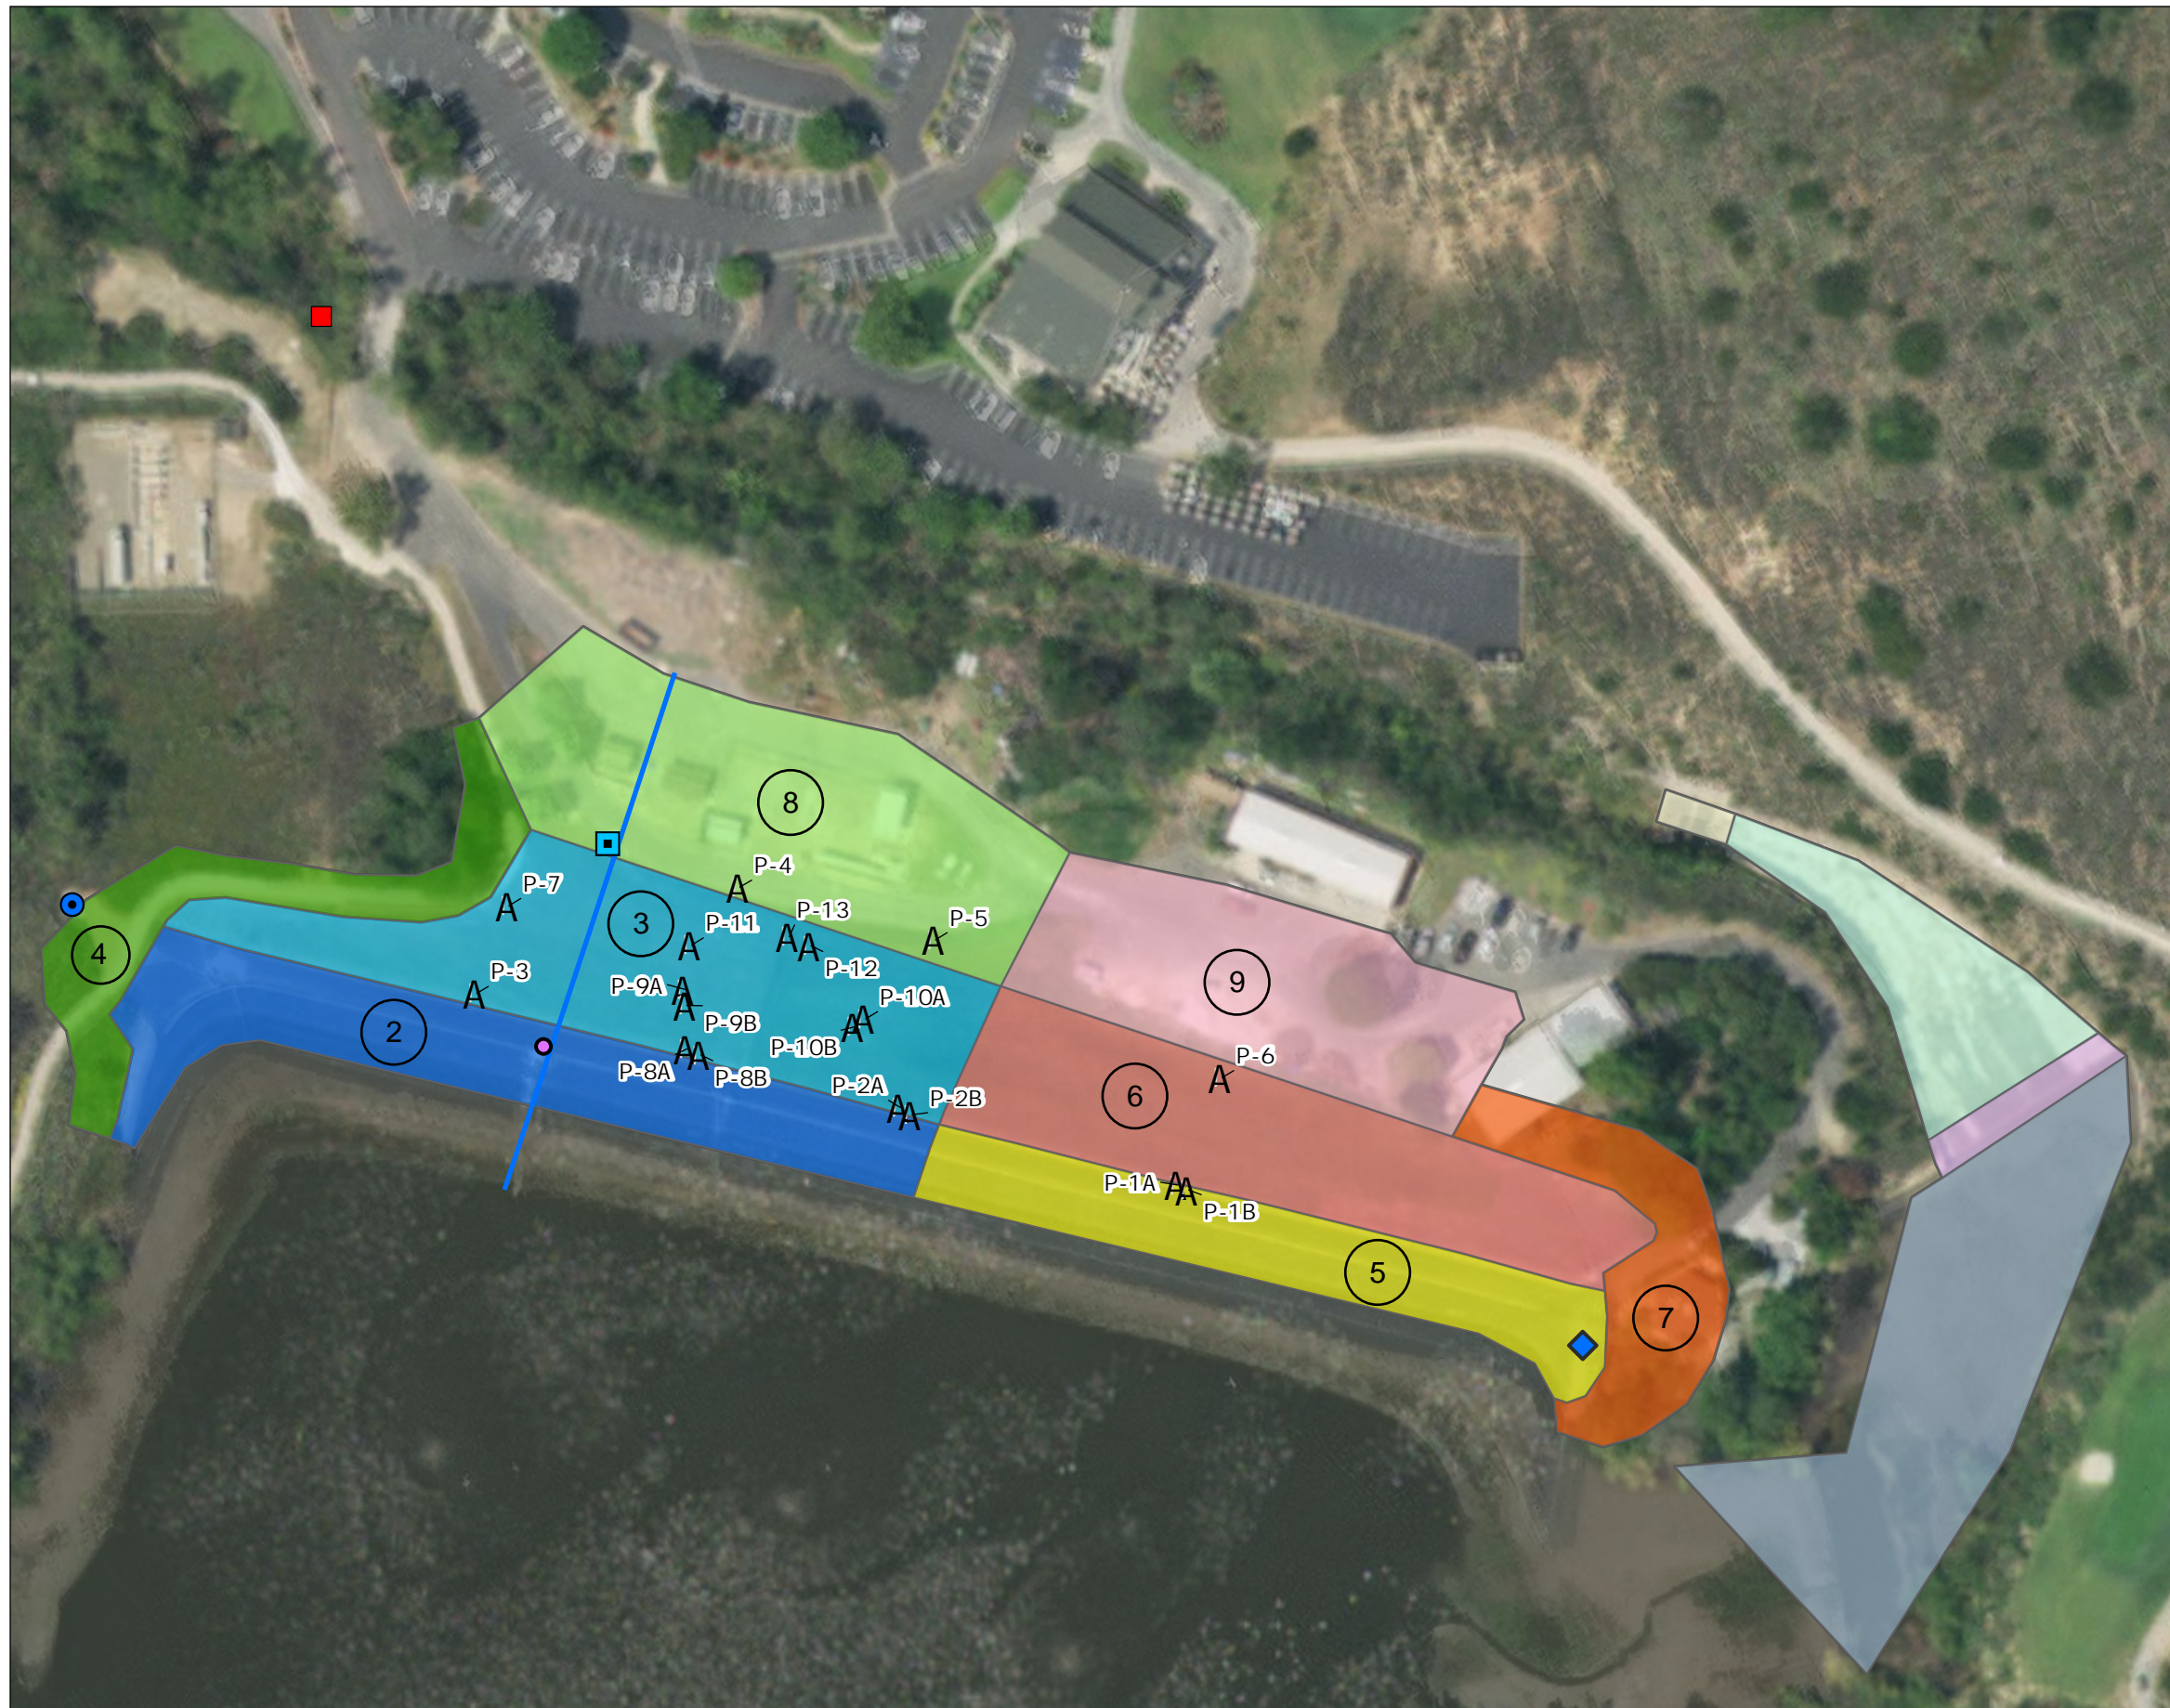
**Title**  
**Sand Canyon Dam Overview**

- A Piezometer
- Outlet Vault
- ◆ Rain Gauge
- Drainage Vault
- Outlet Valves
- Emergency Outlet
- Outlet Pipe
- # Area Number
- Left Abutment
- Right Abutment
- Dam Crest and Upstream
- Embankment, Left Side
- Dam Crest and Upstream
- Embankment, Right Side
- Downstream
- Embankment, Left Side
- Downstream
- Embankment, Right Side
- Toe of Dam, Left Side
- Toe of Dam, Right Side
- Energy Dissipator
- Spillway Approach
- Spillway Channel
- Spillway Crest

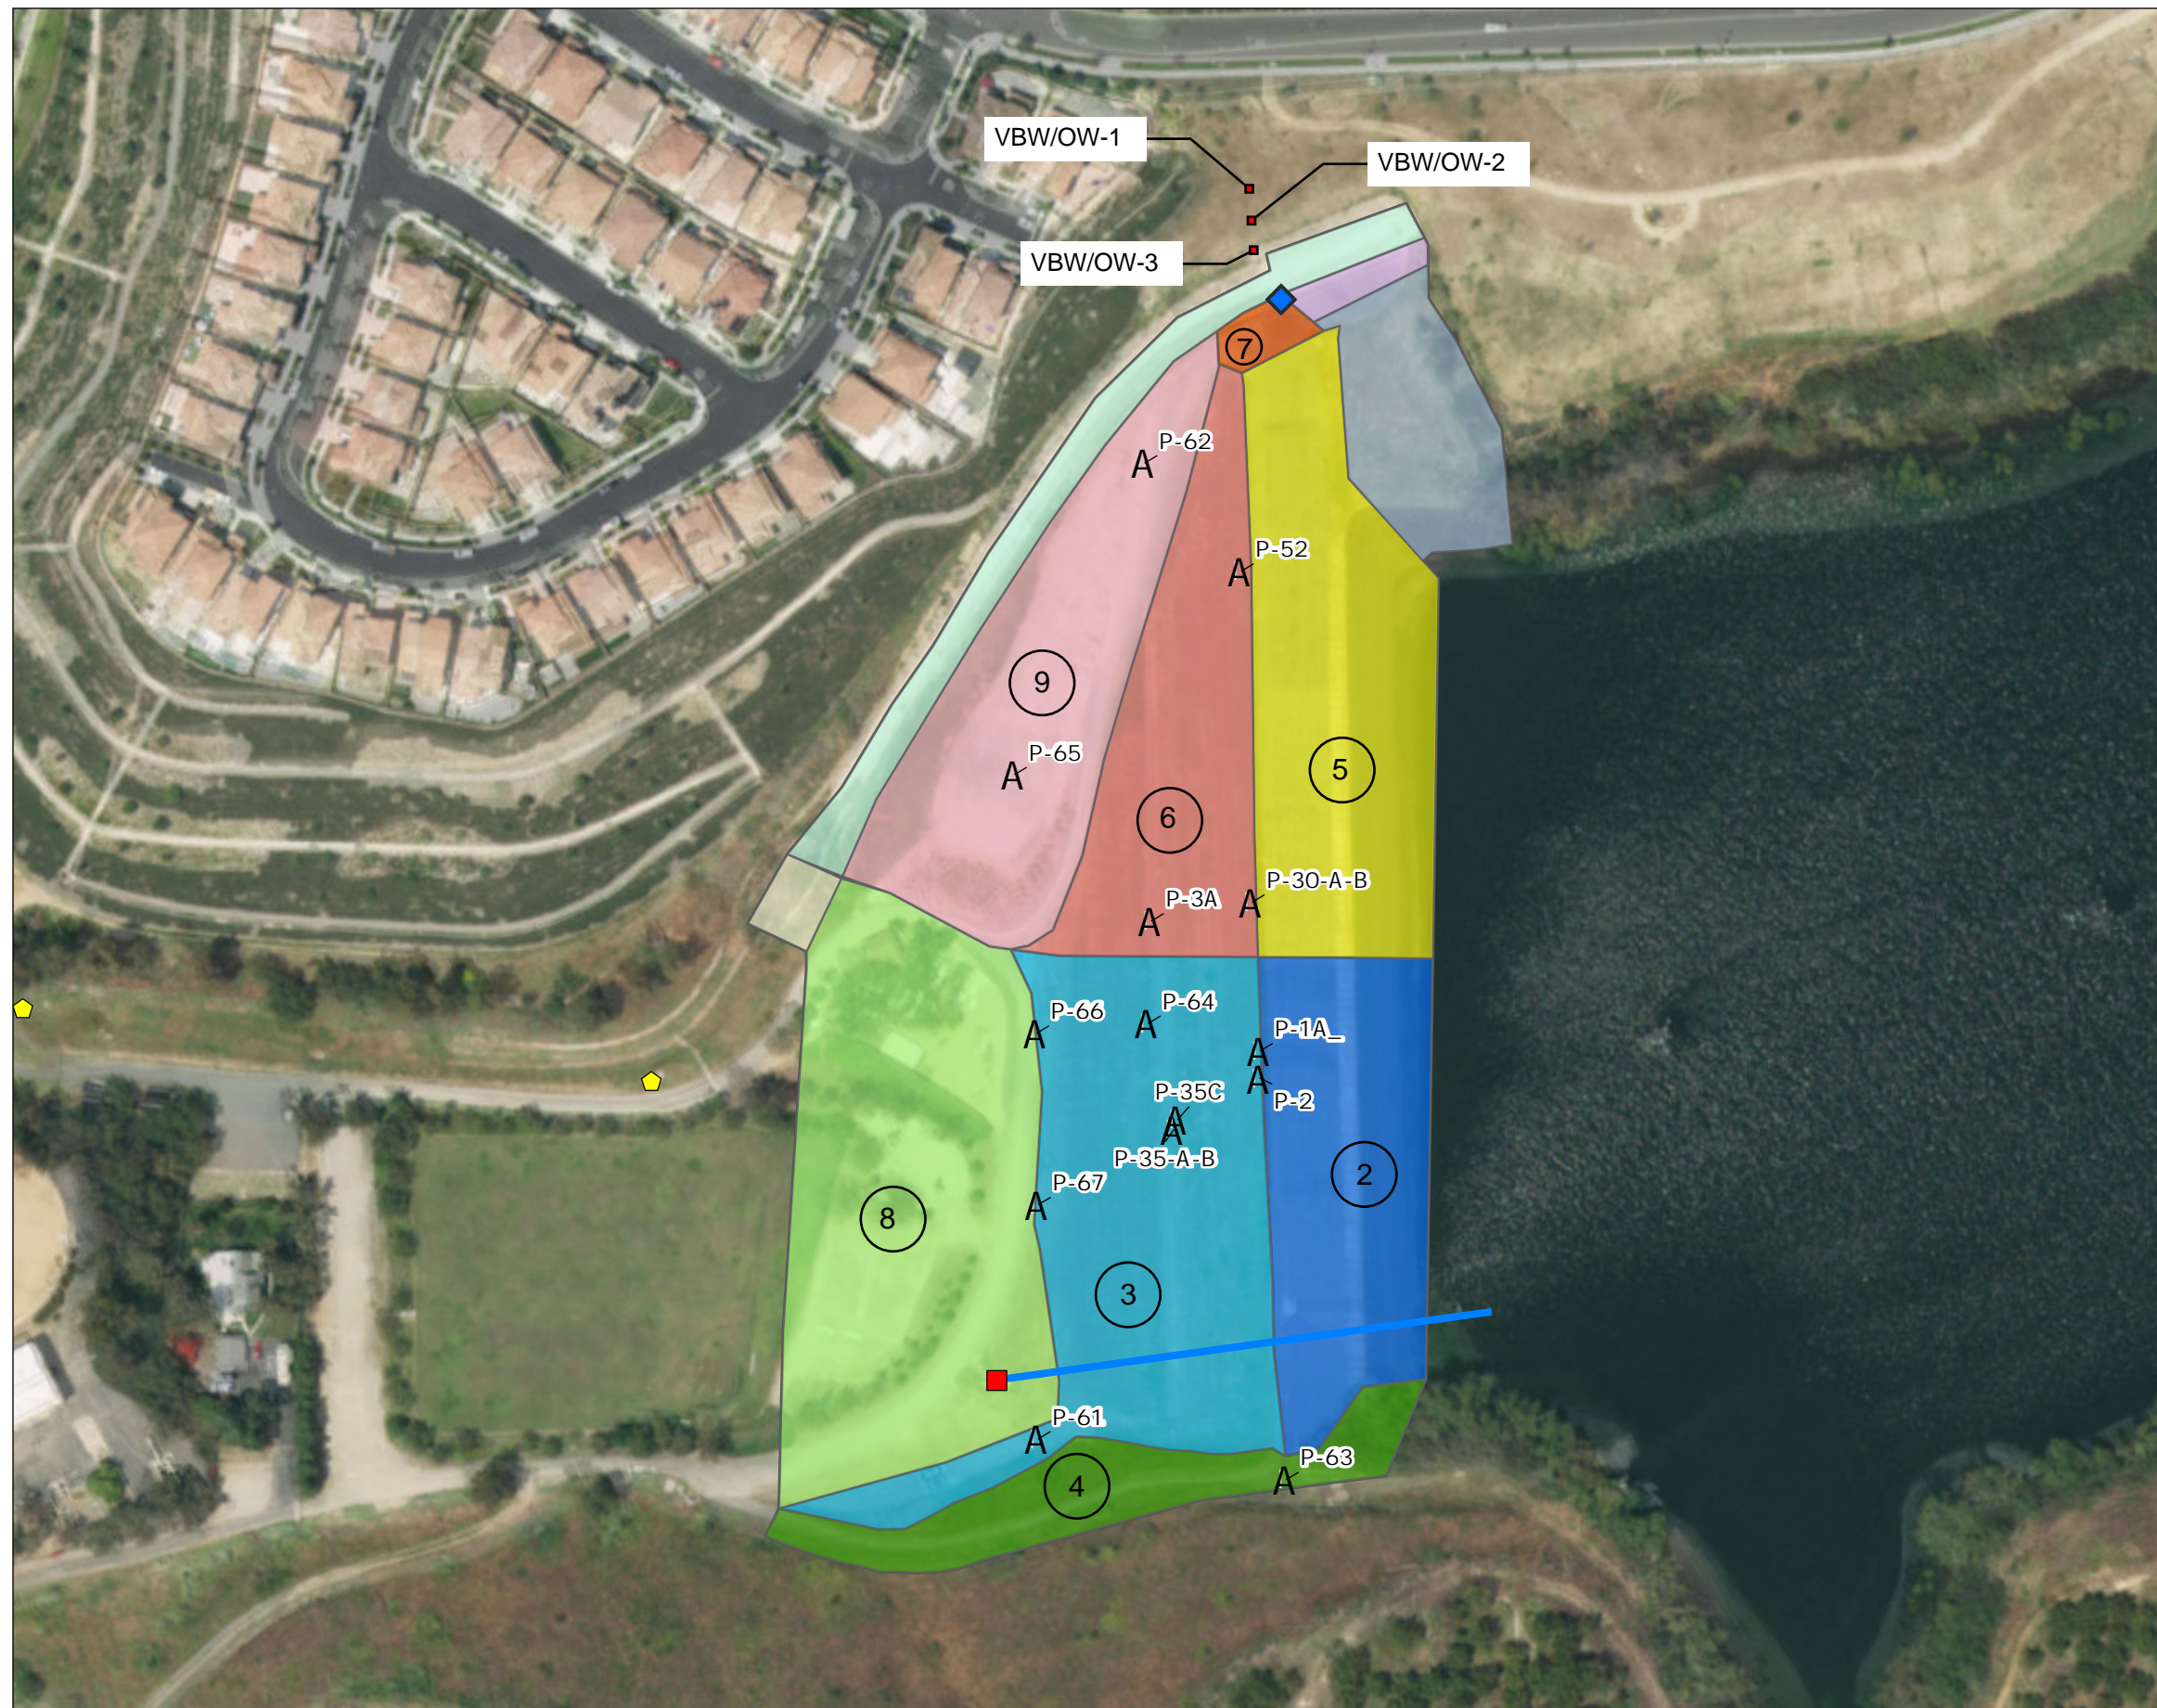
**Title**  
**Rattlesnake Dam Overview**

- A Piezometer
- ◆ Rain Gauge
- Emergency Outlet
- ⬠ Seepage Collection Vault
- Outlet Pipe
- Ⓚ Area Number
- Left Abutment
- Right Abutment
- Dam Crest and Upstream
- Embankment, Left Side
- Dam Crest and Upstream Embankment, Right Side
- Downstream Embankment, Left Side
- Downstream Embankment, Right Side
- Toe of Dam, Left Side (Stability Berm)
- Toe of Dam, Right Side
- Energy Dissipator
- Spillway Approach
- Spillway Channel
- Spillway Crest
