# **DAM SAFETY PROGRAM**

## **Guidelines & Governance**

**Irvine Ranch  
Water District**

**July 2023**

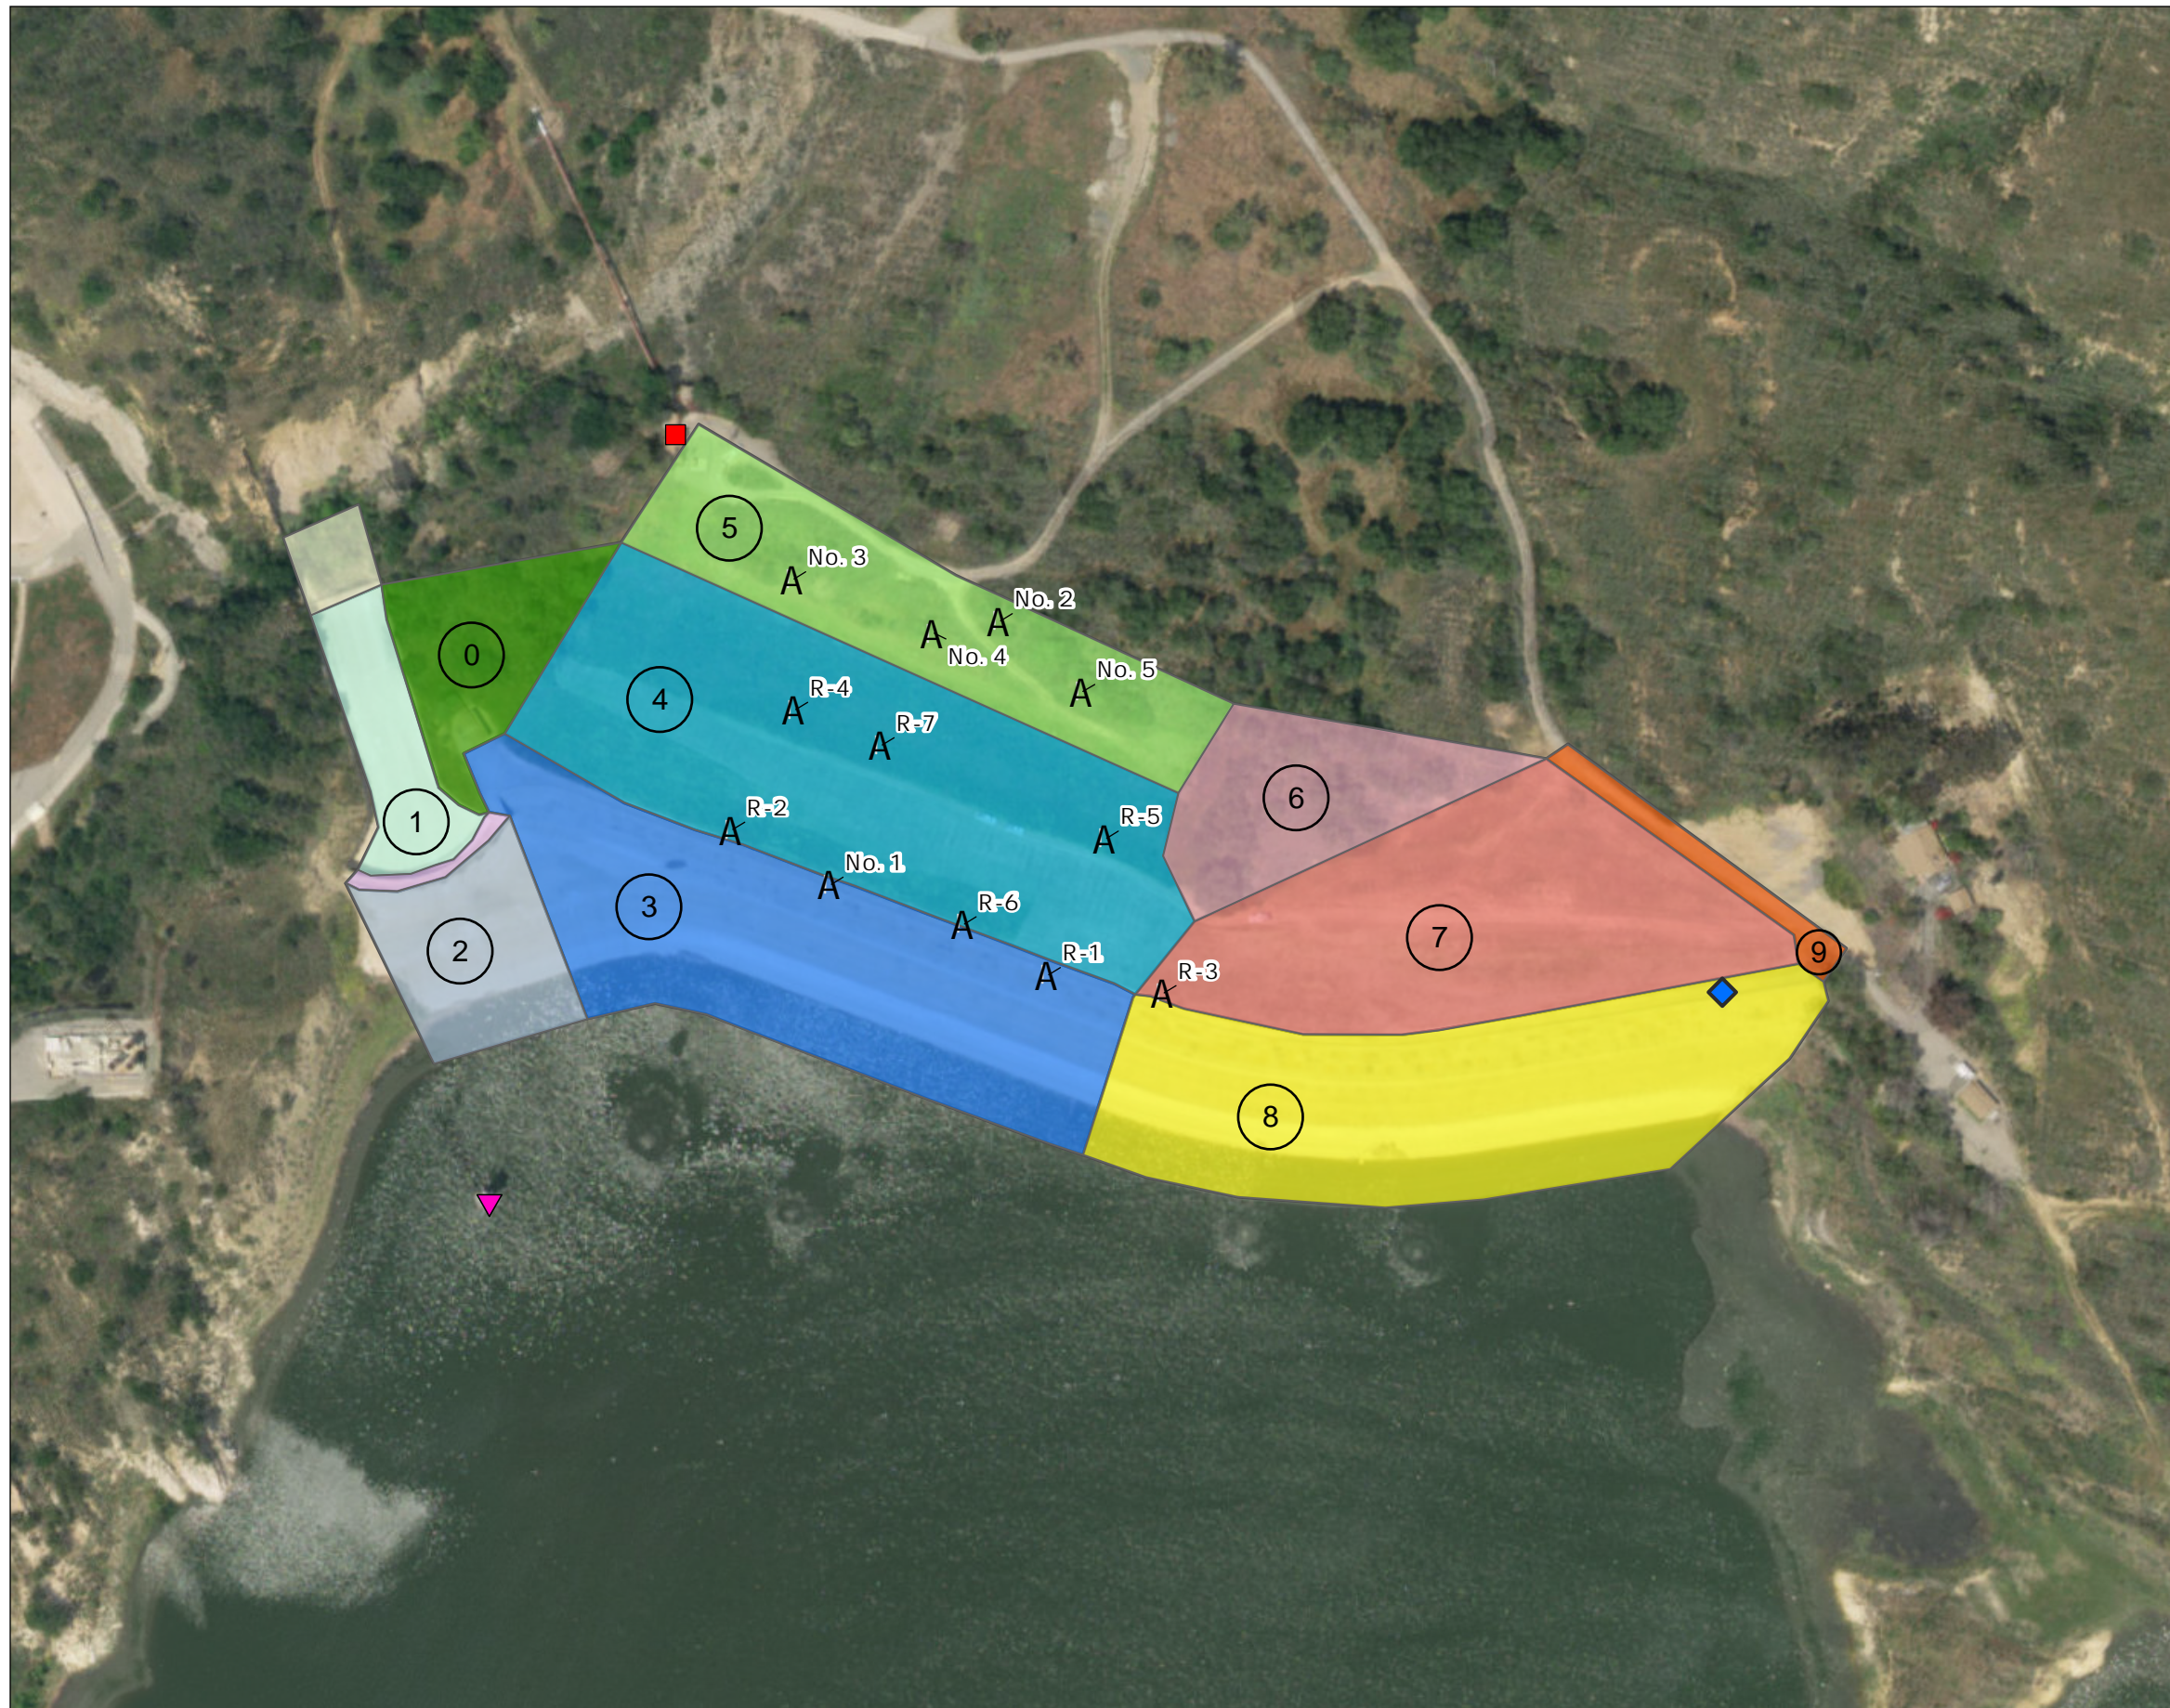
**Figure No.**  
**1**

**Title**  
**Santiago Creek Dam Overview**

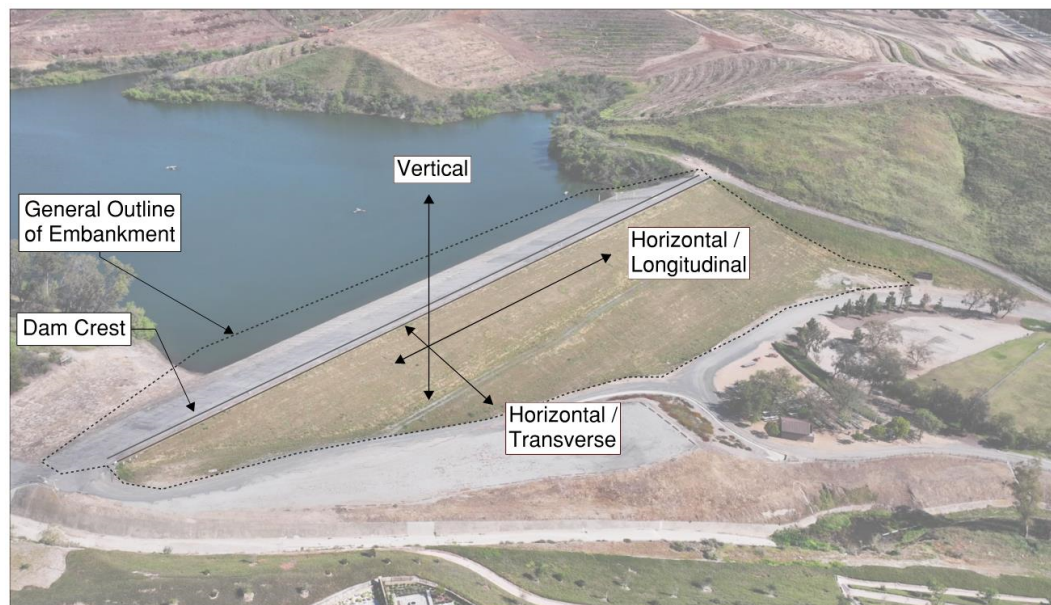
Movement - the change in location or displacement of material or markers in the vertical and/or horizontal direction. Description of the of movement is shown in the below exhibit.

*Figure 1: Description of directional movement/displacement.*

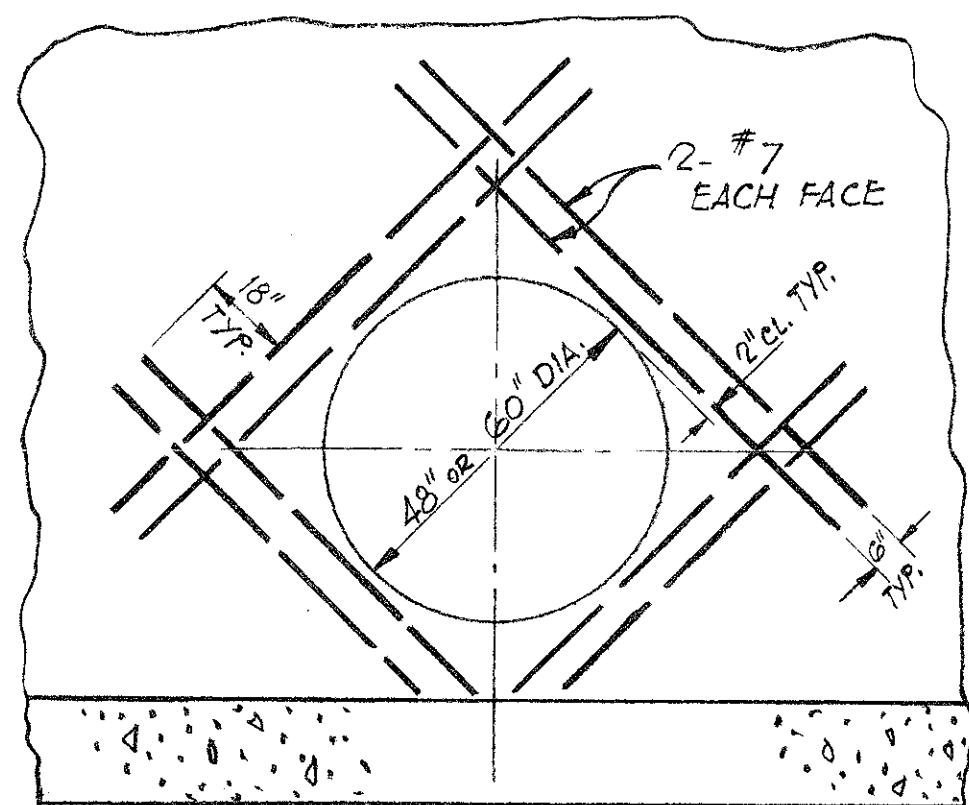
**TYPICAL DETAIL FOR PIPE OPENING**  
SCALE: 3/8" = 1'-0"

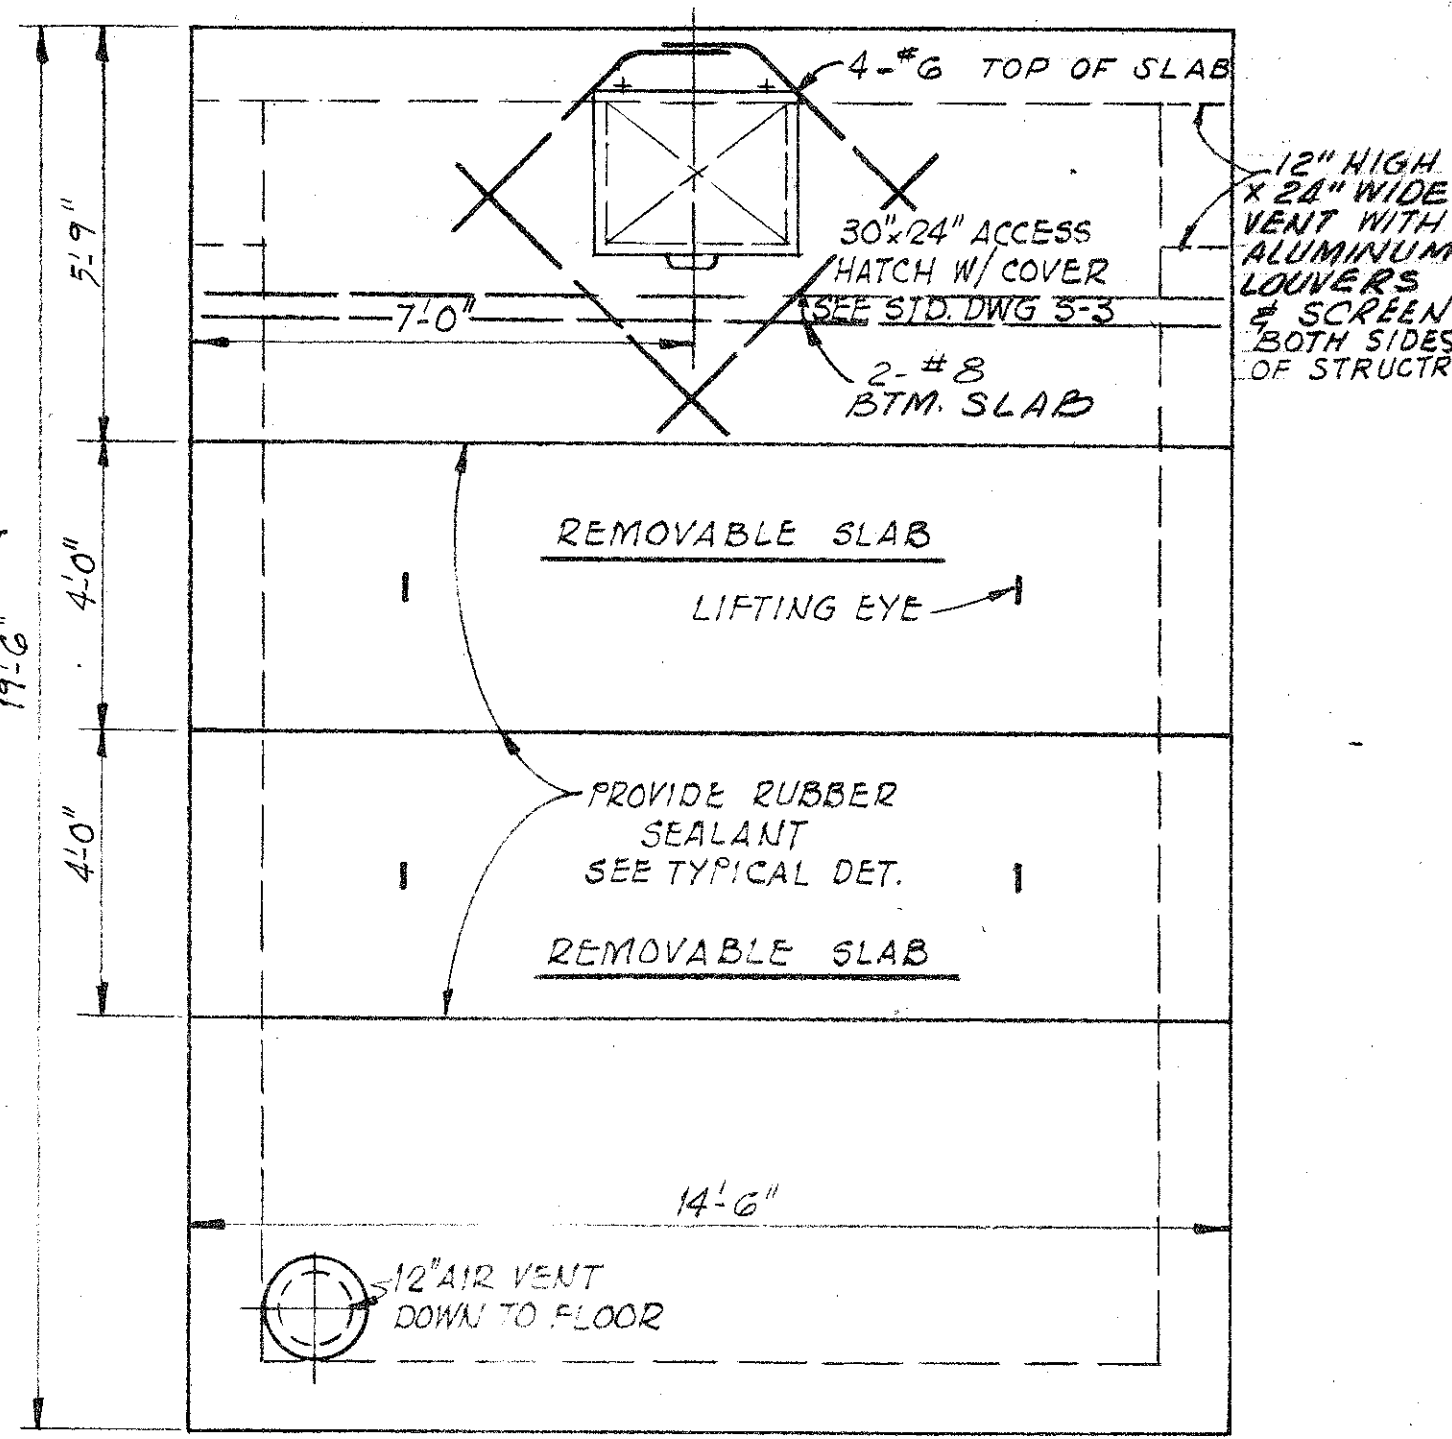
**ROOF PLAN**  
SCALE: 3/8" = 1'-0"

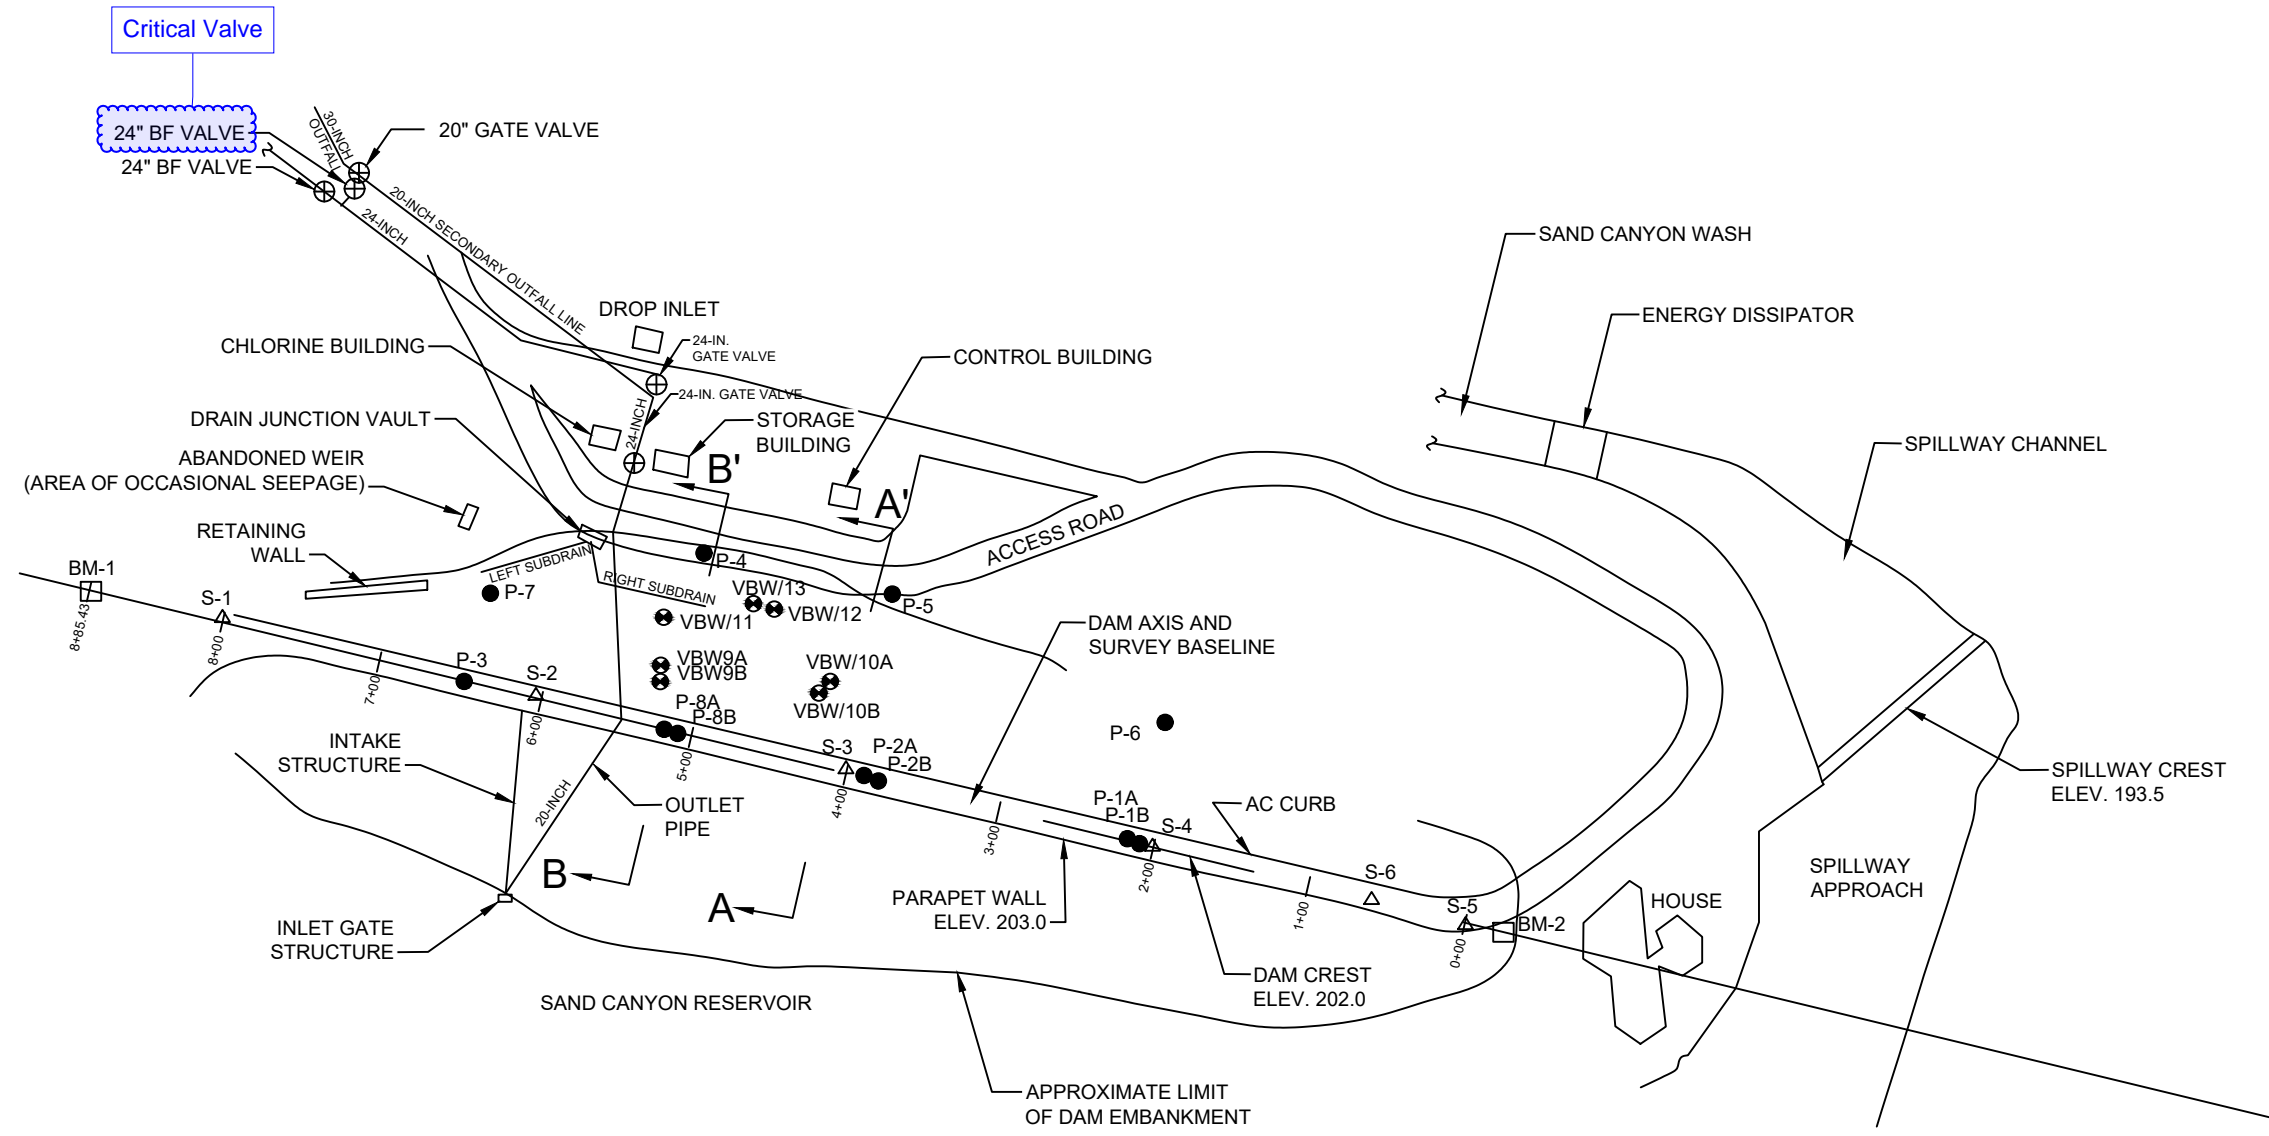
DAM AND RESERVOIR SITE PLAN
Irvine Ranch Water District Irvine, CA	Project 1901888	August 2022 <span style="float: right;">Fig. 2</span>

Exhibit 6.1  
Location of Critical Valve at San Joaquin Dam

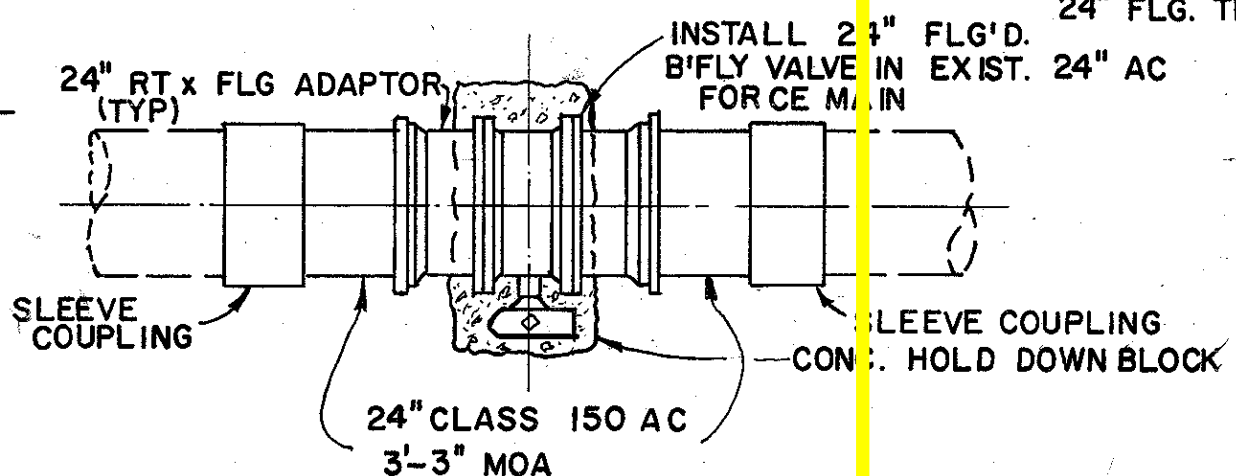
DETAIL D  
NO SCALE

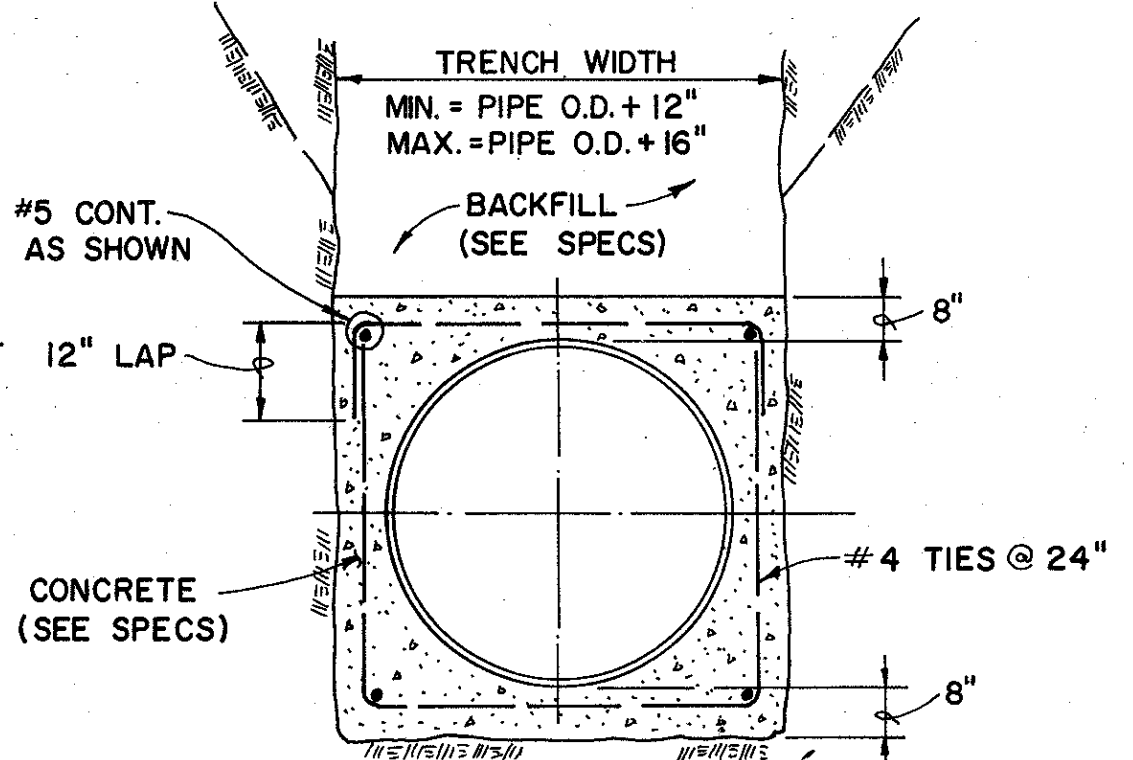
CONCRETE ENCASEMENT  
DETAIL  
NO SCALE

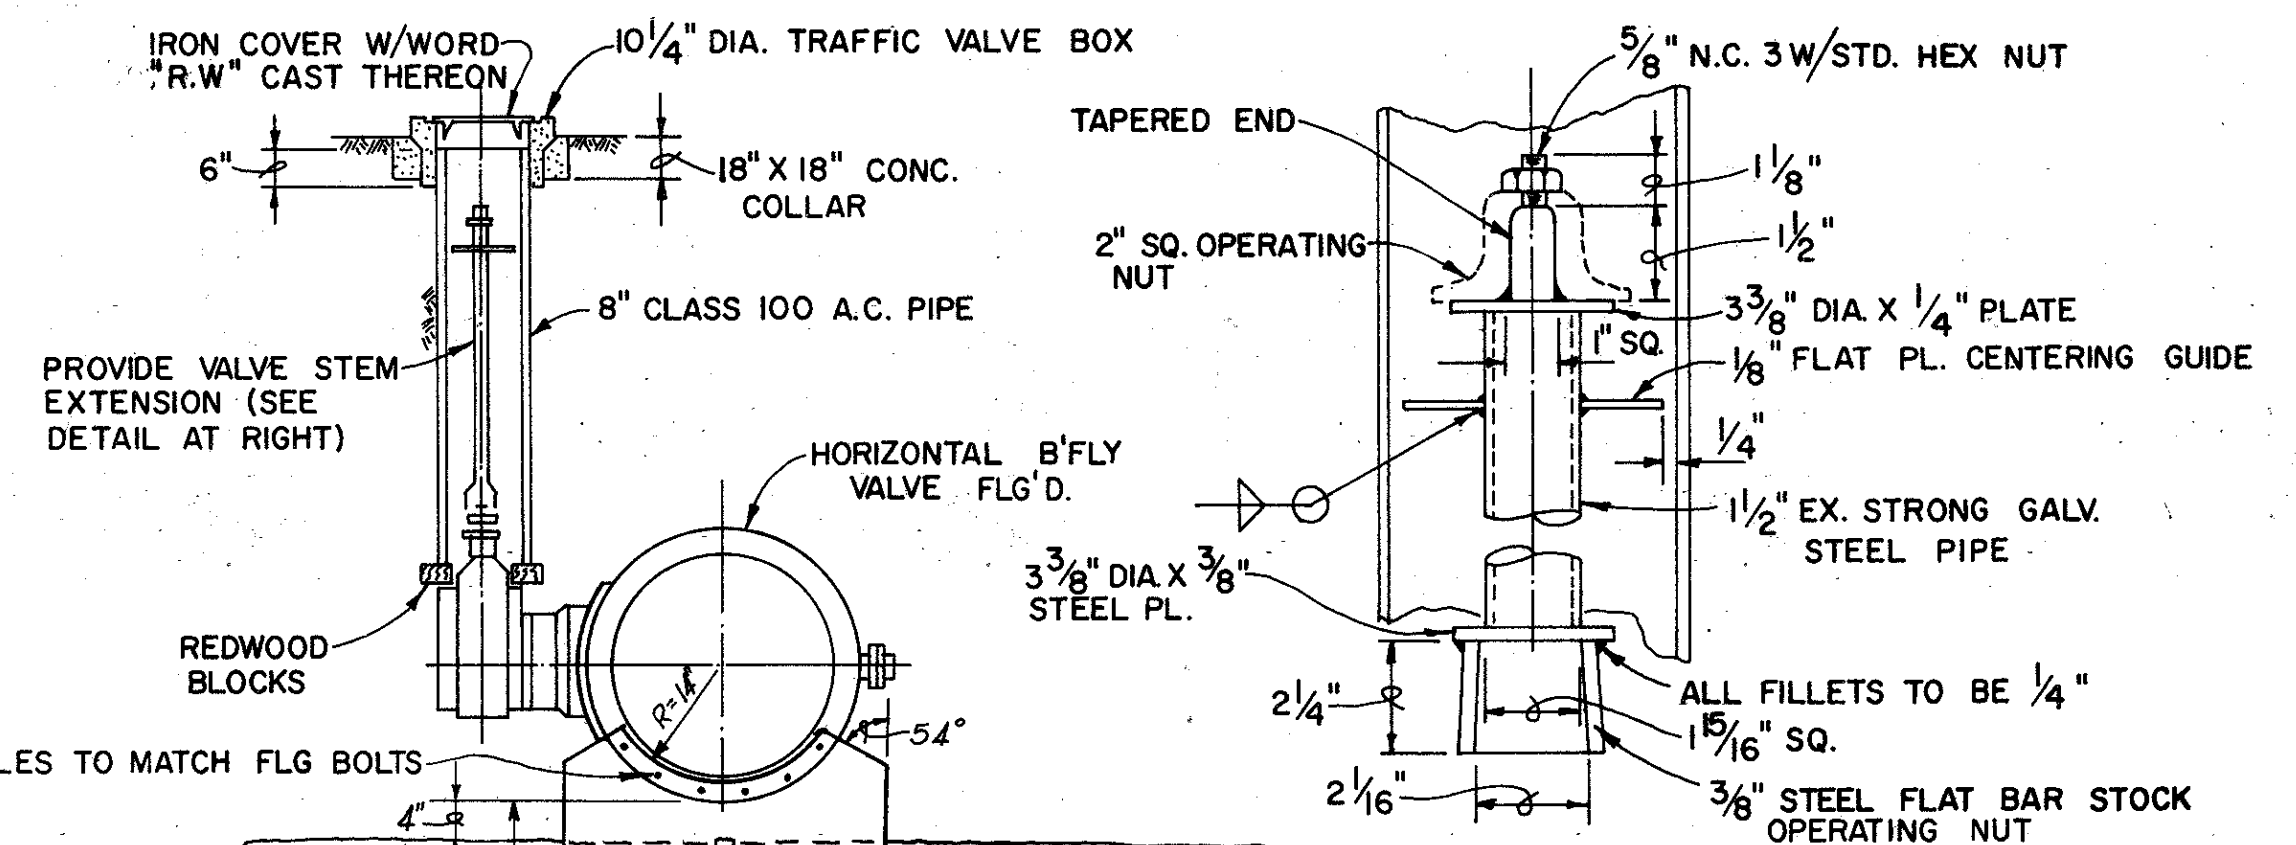
B' FLY VALVE INSTALLATION DETAIL  
NO SCALE

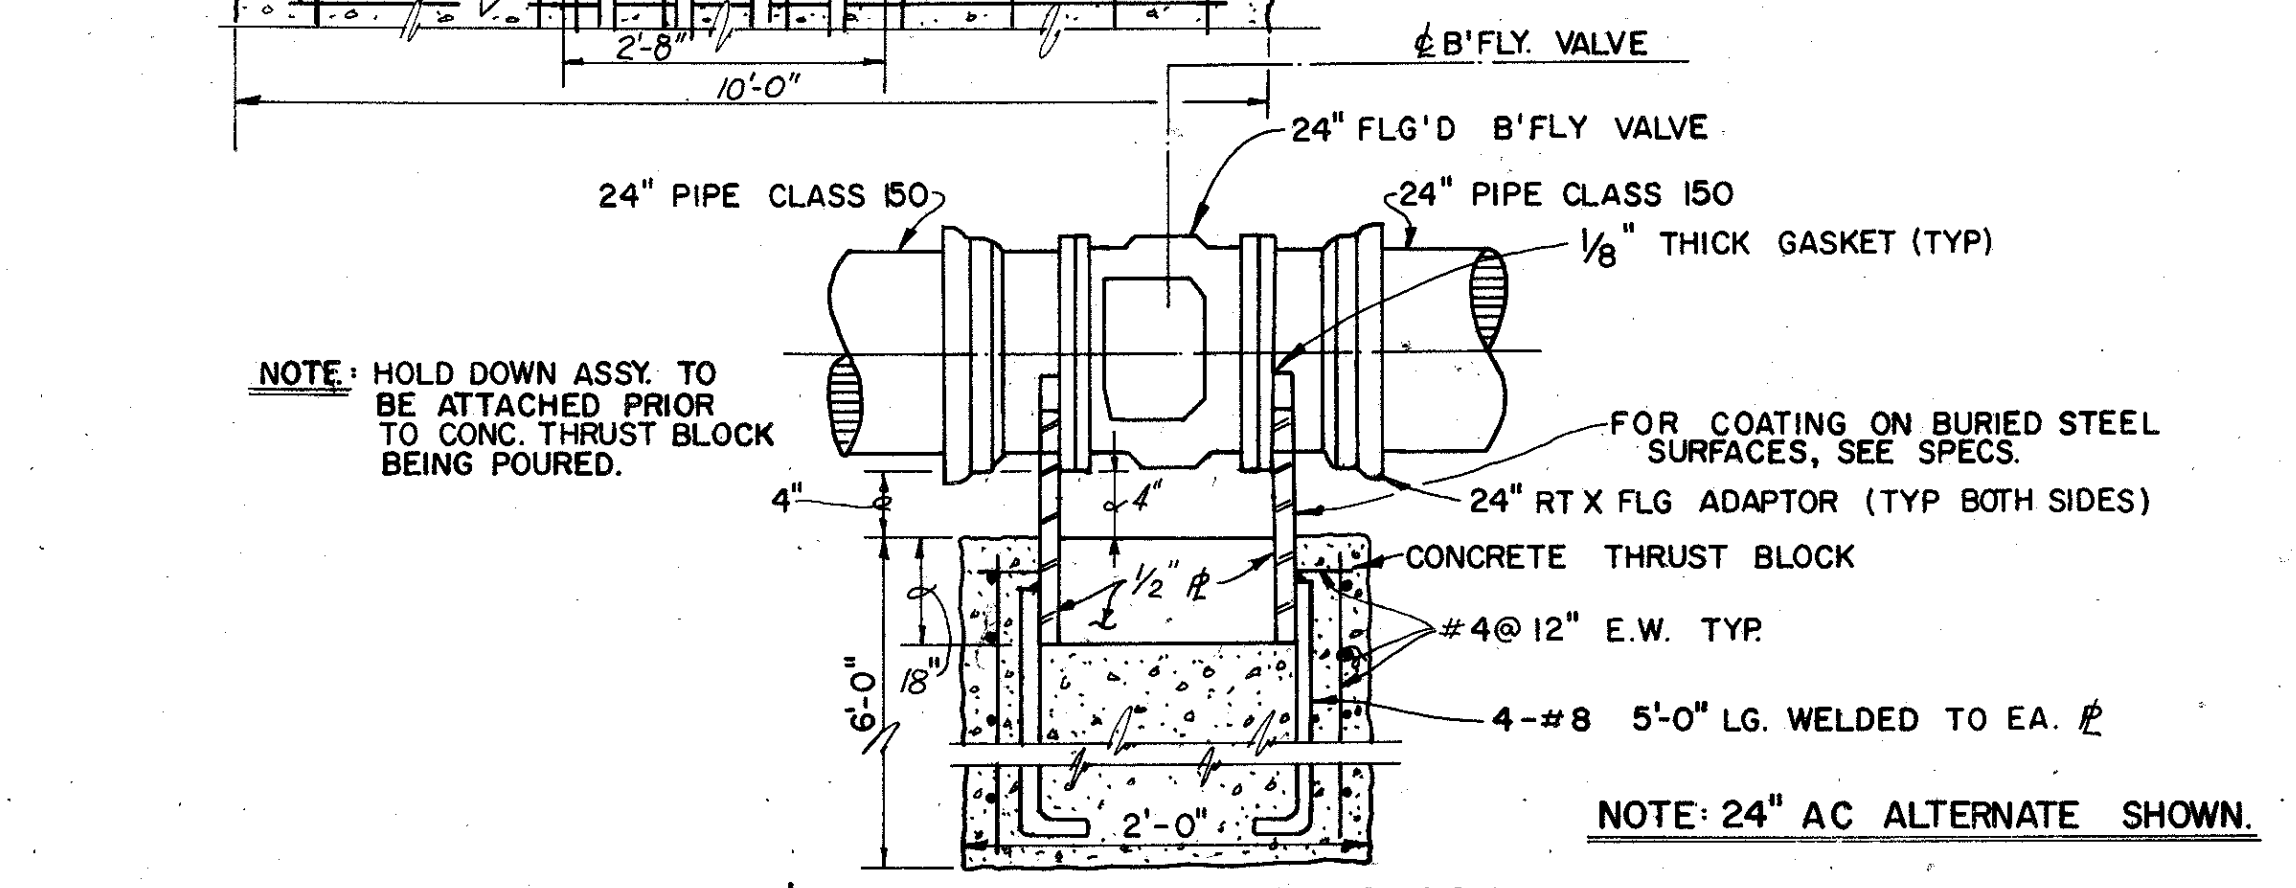
B' FLY VALVE HOLD DOWN BLOCK  
NO SCALE

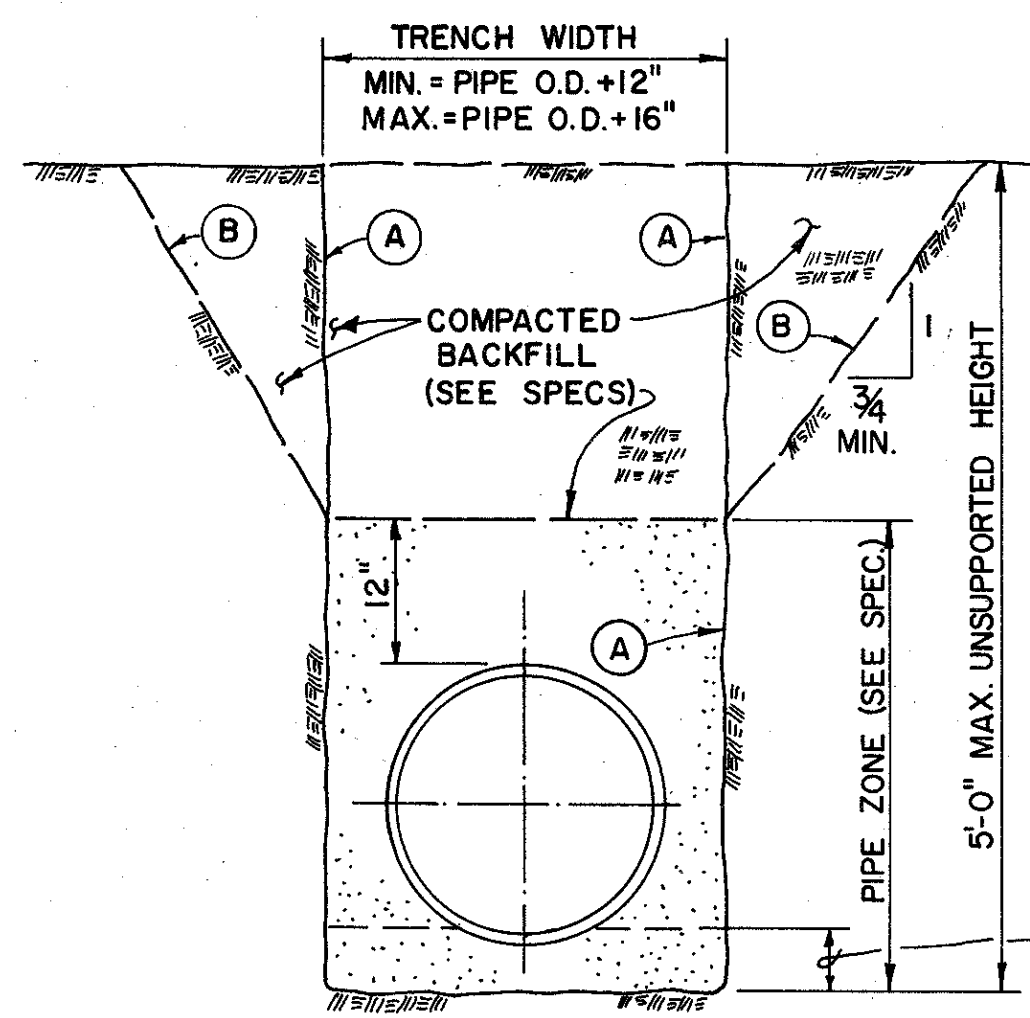
TYPICAL TRENCH SECTION  
NO SCALE

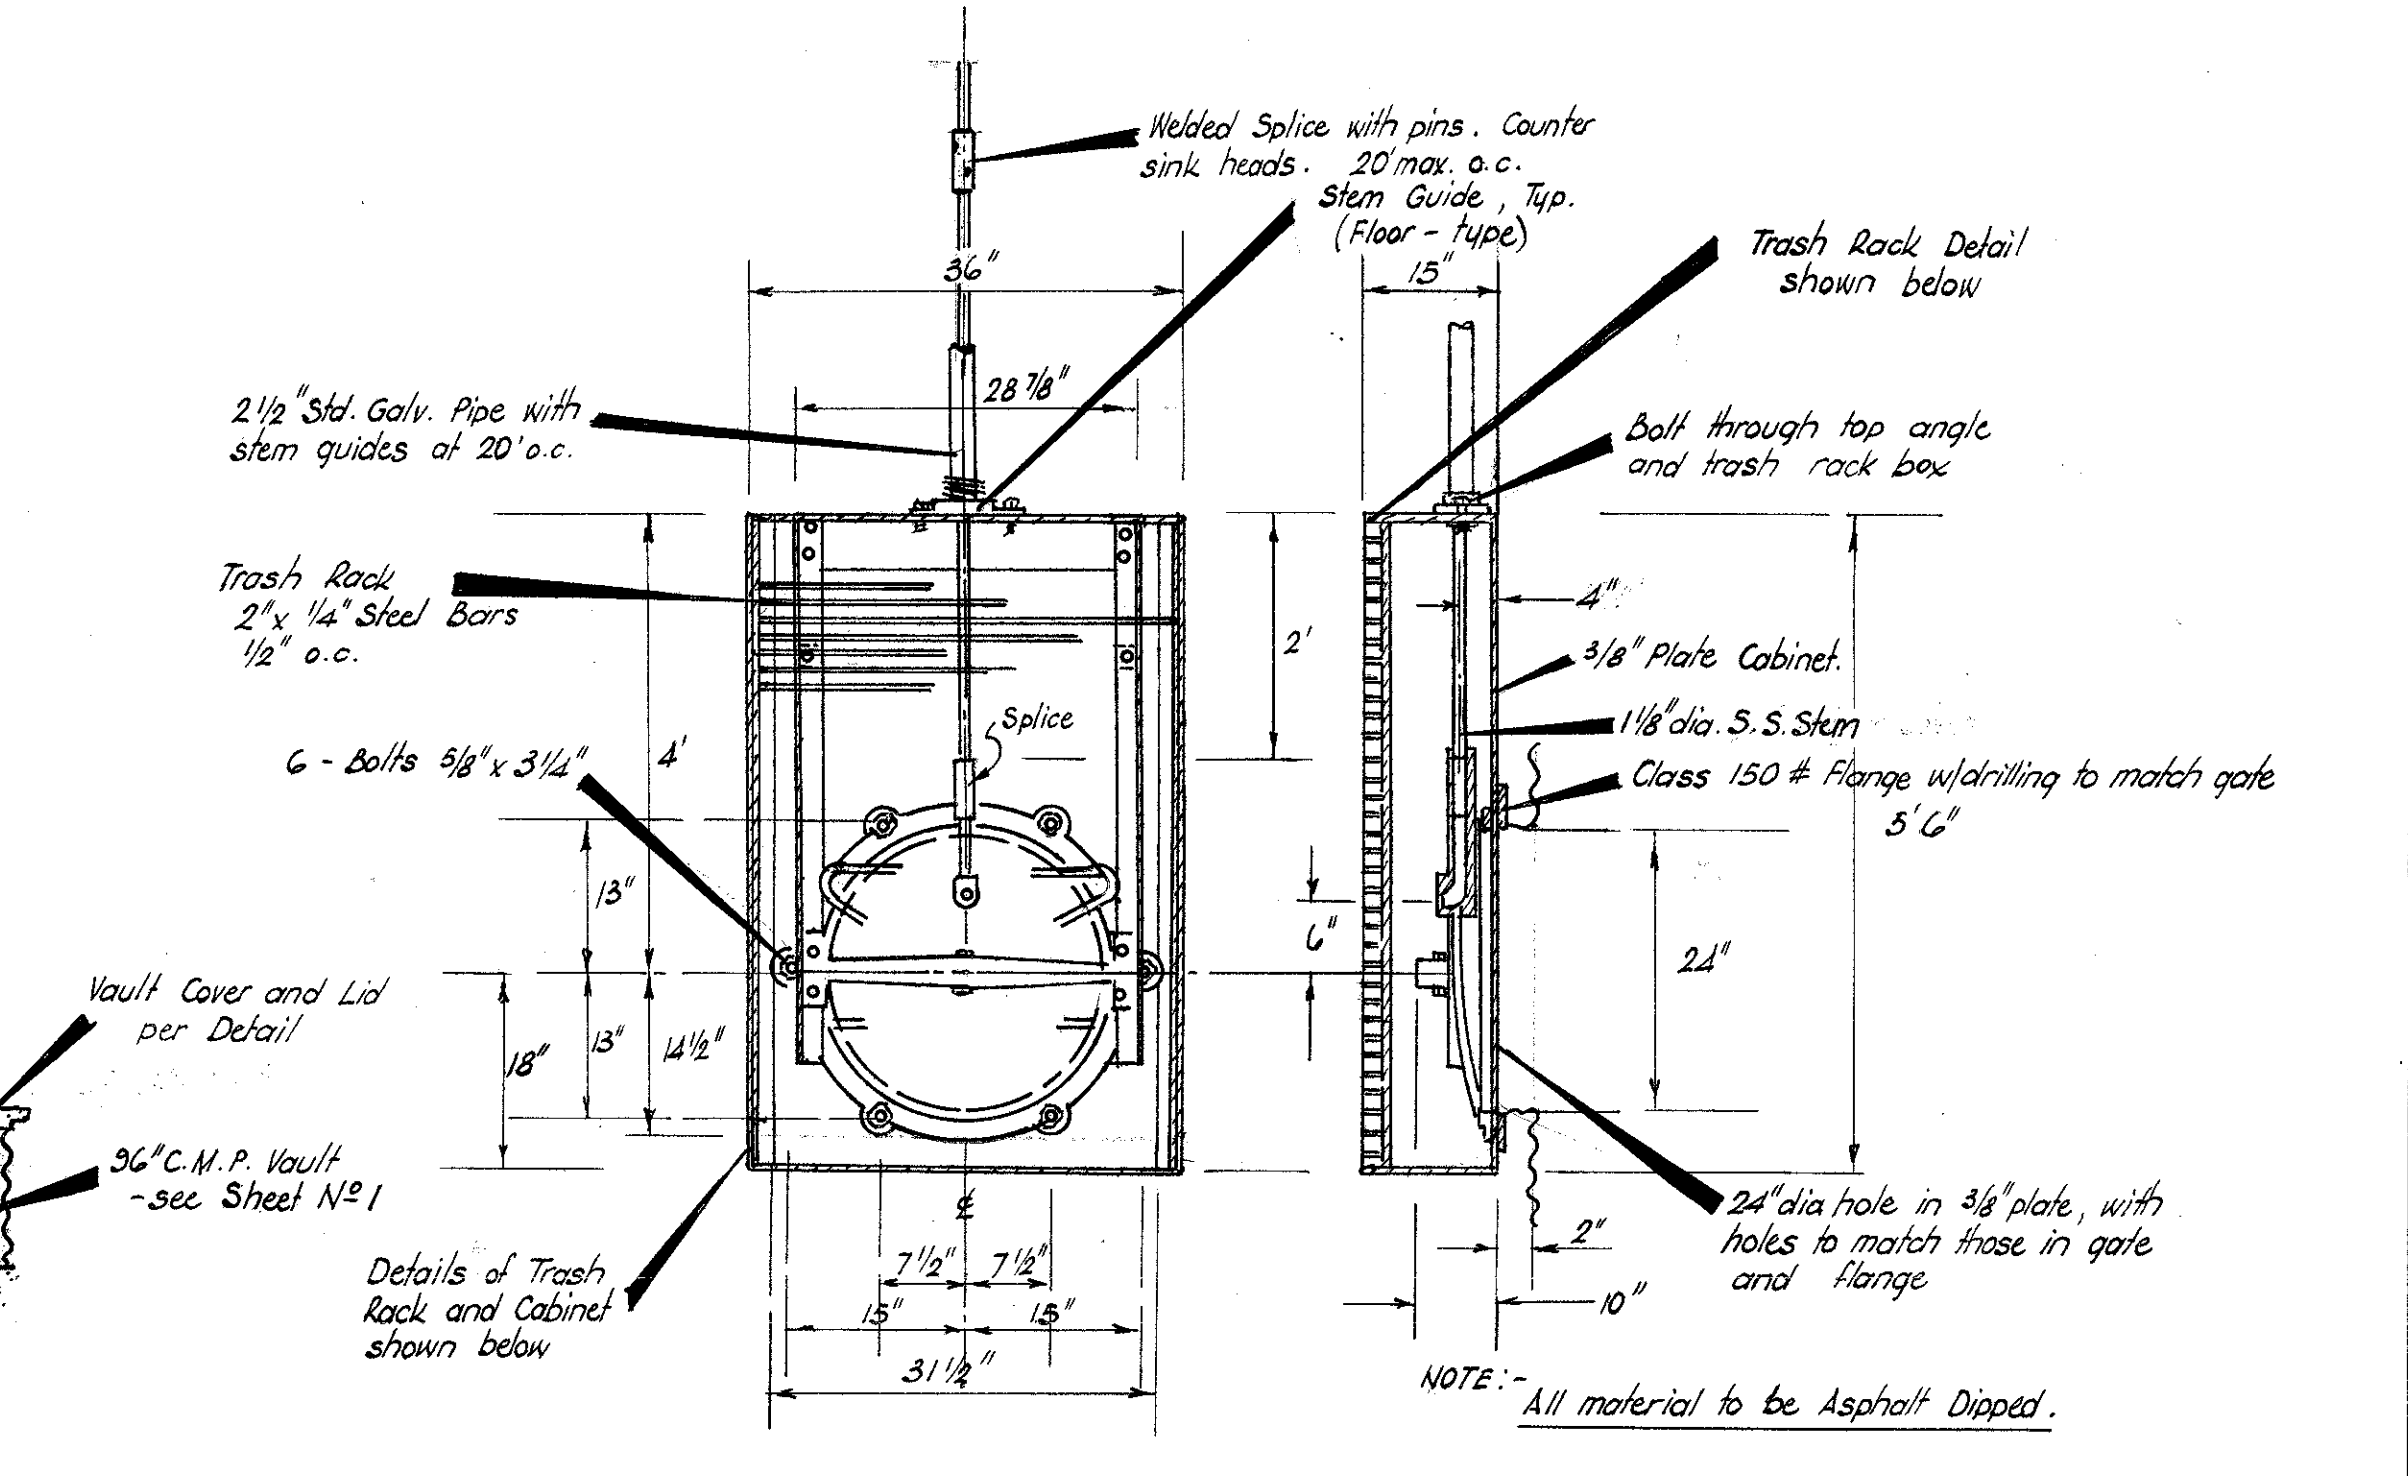
**DETAIL of GATE ASSEMBLIES**

(3 REQUIRED)

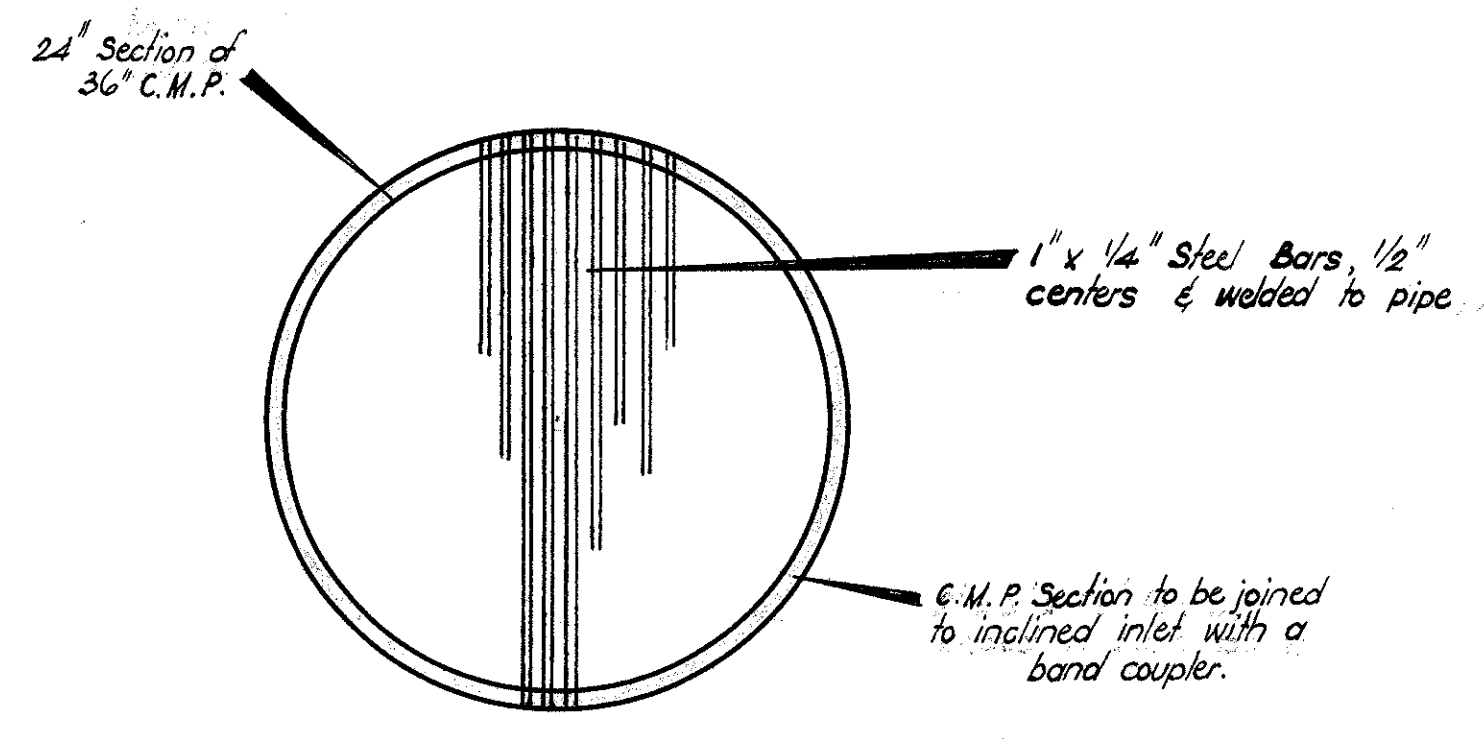
**DETAIL of TRASH RACK for UNGATED OPENING**

NOTE: All material to be Asphalt Coated

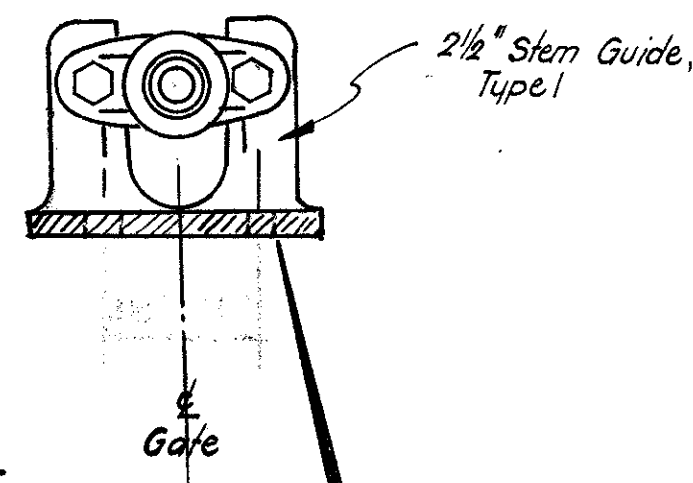
**DETAIL of STEM GUIDE**

Armo Type 1, 2 1/2" Stem Guides, attached with welded 2 1/2" x 3/4" Studs. Provide as needed on the three separate assemblies
