# **DAM SAFETY PROGRAM**

## **Guidelines & Governance**

**Irvine Ranch  
Water District**

**July 2023**

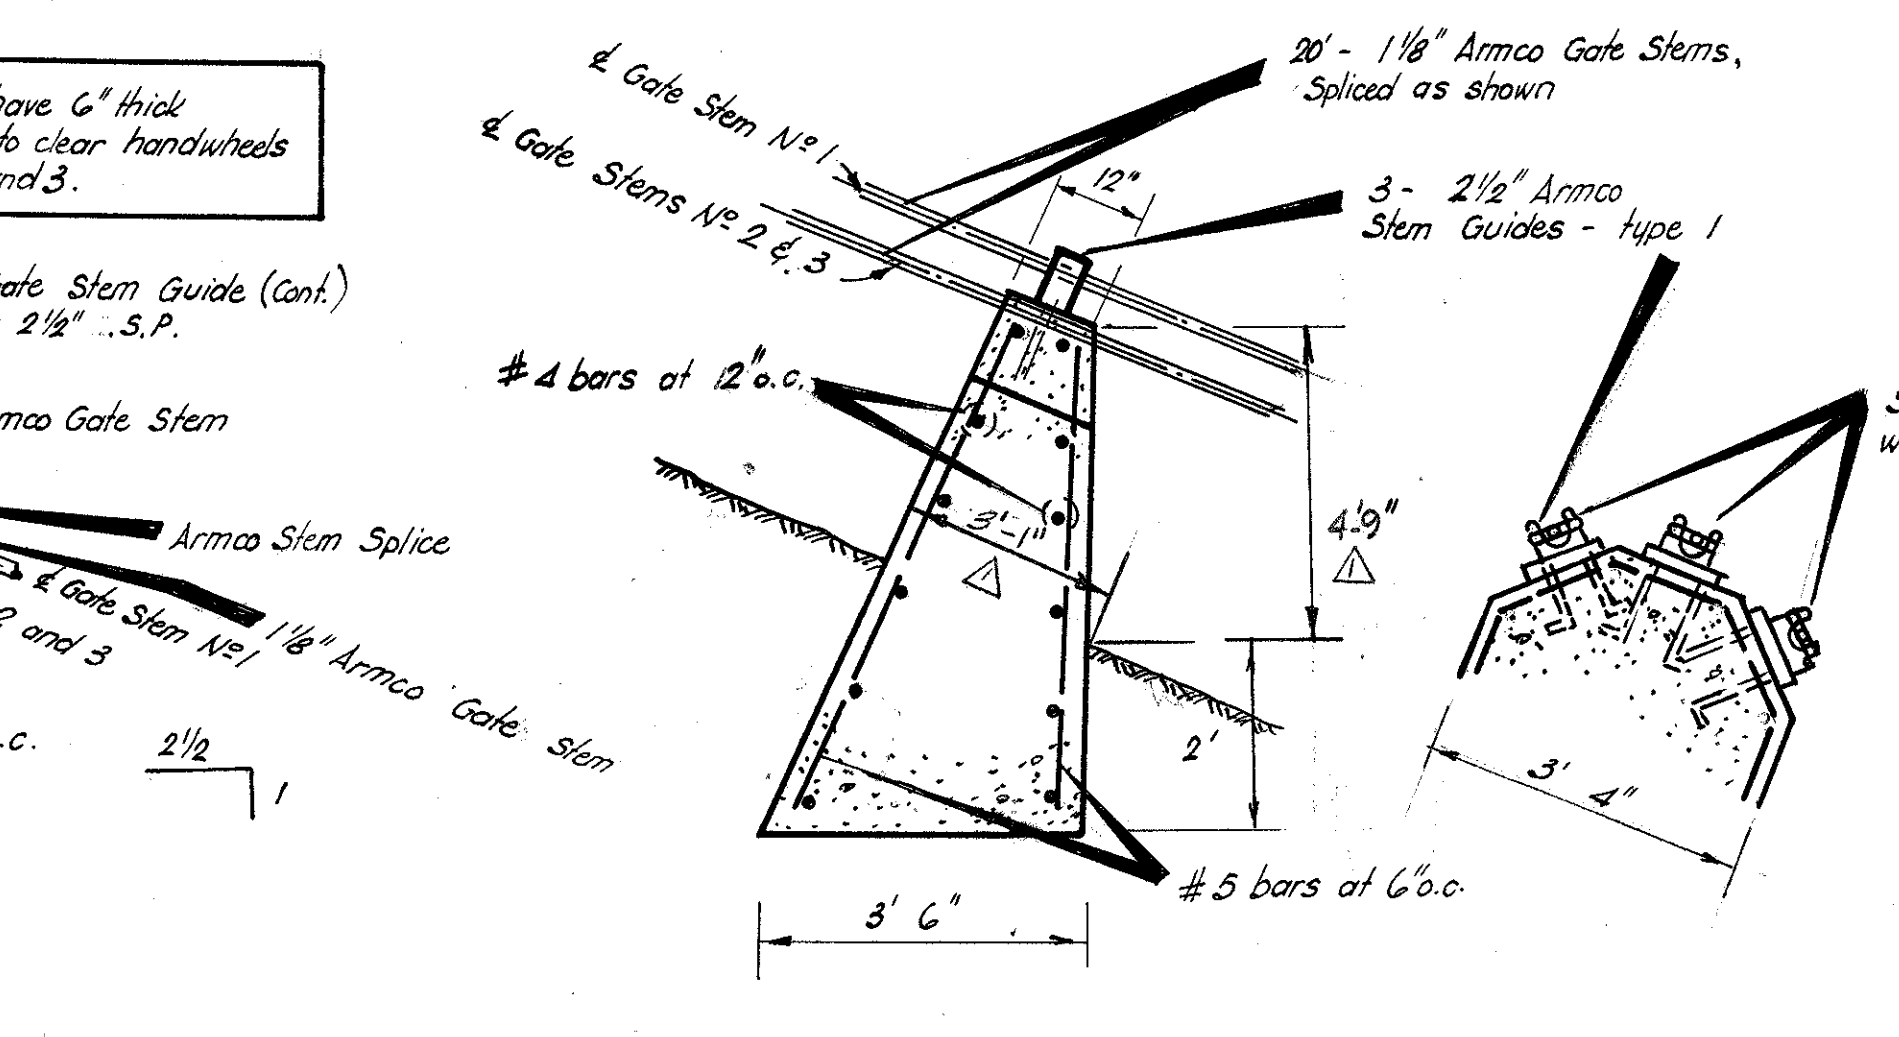
**STEM GUIDE SUPPORTS**

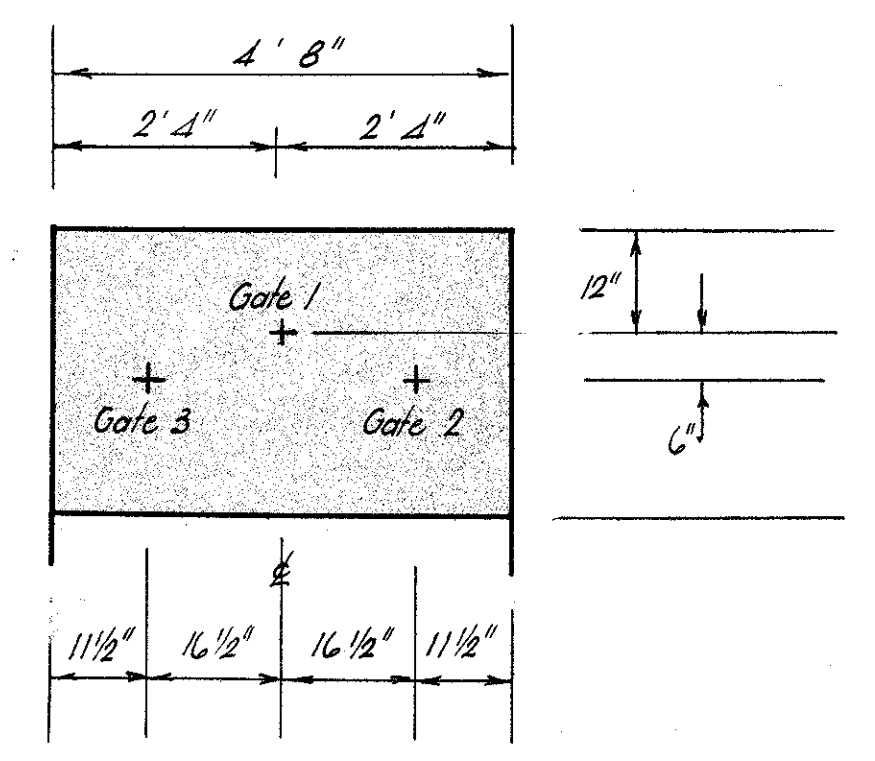
**TEMPLATE for POSITIONING HANDWHEEL LIFTS**

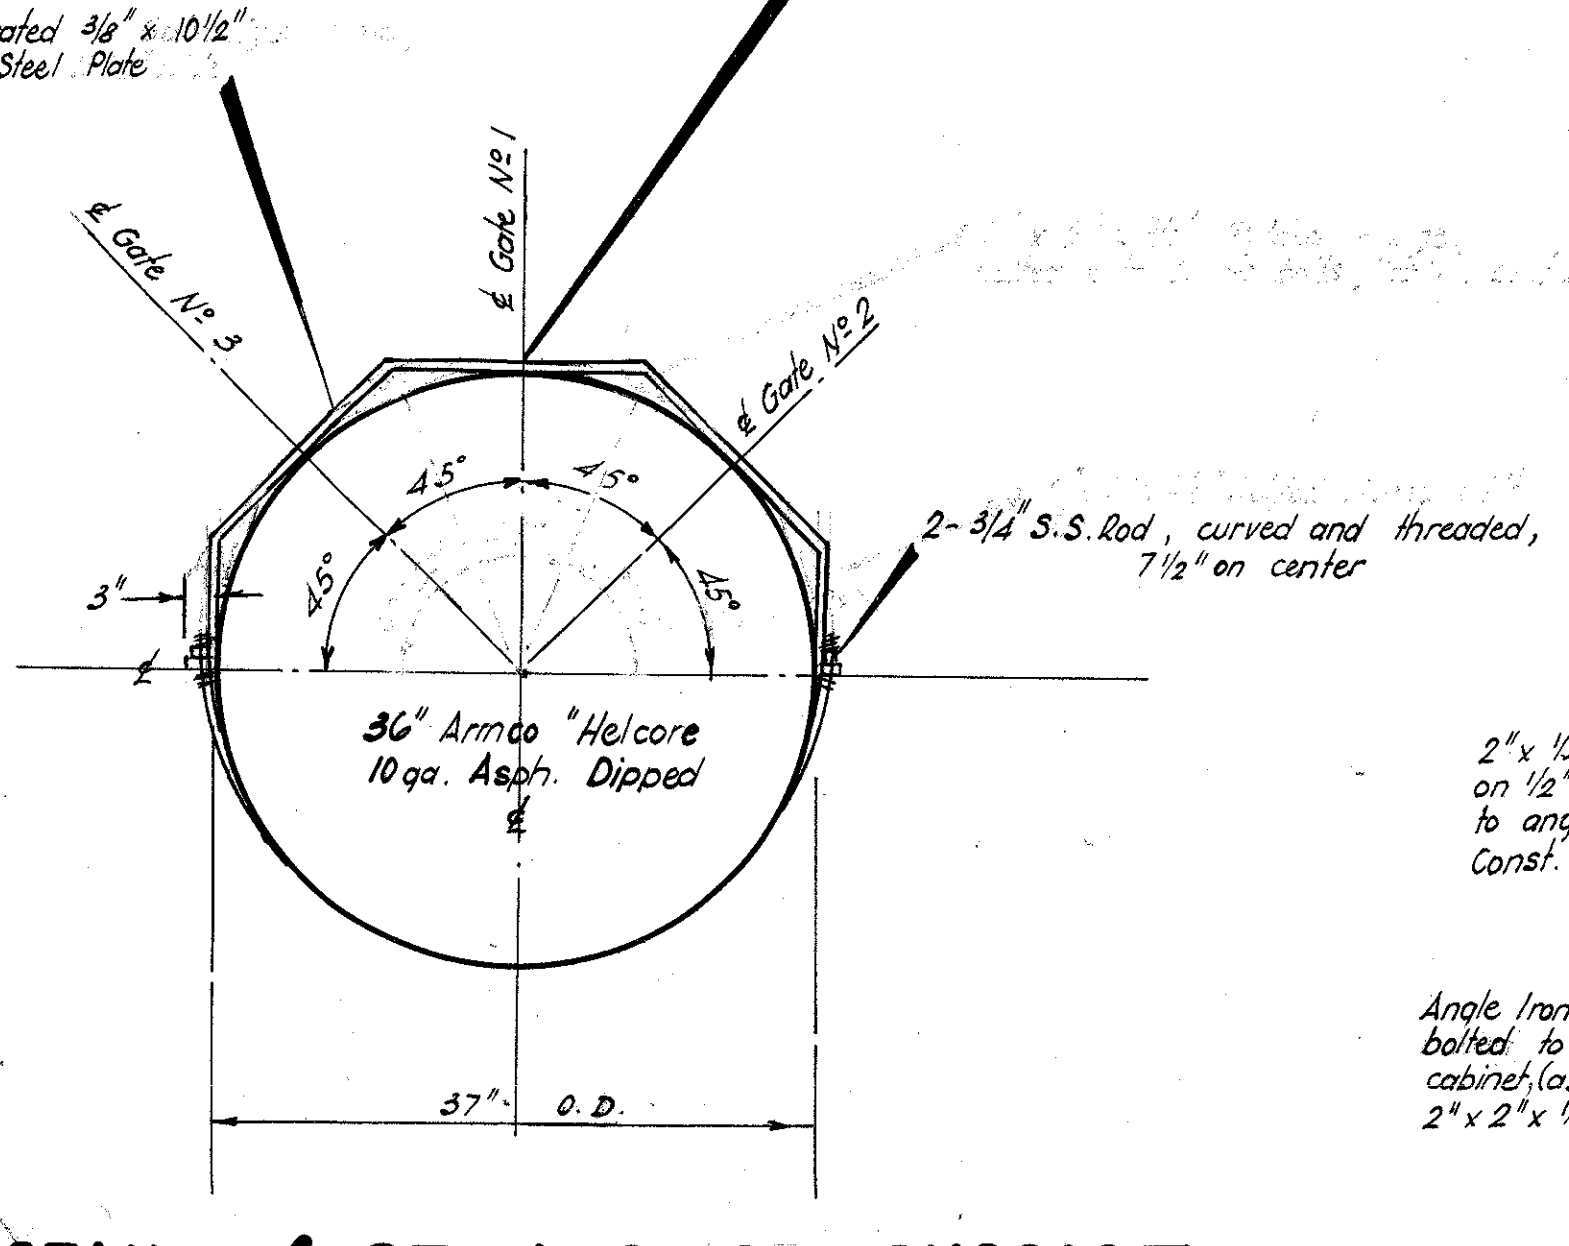
**DETAIL of STEM GUIDE SUPPORT (6 REQUIRED)**

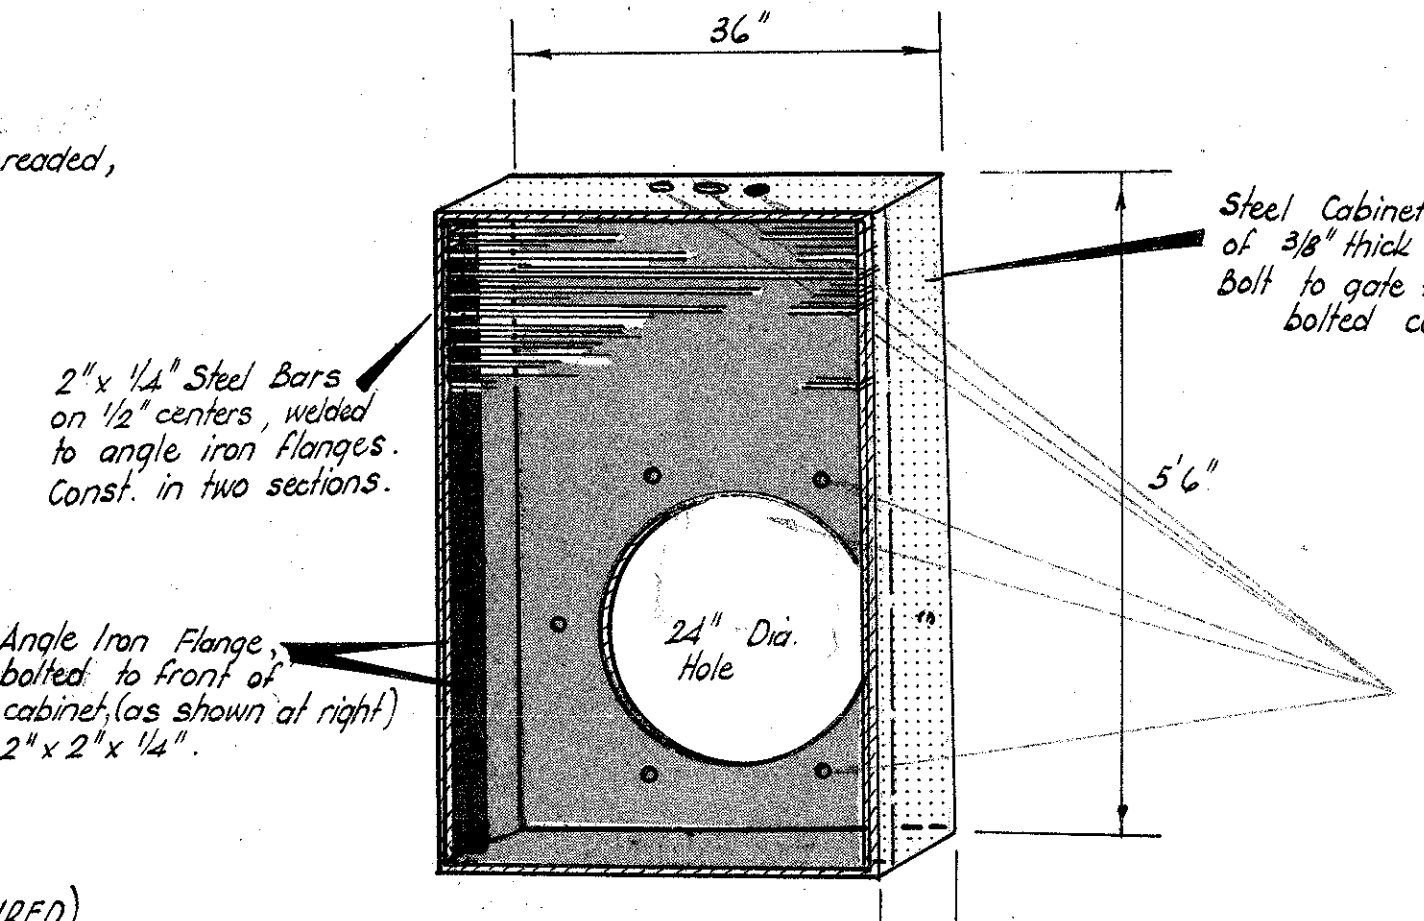
**DETAIL of TRASH RACK at GATED OPENINGS**

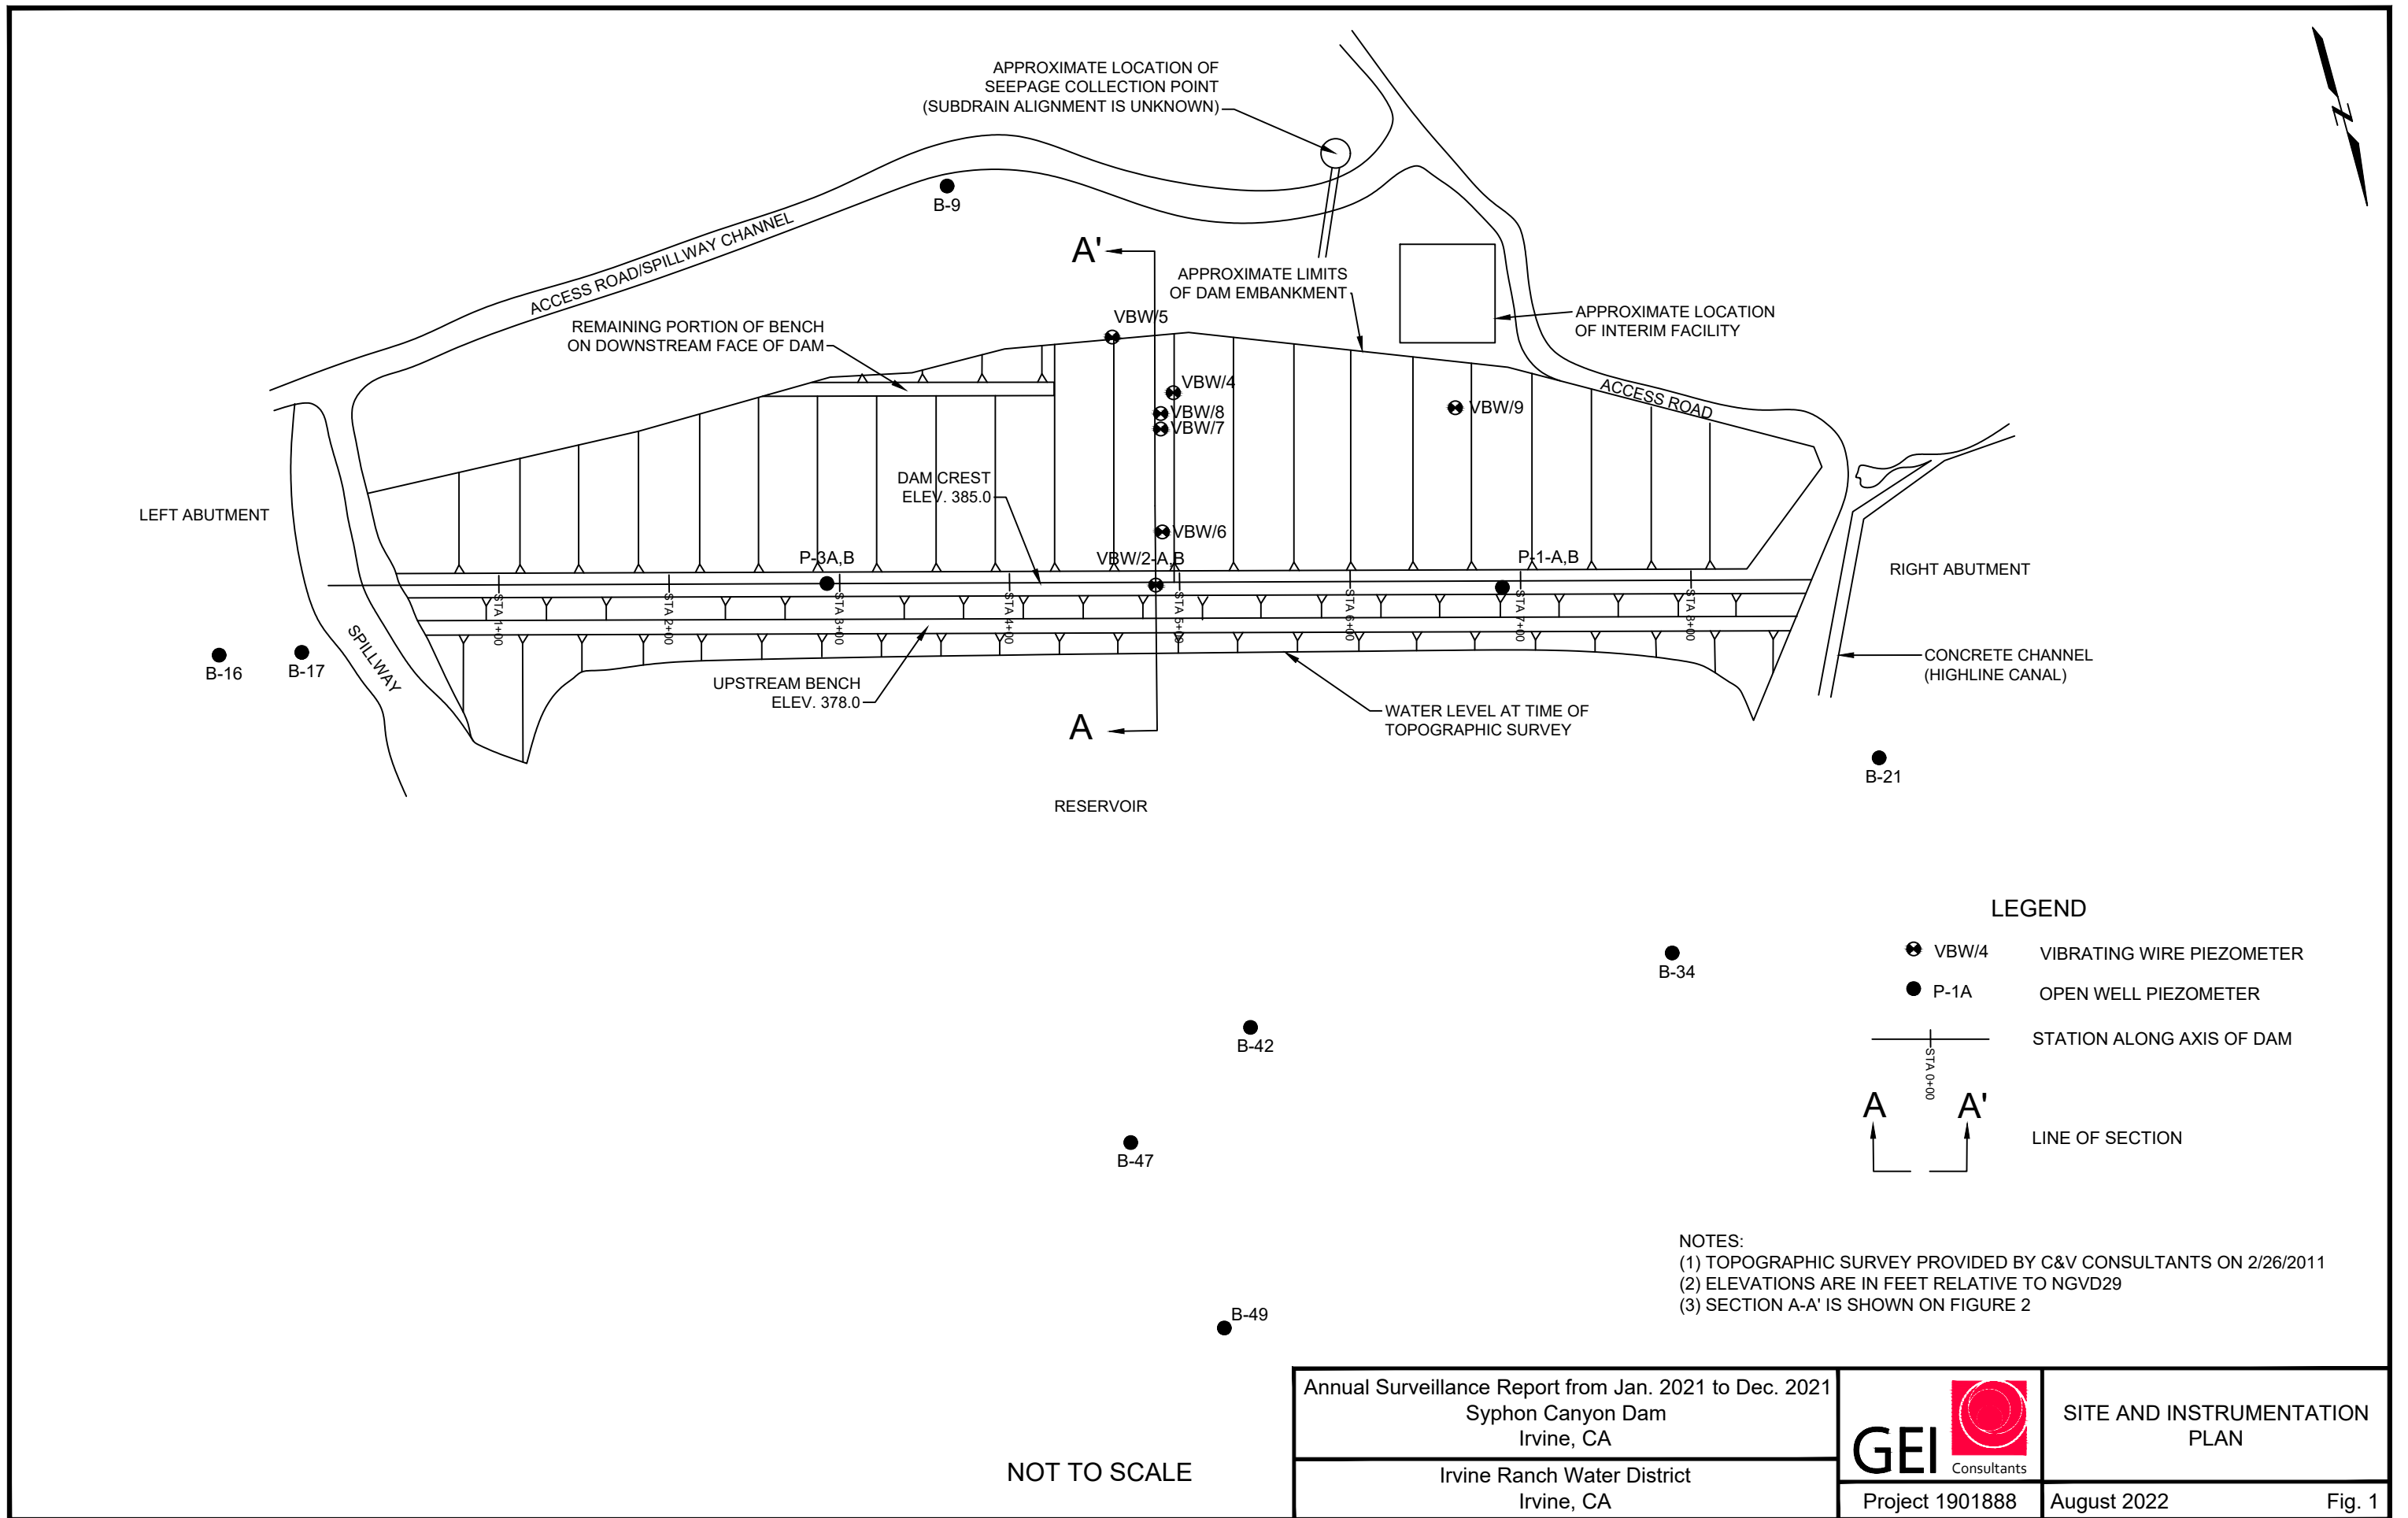
Exhibit 6.3  
Location of Critical Valve at Syphon Dam

SITE AND INSTRUMENTATION PLAN
Project 1901888 August 2022 Fig. 1

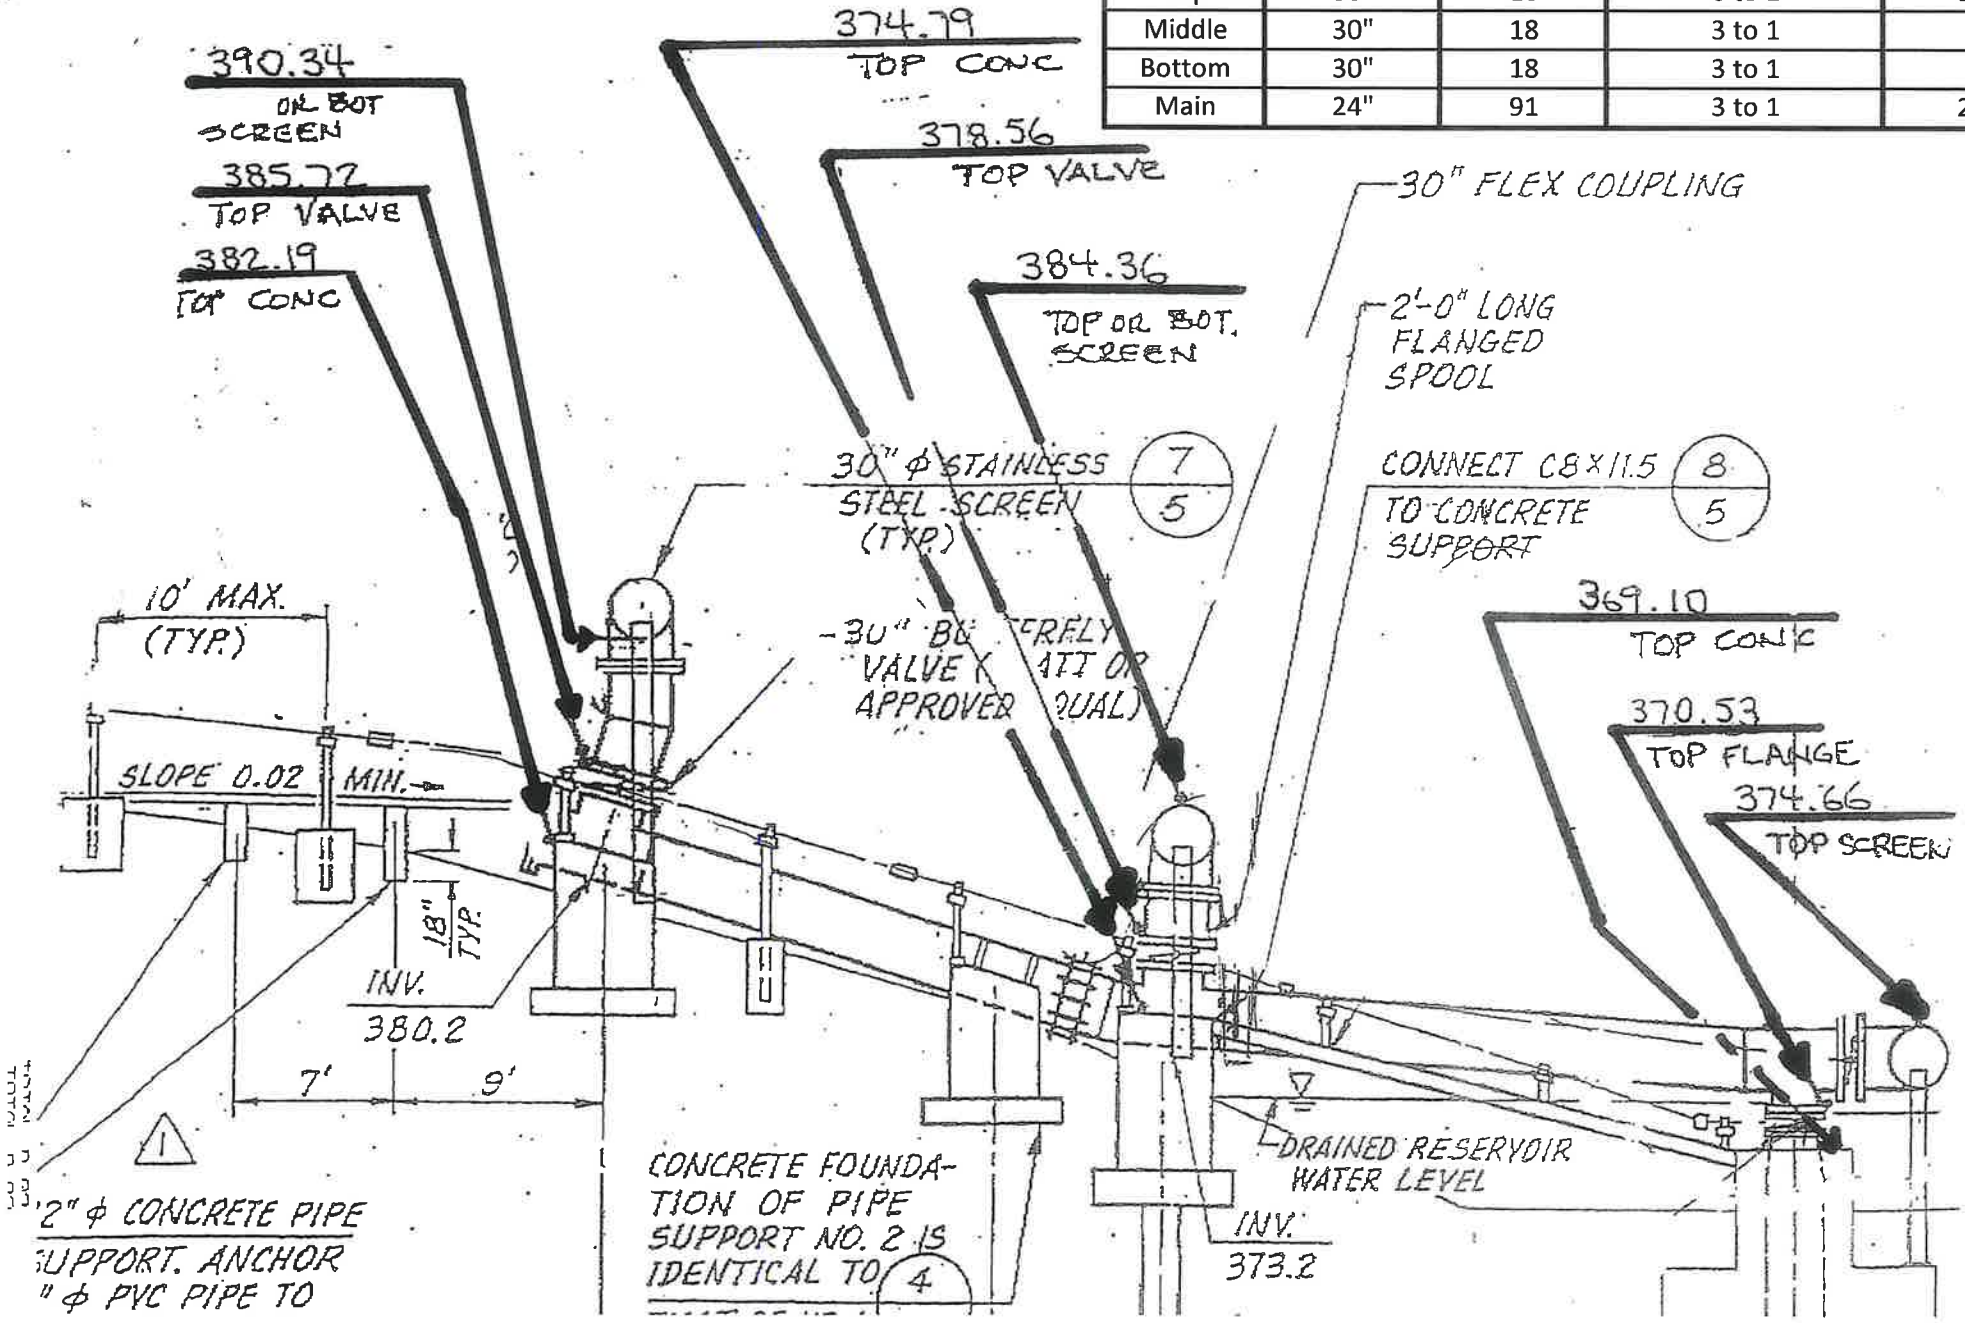
# Rattlesnake Reservoir Outlet Structure

Location	Valve Size	# Turns	Top Gear Reduction	Total # Turns
Top	30"	18	6 to 1	108
Middle	30"	18	3 to 1	54
Bottom	30"	18	3 to 1	54
Main	24"	91	3 to 1	273

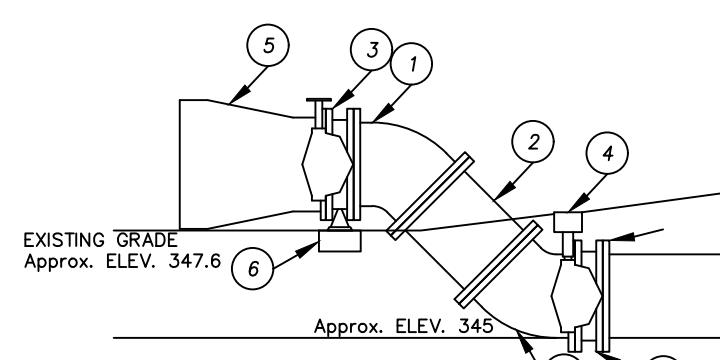
39 SECTION  
AUGMENT VALVES  
3/8" = 1'-0"

- CONSTRUCTION NOTES
- 1 DIP 45° BEND, F.E. X F.E.
  - 2 DIP SPOOL, F.E. X F.E.
  - 3 24" BUTTERFLY VALVE
  - 4 VALVE CAN
  - 5 24" TIDEFLEX CHECK VALVE
  - 6 PIPE SUPPORT

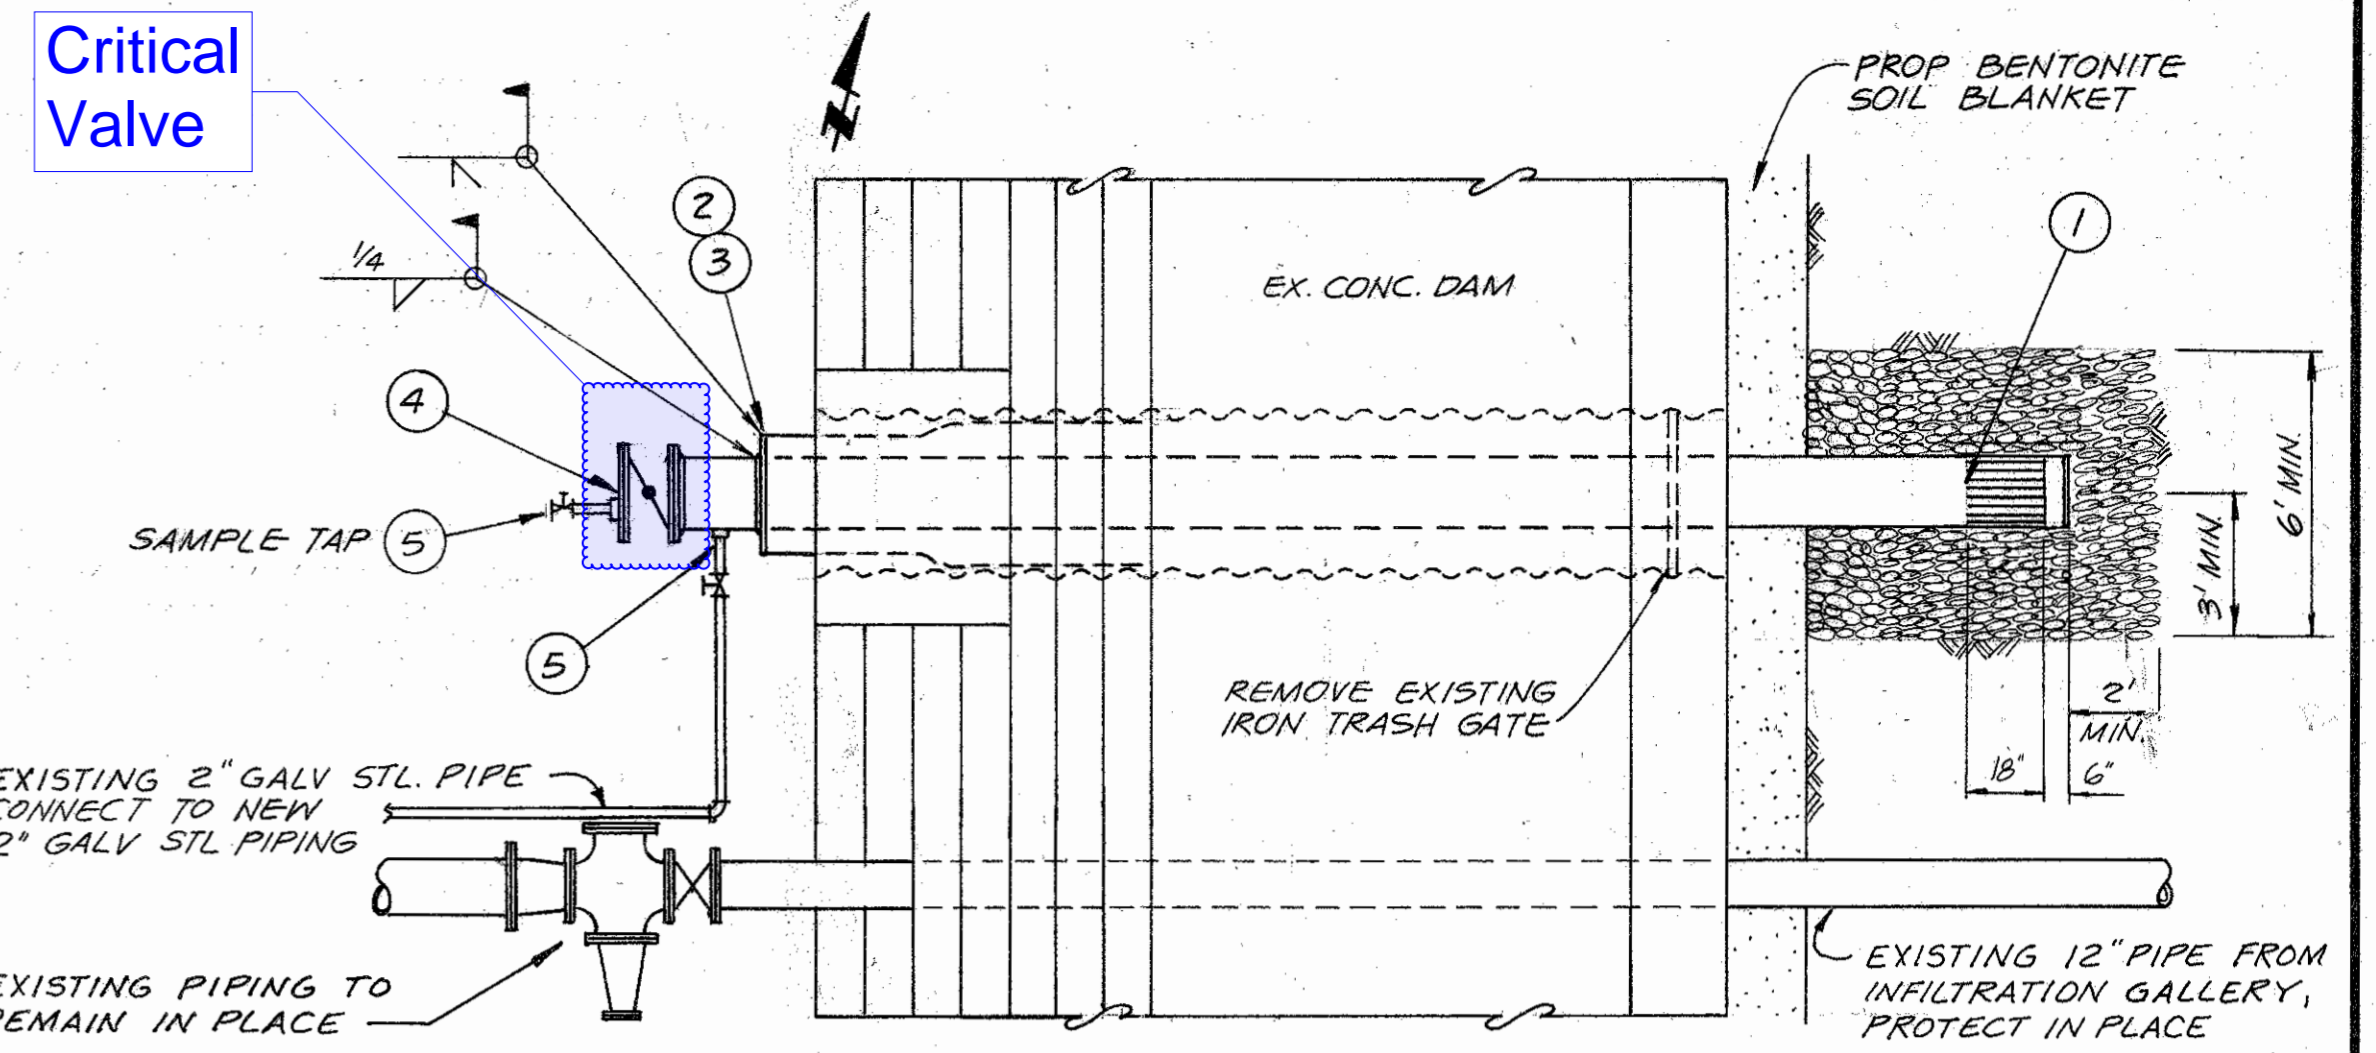
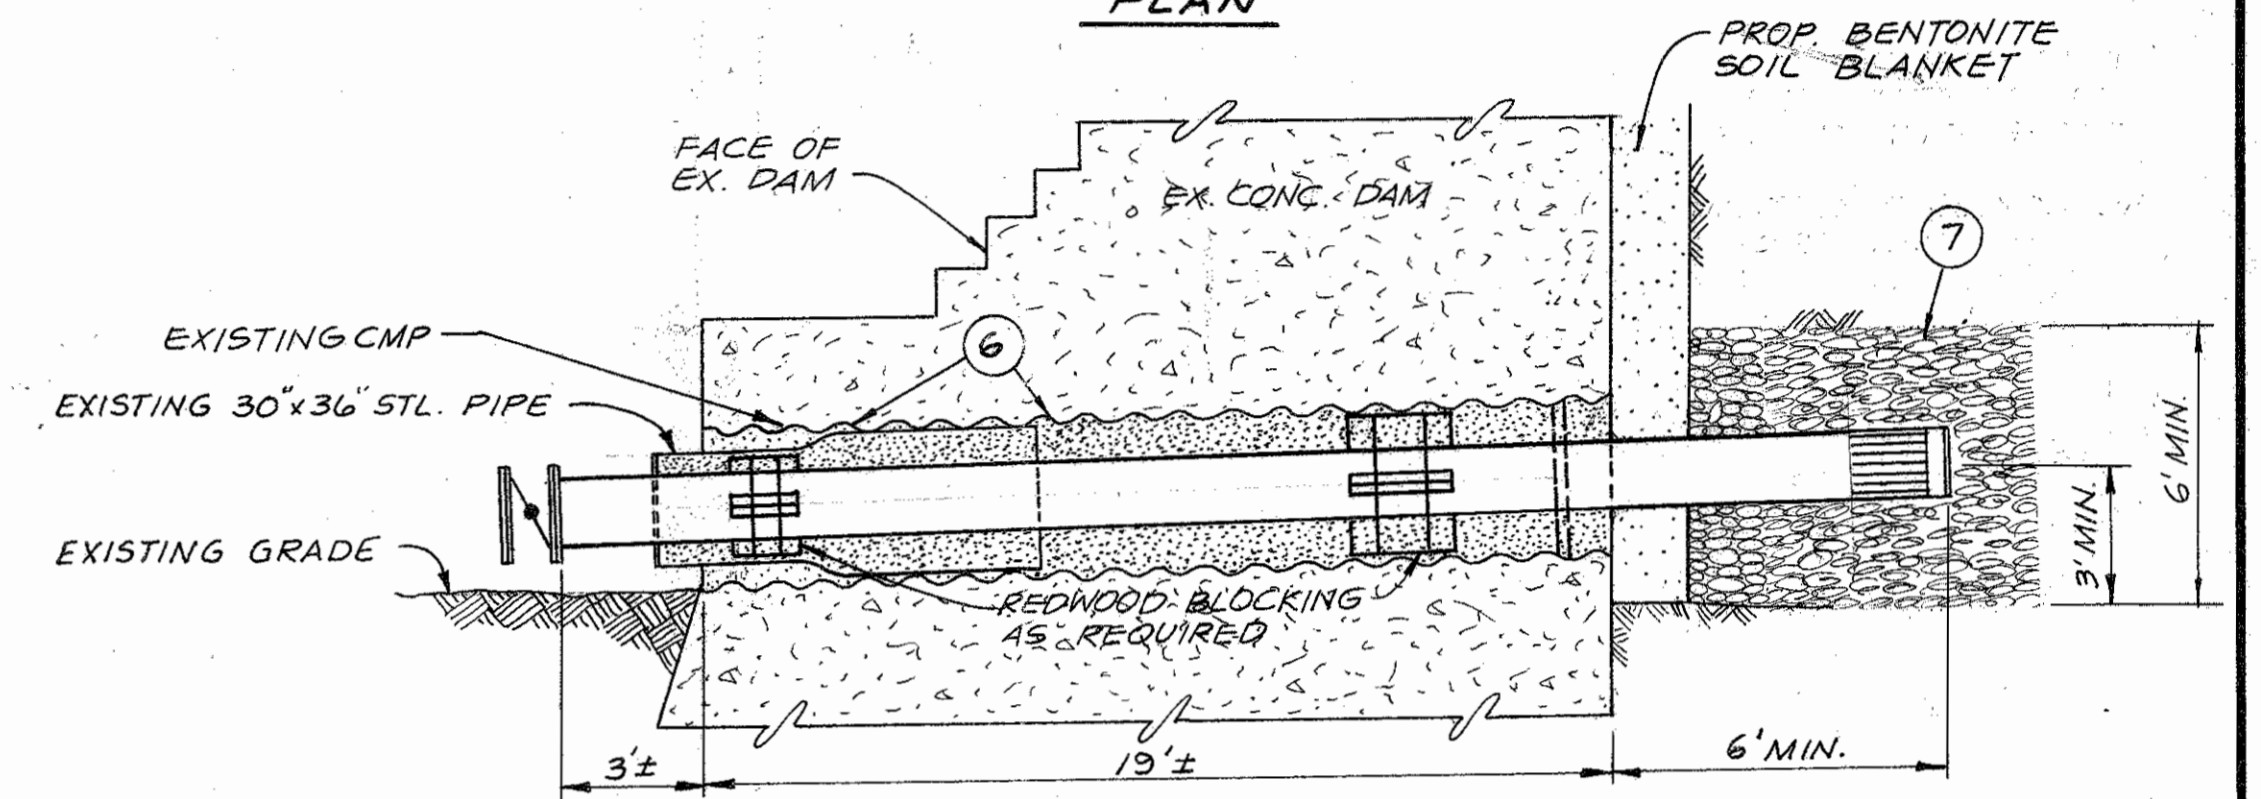
DRAIN PIPING DETAIL (1)

PLAN

SECTION

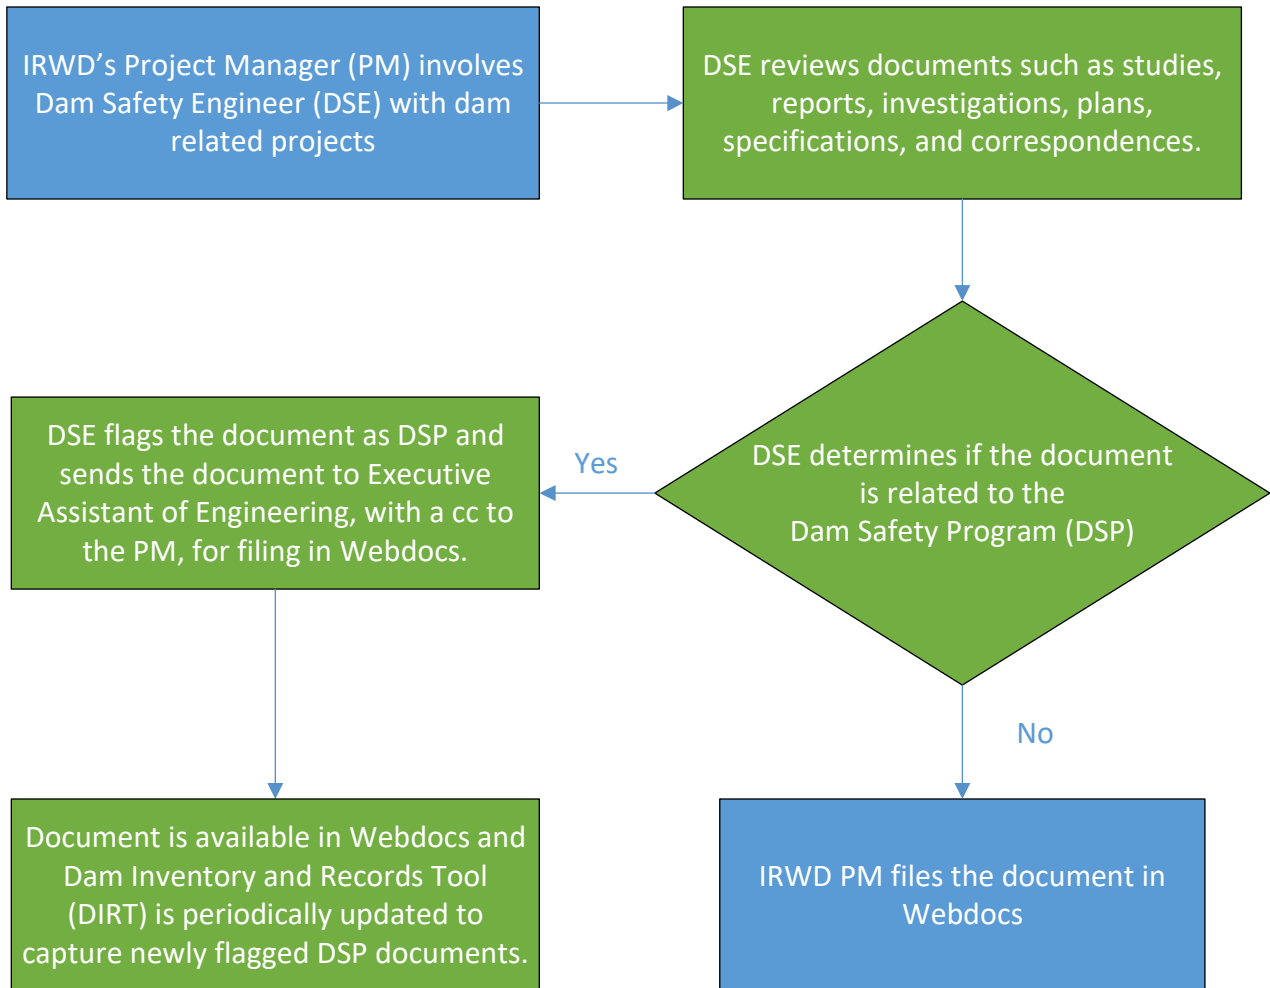
Figure 1: Data Management Process for IRWD's Dam Inventory and Records Tool

Blue = Project Manager Item

Green = Dam Safety Engineer Item

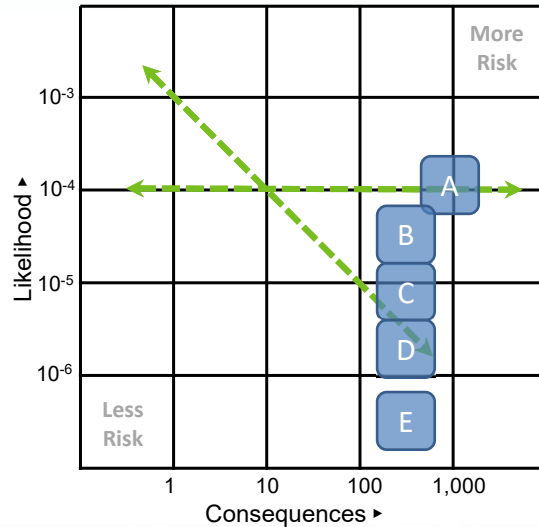
## Background – Potential Failure Modes Influencing Total Risk at Rattlesnake Dam

B: Internal erosion through soil foundation

D: Spillway slab failure

E: Internal erosion through embankment

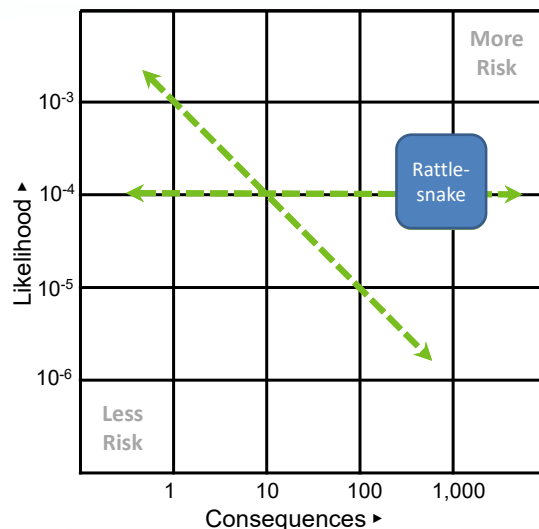
- Previous studies indicate presence of alluvium foundation material, potential for liquefaction of foundation, and a wide range of material strengths.
- Additional geotechnical investigations and evaluations are needed to characterize extent and strengths of liquefiable materials.
- Permitted operating level of 406-ft may not provide adequate risk reduction.
- Preliminary slope stability analysis indicates significant risk reduction by operating at or below elevation 395-ft.
